## FIELD INSPECTION REPORT

| Project Name: | Mountain Valley Pipeline | Inspector: | Marshall Willis |
| Spread H:<br>Franklin County | STA 13197+55 – 13262+62<br>MVP-FR-293.01<br>ATWS 1055/1411 | Weather: | Dry |

## FIELD INSPECTION PHOTO LOG

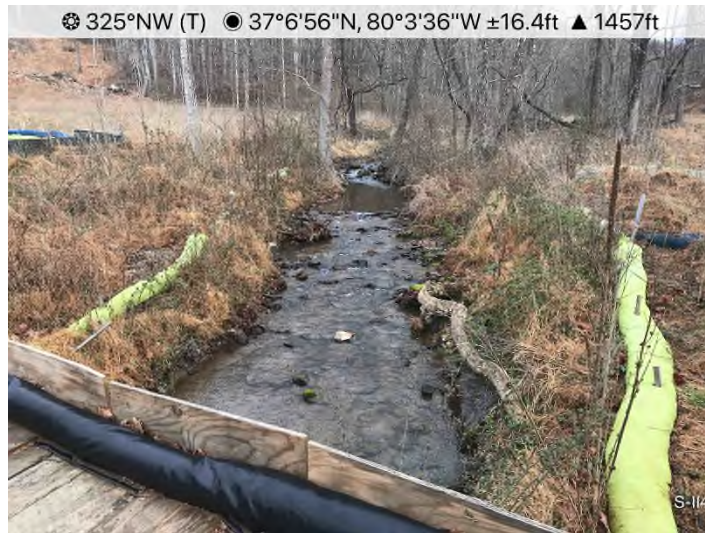
**Figure 1: Stream S-II4** – Controls in place and functioning properly around stream S-II4.

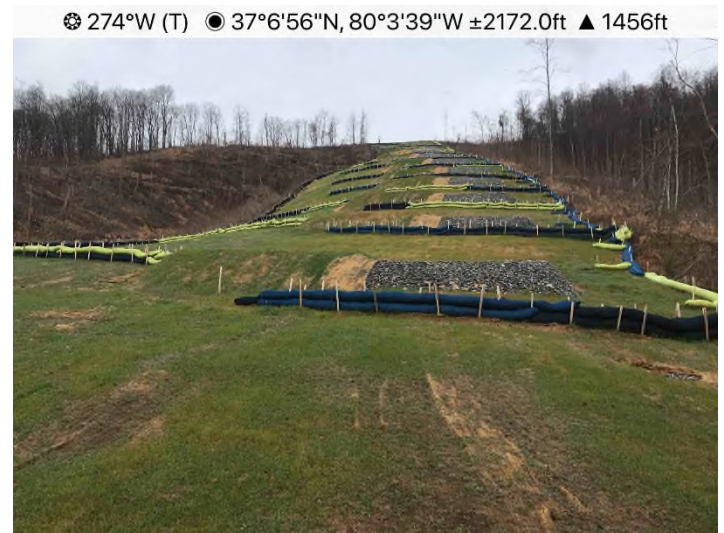
**Figure 2: STA 13260+00** – Controls in place and functioning properly.

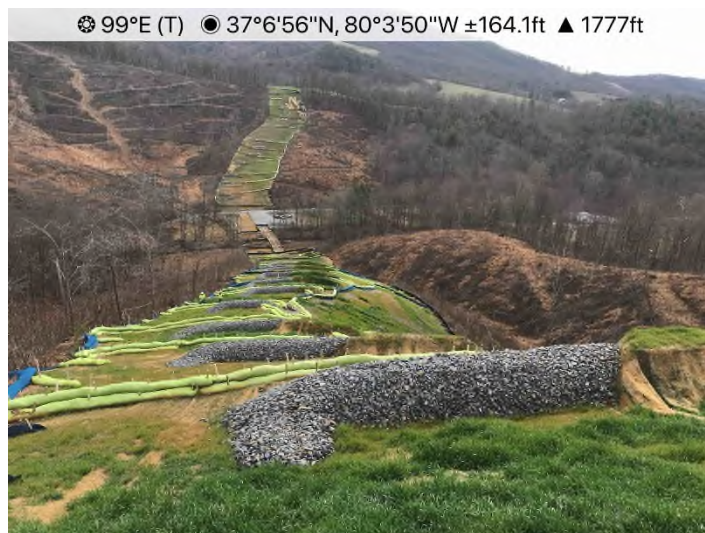
**Figure 3: STA 13249+00** – Controls in place and functioning properly.

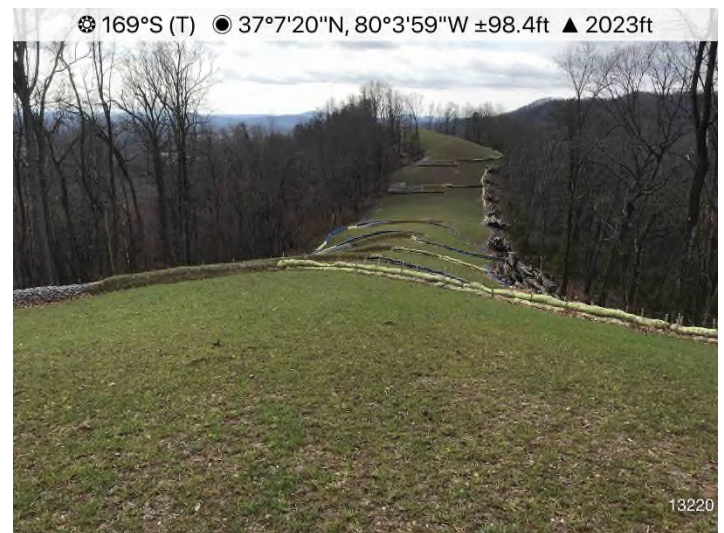
**Figure 4: STA 13220+00** – Controls in place and functioning properly.
