## FIELD INSPECTION REPORT

| <b>Project Name:</b> | Mountain Valley Pipeline | <b>Inspector:</b> | Marshall Willis |
| <b>Inspection Date:</b> | Monday, March 9, 2020 | <b>Project Contact:</b> | Brian Clauto, Cory Chalmers |
| <b>Spread I:<br/>Pittsylvania County</b> | STA 15853+73 – 15947+64<br>MVP-PI-340<br>ATWS 506/1321/1322/1323/611/612 | <b>Weather:</b> | Dry |

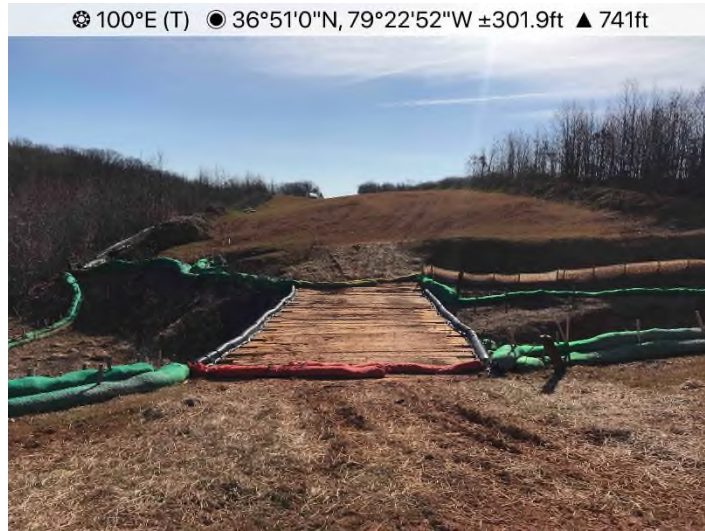
**Figure 1: STA 15868+00** – Controls in place and functioning properly.

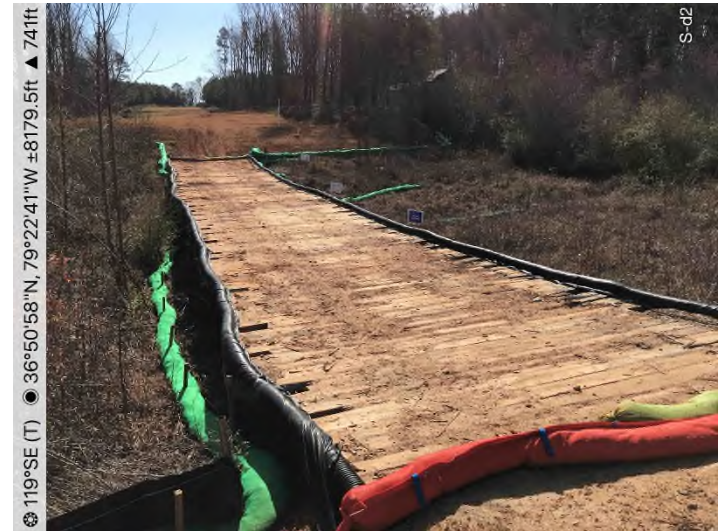
**Figure 2: Stream S-B2** – Controls in place and functioning properly around stream S-B2.

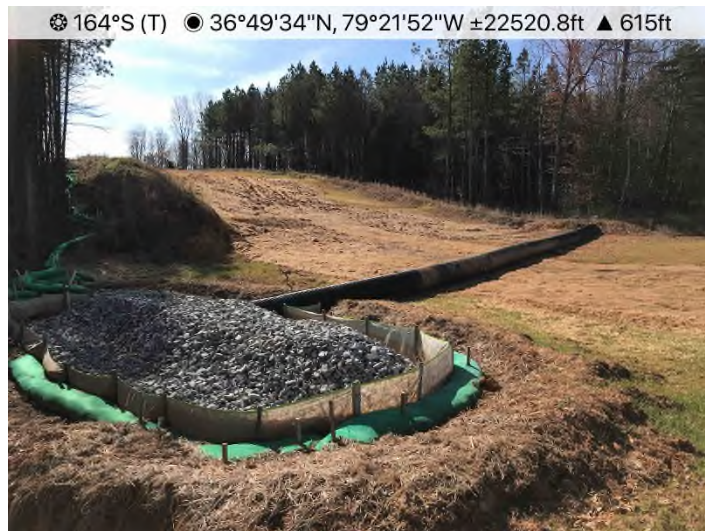
**Figure 3: STA 15933+00** – Controls in place and functioning properly.

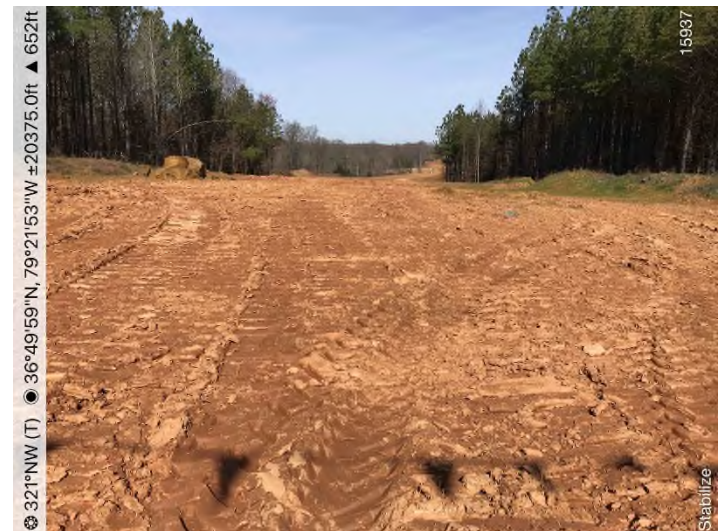
**Figure 4: STA 15937+00 to 15939+00** – Re-stabilization needed.

- STA 15937+00 to 15939+00: Re-stabilize ROW.

**Recommended Corrective Action:** Maintain and install all controls per the approved PSS&S.
