## FIELD INSPECTION REPORT

| <b>Project Name:</b> | Mountain Valley Pipeline | <b>Inspector:</b> | Marshall Willis |
| <b>Spread H:<br/>Franklin County</b> | STA 13061+44 – 13120+00<br>ATWS 344/1248A/1248/1038/1039<br>MVP-FR-290/291 | <b>Weather:</b> | Dry |

## FIELD INSPECTION PHOTO LOG

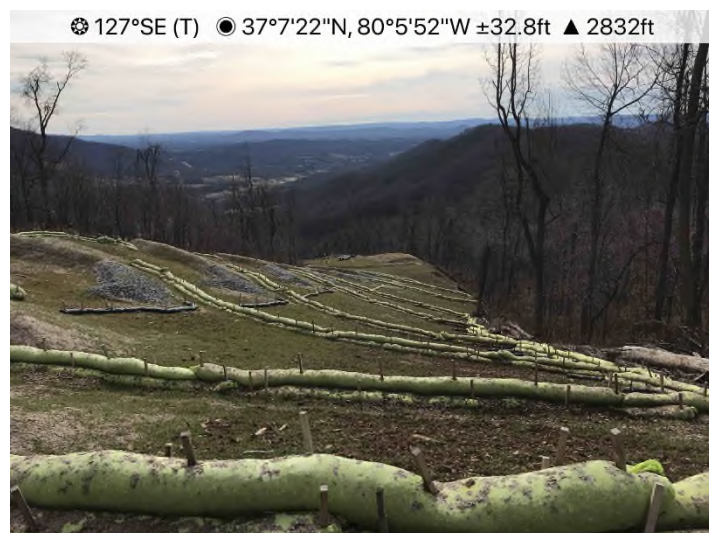
**Figure 1: STA 13109+00** – Controls in place and functioning properly.

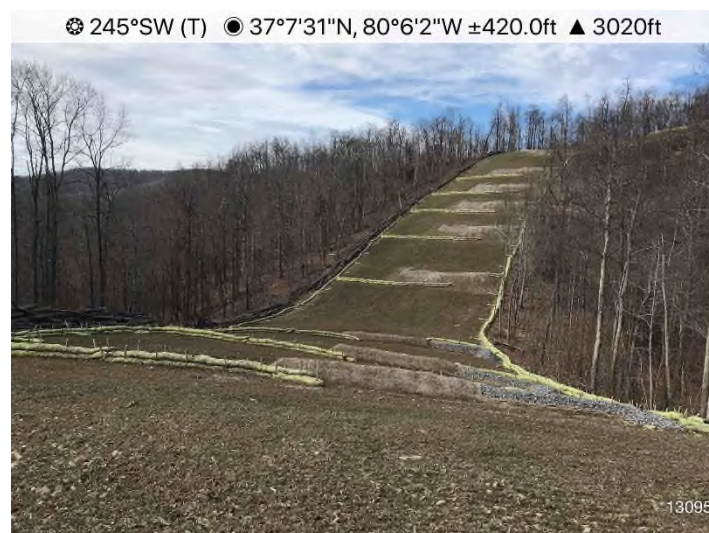
**Figure 2: STA 13095+00** – Controls in place and functioning properly.

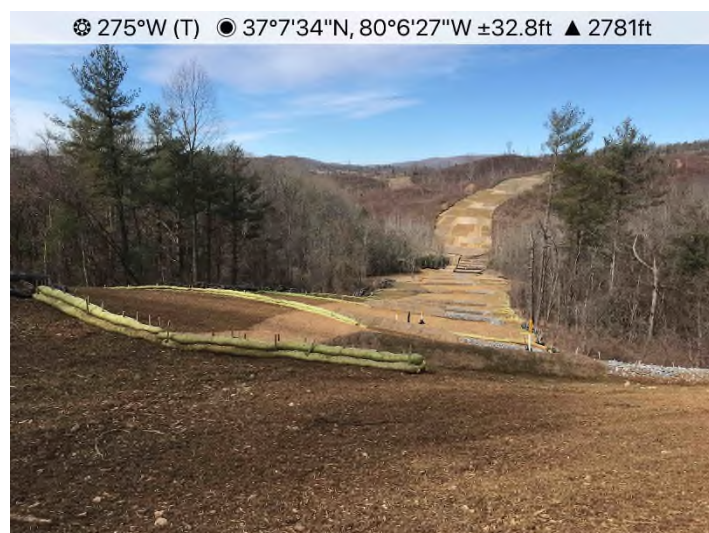
**Figure 3: STA 13072+00** – Controls in place and functioning properly.

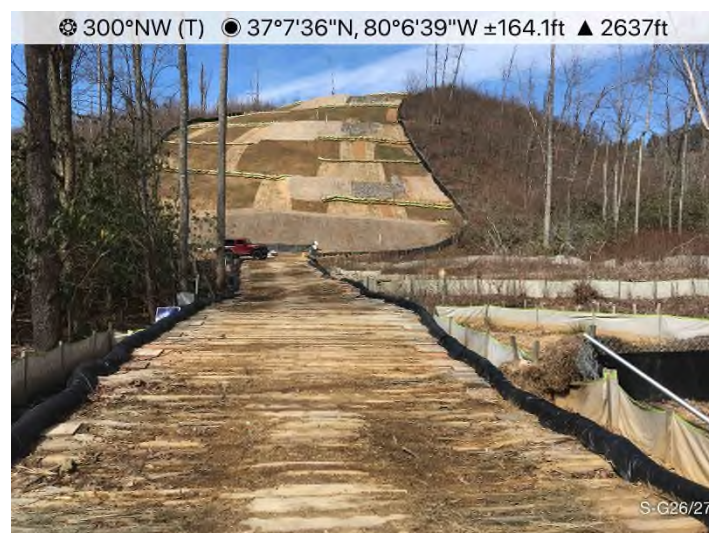
**Figure 4: Stream S-G26/27** – Controls in place and functioning properly.
