FIELD INSPECTION REPORT

Project Name:	Mountain Valley Pipeline	Inspector:	Marshall Willis
Inspection Date:	Tuesday, March 3, 2020	Project Contact:	Brian Clauto, Cory Chalmers
Spread I: Pittsylvania County	STA 15584+23 - 15647+03 ATWS 813/1445	Weather:	Rainy

FIELD INSPECTION PHOTO LOG

Project Name: Mountain Valley Pipeline

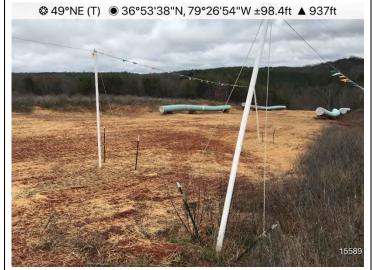
Figure 1: **STA 15589+00** – Controls in place and functioning properly.

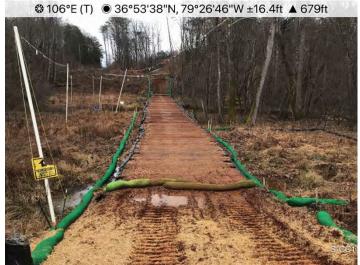
<u>Figure 2</u>: **Stream S-CC1** – Controls in place and functioning properly.

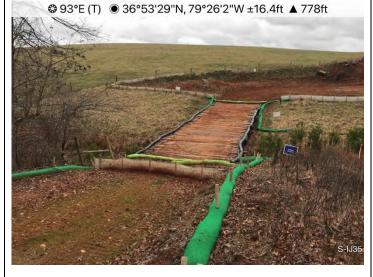
<u>Figure 3</u>: **Stream S-IJ35-EPH** – Controls in place and functioning properly.

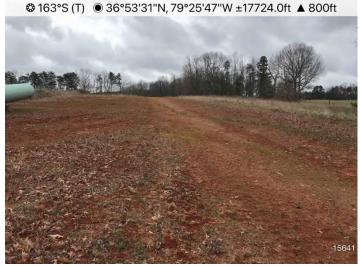
Figure 4: STA 15641+00 – Controls in place and functioning properly. Area stabilized with Earth-Guard.
