## FIELD INSPECTION REPORT

| <b>Project Name:</b> | Mountain Valley Pipeline | <b>Inspector:</b> | Matthew Grant |
| <b>Spread H:</b><br><br>Franklin | MP 251-252<br>MP253.8- 253.9<br>ATWS 1412, 1055<br>AR FR 293.01 | <b>Weather:</b> | Dry |

## FIELD INSPECTION PHOTO LOG

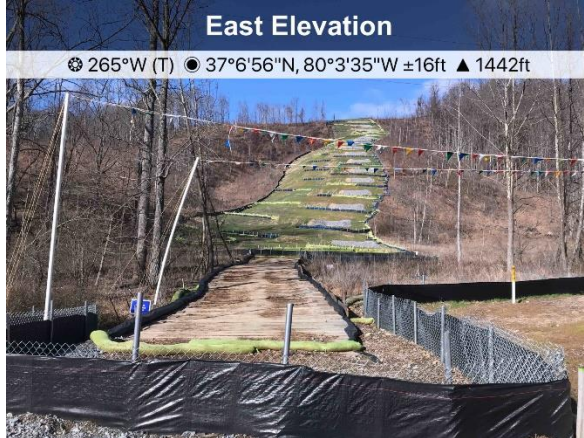
Figure 1: Designated crossing S-II4, ECD's are in place.

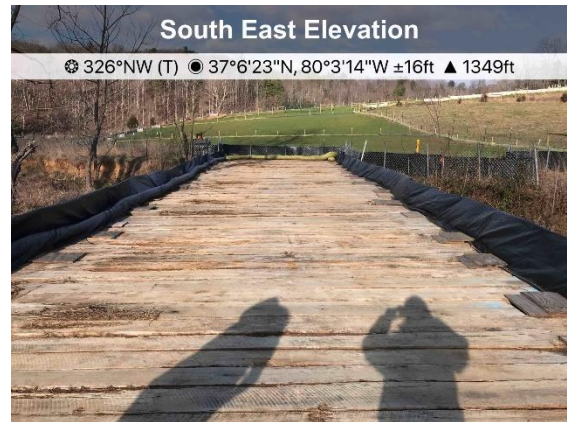
Figure 2: Designated crossing S-GH7, ECD's are in place.

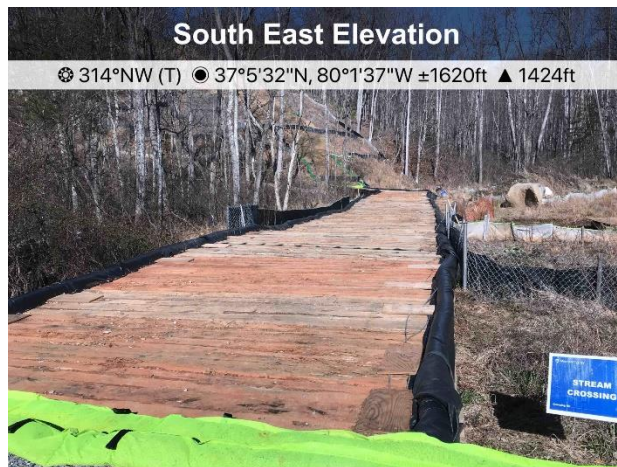
Figure 3: Designated crossings S-IJ1 & W-IJ2, ECD's are in place.

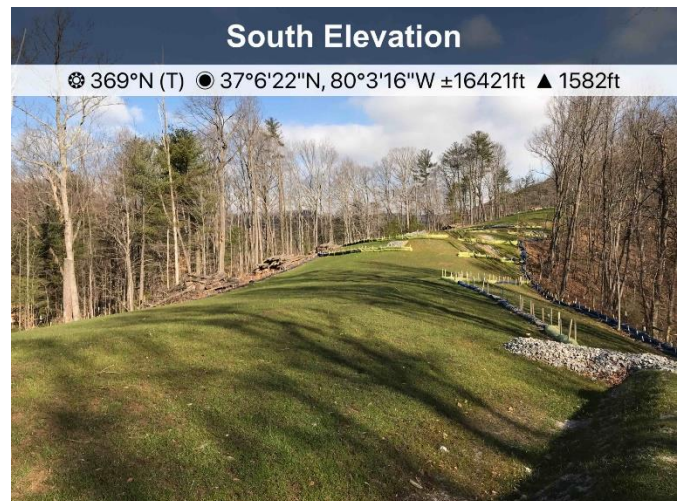
Figure 4: Near MP25.3 ECD's are in place and the area is well stabilized.
