FIELD INSPECTION REPORT

Project Name:	Mountain Valley Pipeline	Inspector:	Matthew Grant
Inspection Date:	Wednesday, February 26, 2020	Project Contact:	Brian Clauto,
Spread I: Franklin	MP 275.3-277.2 MP 285.1-286 ATWS 362	Weather:	Wet

FIELD INSPECTION PHOTO LOG

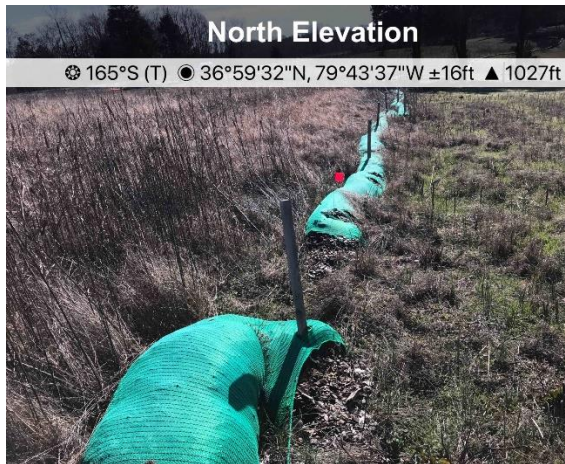
- St14639+85 CFS is torn and requires repair.
- St15092+00 P1 ECD has holes and requires repair.

- Figure 1: St14639+85 CFS has been torn and requires repair, the area is well stabilized.

Recommended Corrective Action: Maintain and install all controls per the approved PSS&S.

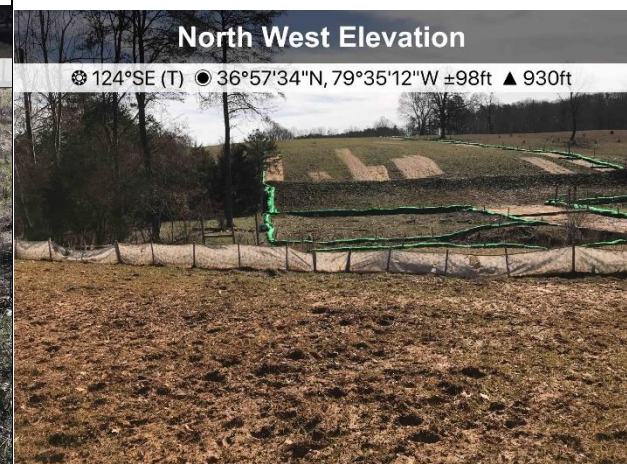
- Figure 2: St15092+00 P1 has holes and requires maintenance.

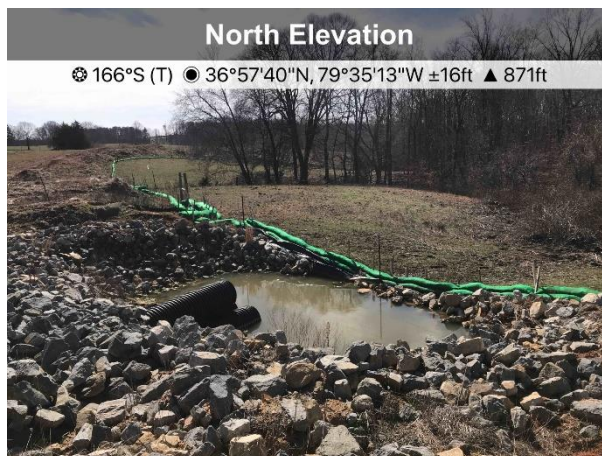
- Figure 3: Near St 14537 CWD is in place.

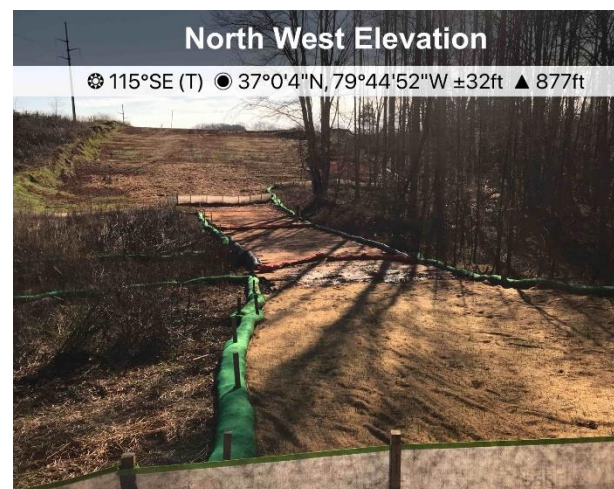
- Figure 4: Designated crossing S-E18, ECD's are in place.
