## FIELD INSPECTION REPORT

| Project Name: | Mountain Valley Pipeline | Inspector: | Marshall Willis |
| Inspection Date: | Wednesday, February 19, 2020 | Project Contact: | Brian Clauto, Cory Chalmers |

## FIELD INSPECTION PHOTO LOG

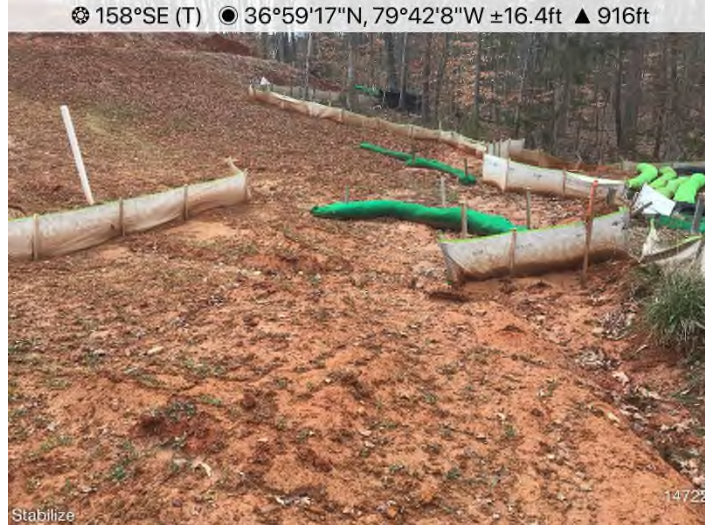
**Figure 1: STA 14717+50 – Re-stabilize denuded ROW and repair erosion.**

**Recommended Corrective Action:** Maintain and install all controls per the approved PSS&S.

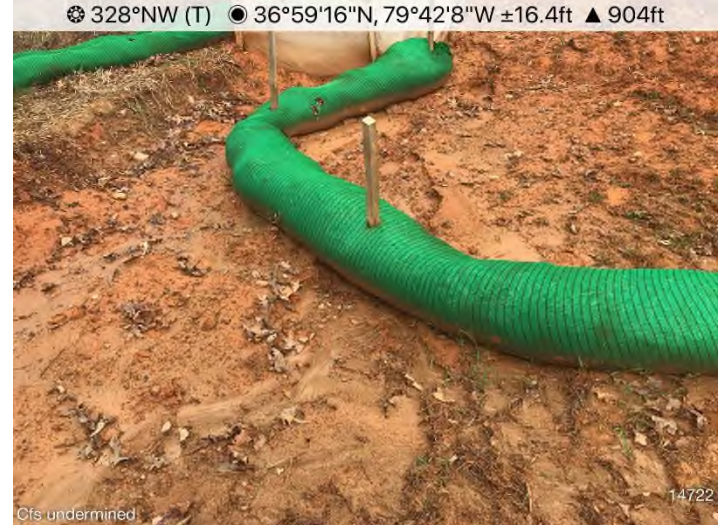
**Figure 2: STA 14717+50 – CFS undermined. Repair needed.**

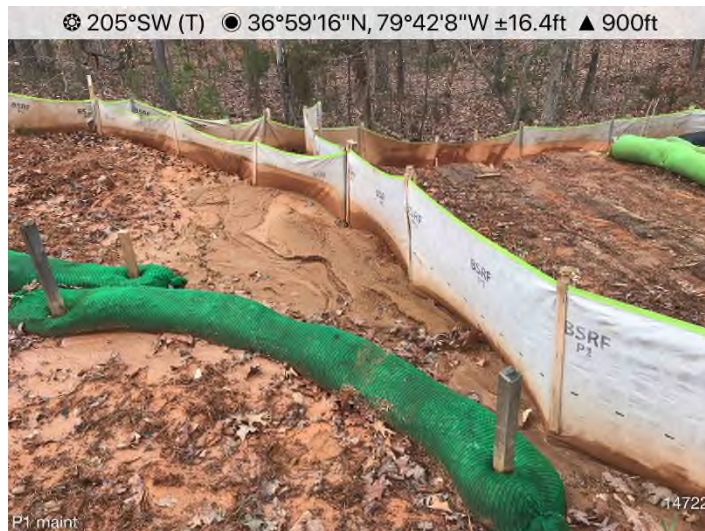
**Figure 3: STA 14717+50 – P1 maintenance needed.**

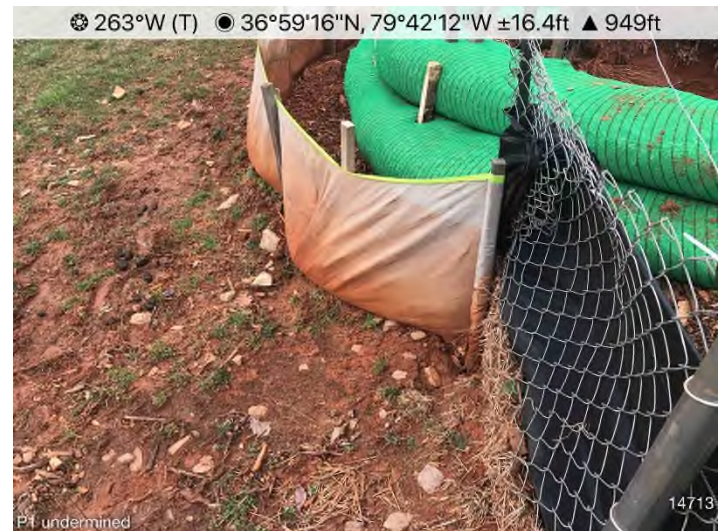
**Figure 4: STA 14713+00 – P1 undermined. Repair needed.**

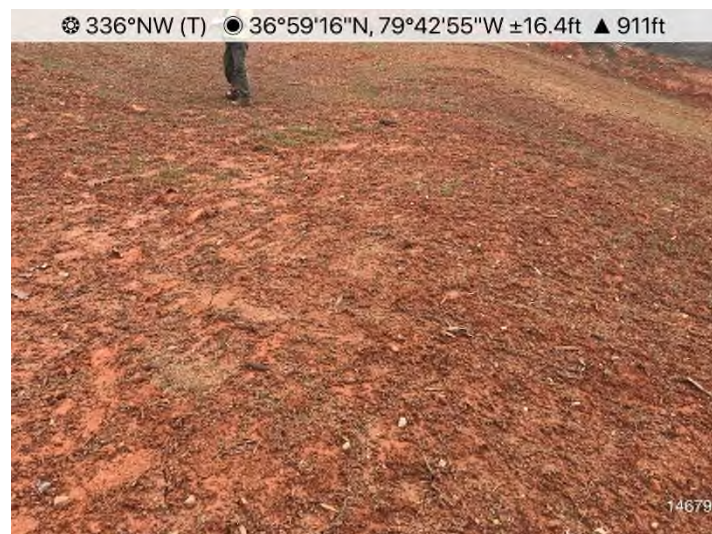
Figure 5: STA 14679+00 – Waterbar maintenance needed.
