## FIELD INSPECTION REPORT

| <b>Project Name:</b> | Mountain Valley Pipeline | <b>Inspector:</b> | Marshall Willis |
| <b>Inspection Date:</b> | Tuesday, June 2, 2020 | <b>Project Contact:</b> | Brian Clauto, Cory Chalmers |
| <b>Spread H:<br/>Montgomery County</b> | STA 12072+50 – 12188+34<br>MVP-MN-270/271/273/274<br>ATWS 1163/1162/701/1167/1168 | <b>Weather:</b> | Dry |

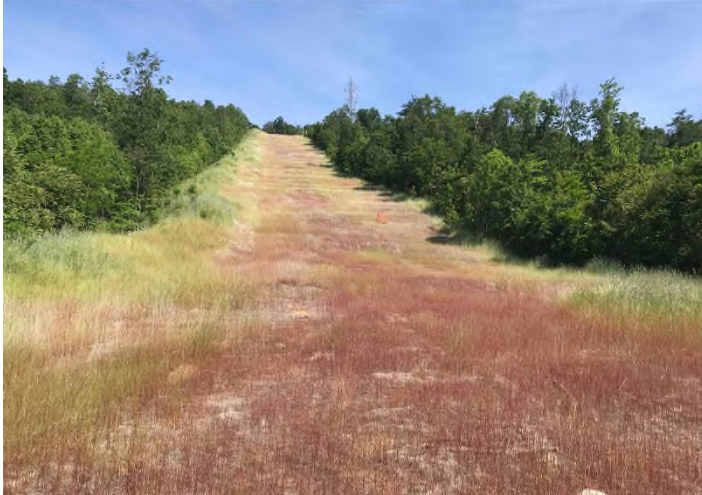
**Figure 1: STA 12072+00** – Controls in place and functioning properly. Area stabilized.

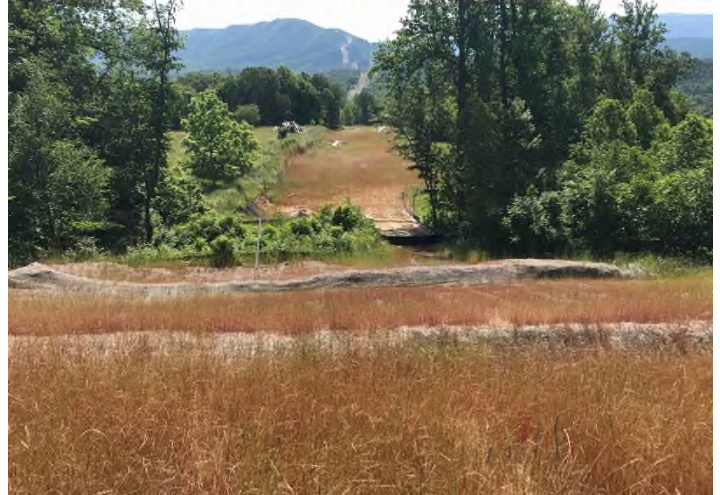
**Figure 2: STA 12085+00** – Controls in place and functioning properly. Area stabilized.

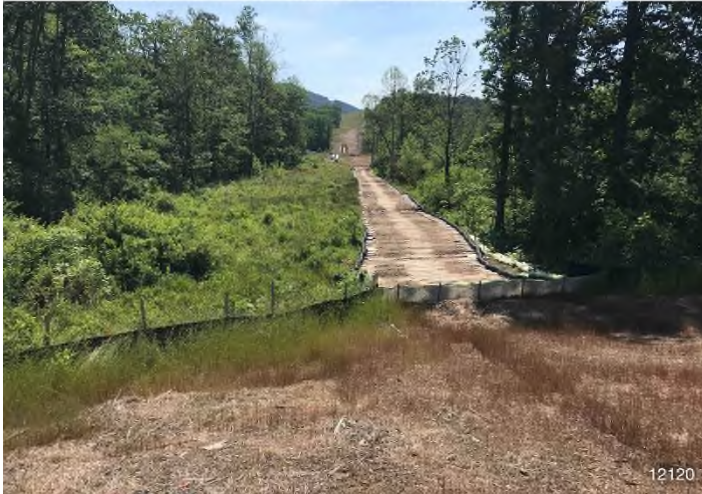
**Figure 3: STA 12120+00** – Controls in place and functioning properly. Area stabilized.

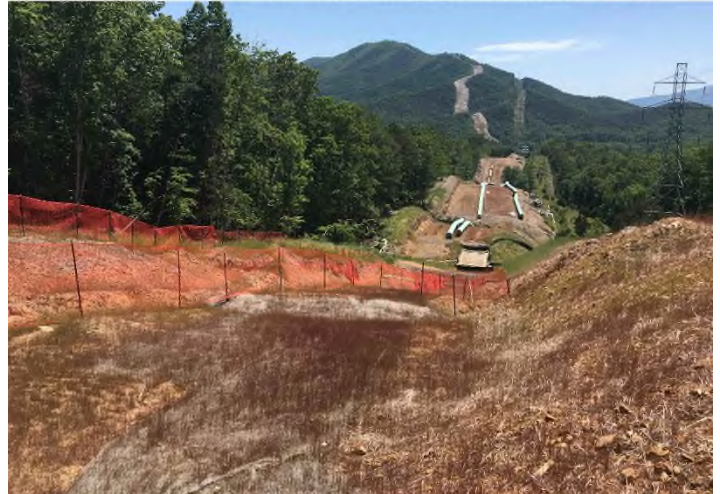
**Figure 4: STA 12155+00** – Controls in place and functioning properly. Area stabilized.
