## FIELD INSPECTION REPORT

| <b>Project Name:</b> | Mountain Valley Pipeline | <b>Inspector:</b> | Marshall Willis |
| <b>Inspection Date:</b> | Friday, May 29, 2020 | <b>Project Contact:</b> | Brian Clauto, Cory Chalmers |
| <b>Spread I:<br/>Pittsylvania County</b> | H-602 STA 0+00 – 22+00<br>H-603 STA 0+00 – 14+00<br>Transco Interconnect | <b>Weather:</b> | Wet |

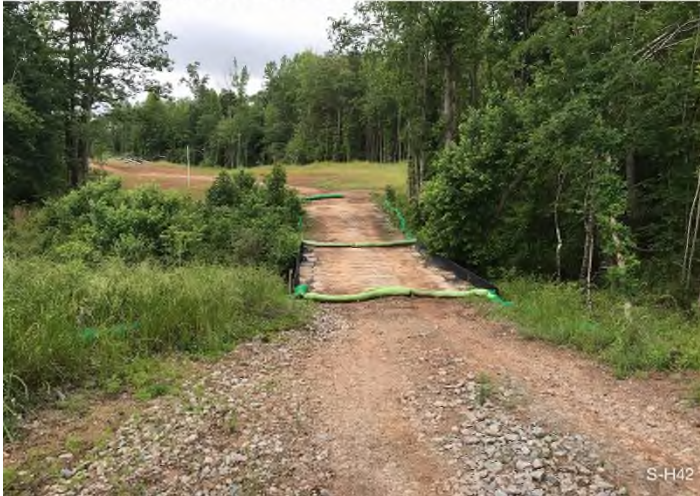
**Figure 1: Stream S-H42** – Controls in place and functioning properly.

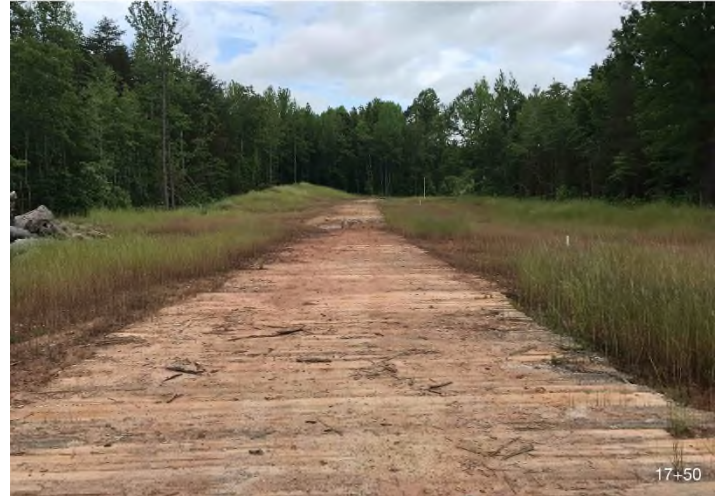
**Figure 2: H-602 STA 17+50** – Controls in place and functioning properly. Area stabilized.

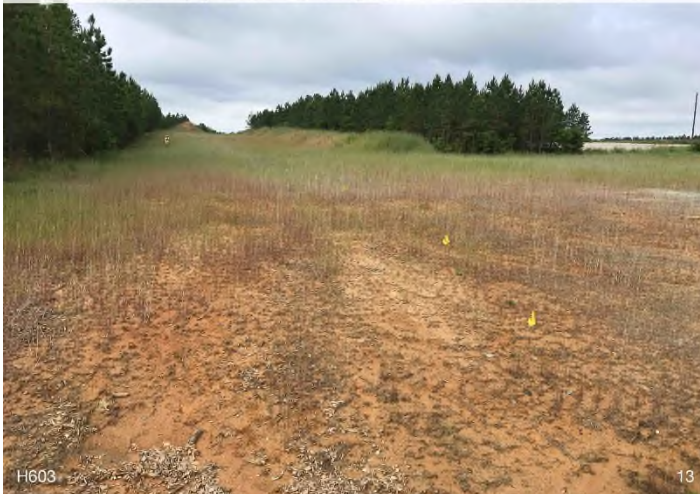
**Figure 3: H-603 STA 13+00** – Controls in place and functioning properly. Area stabilized.
