## FIELD INSPECTION REPORT

| <b>Project Name:</b> | Mountain Valley Pipeline | <b>Inspector:</b> | Marshall Willis |
| <b>Inspection Date:</b> | Wednesday, May 27, 2020 | <b>Project Contact:</b> | Brian Clauto, Cory Chalmers |
| <b>Spread H:<br/>Franklin County</b> | STA 13306+16 – 13316+00<br>STA 13411+83 – 13415+51<br>ATWS 1412/1352 | <b>Weather:</b> | Rainy |

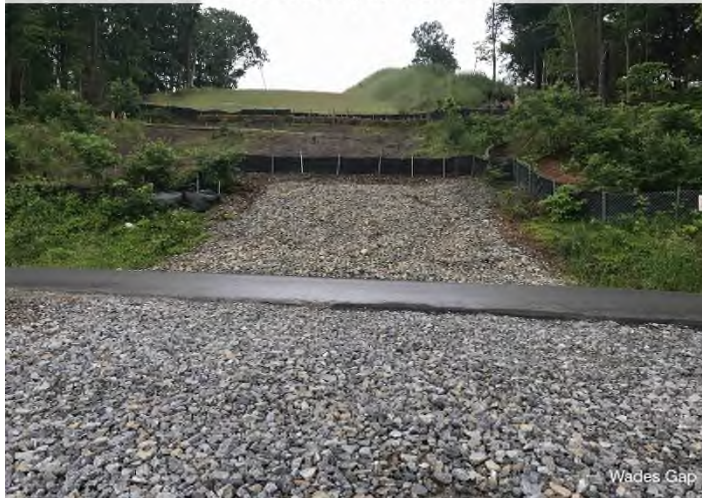
**Figure 1: STA 11306+50** – Controls in place and functioning properly at the Wades Gap crossing.

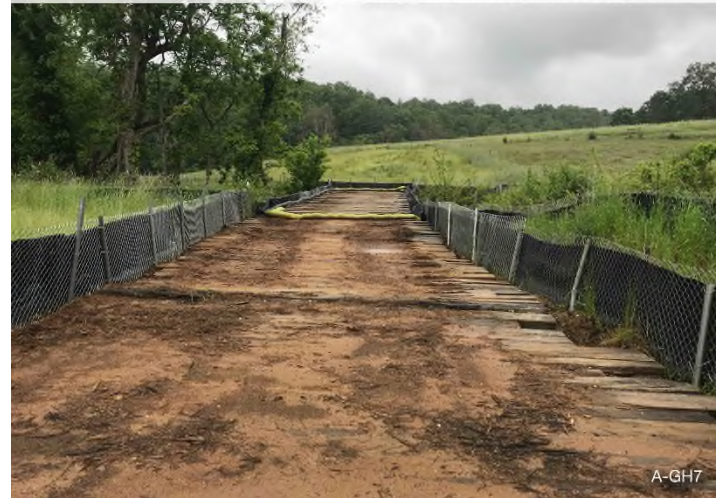
**Figure 2: Stream S-GH7** – Controls in place and functioning properly around S-GH7 crossing. Area stabilized.

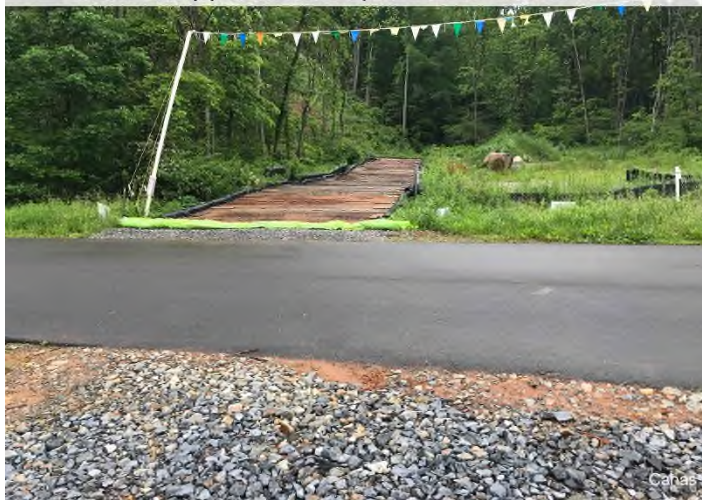
**Figure 3: STA 11306+50** – Controls in place and functioning properly at the Cahas Road crossing.

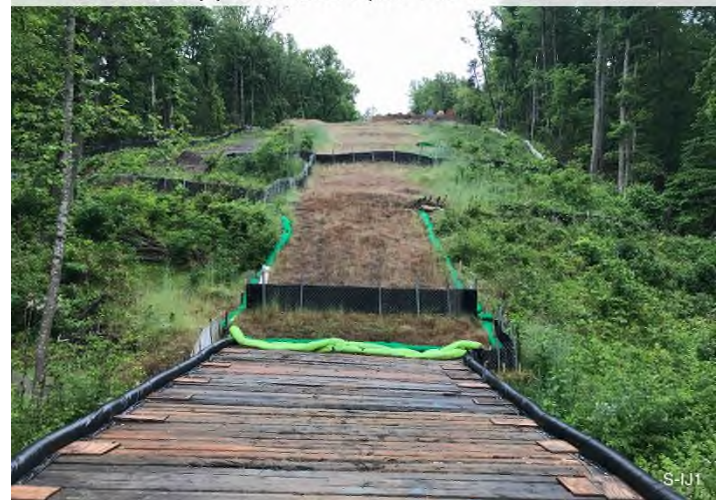
**Figure 4: Stream S-IJ1** – Controls in place and functioning properly at stream S-IJ1 crossing. Area stabilized.
