## FIELD INSPECTION REPORT

| <b>Project Name:</b> | Mountain Valley Pipeline | <b>Inspector:</b> | Marshall Willis |
| <b>Inspection Date:</b> | Tuesday, May 19, 2020 | <b>Project Contact:</b> | Brian Clauto, Cory Chalmers |
| <b>Spread H:<br/>Montgomery County</b> | STA 12183+00 – 12203+00<br>STA 12117+00 – 12120+00<br>MVP-MN-274/275<br>ATWS 703/1446/1062/704/1375 | <b>Weather:</b> | Rainy |

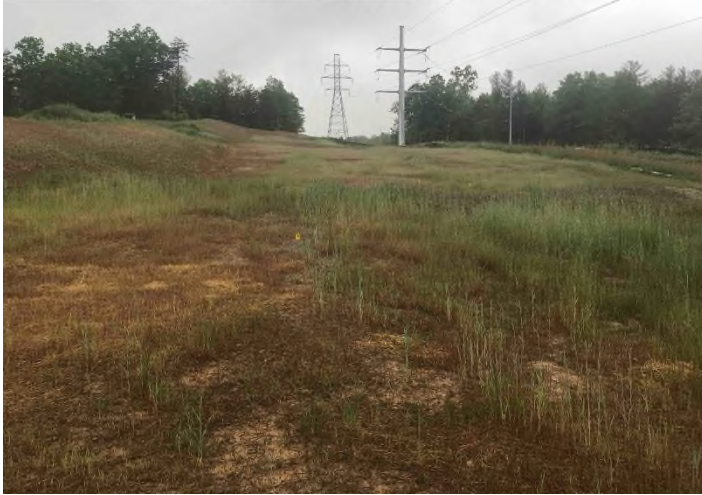
**Figure 1: STA 12187+00** – Controls in place and functioning properly.

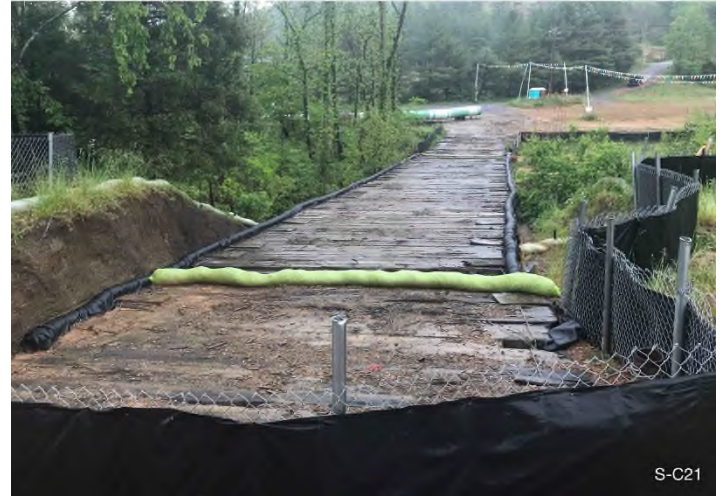
**Figure 2: Stream S-C21** – Controls in place and functioning properly around Bradshaw Creek crossing.

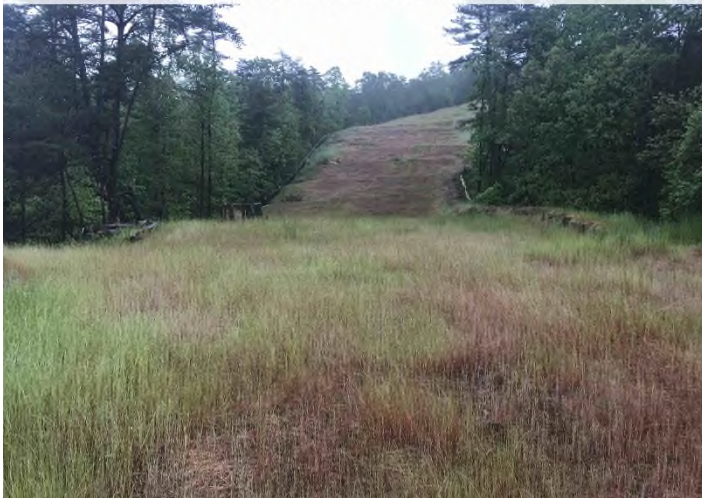
**Figure 3: STA 12200+00** – Controls in place and functioning properly.

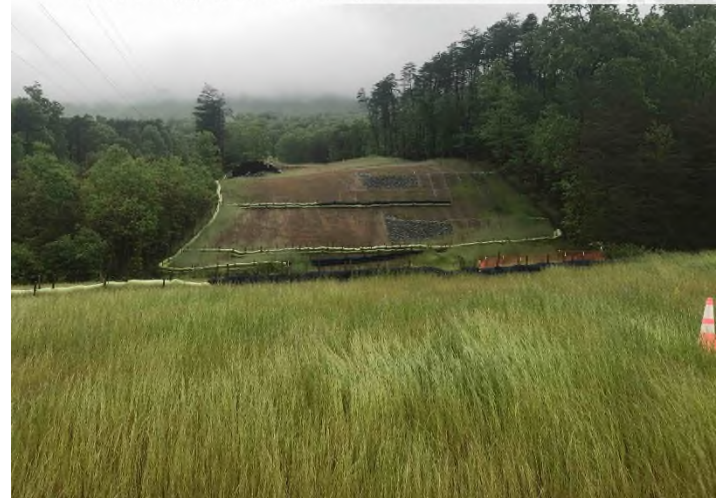
**Figure 4: STA 12118+00** – Controls in place and functioning properly.
