## FIELD INSPECTION REPORT

| <b>Project Name:</b> | Mountain Valley Pipeline | <b>Inspector:</b> | Marshall Willis |
| <b>Inspection Date:</b> | Thursday, May 14, 2020 | <b>Project Contact:</b> | Brian Clauto, Cory Chalmers |
| <b>Spread I:<br/>Pittsylvania County</b> | STA 15323+24 – 15480+67<br>MVP-PI-332<br>ATWS 392/492/547/493/548/549 | <b>Weather:</b> | Dry |

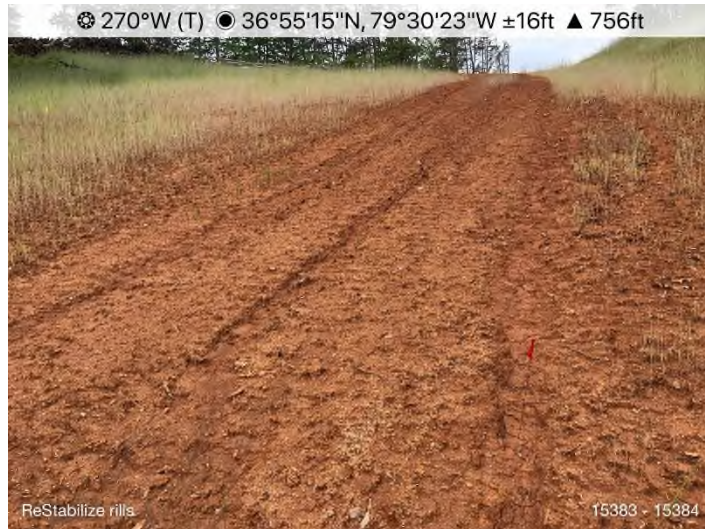
- STA 15383+00 through 15384+00: Re-stabilize travel lane. Repair and stabilize rill erosion.

**Figure 1: STA 15383+00 – 15384+00** – Re-stabilize travel lane. Repair and stabilize rill erosion.

**Recommended Corrective Action:** Maintain and install all controls per the approved PSS&S.

**Deadline:** Within 72-Hour of Notification

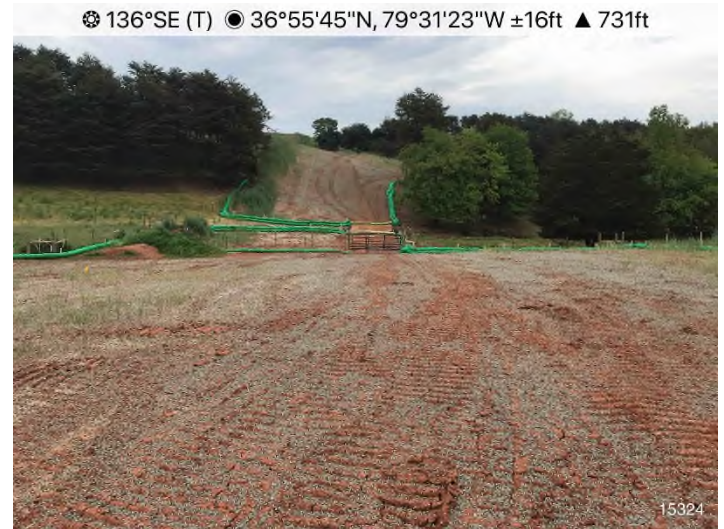
**Figure 2: STA 15324+00** – Controls in place and functioning properly. Row stabilized with Earth Guard Edge.

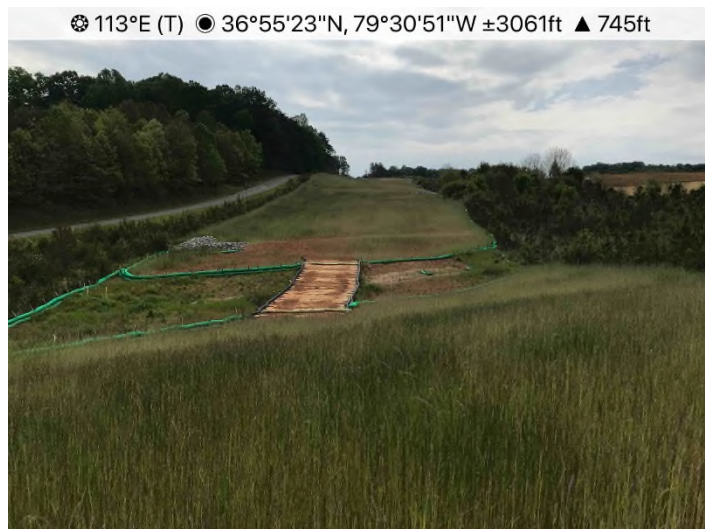
**Figure 3: STA 15360+00** – Controls in place and functioning properly.

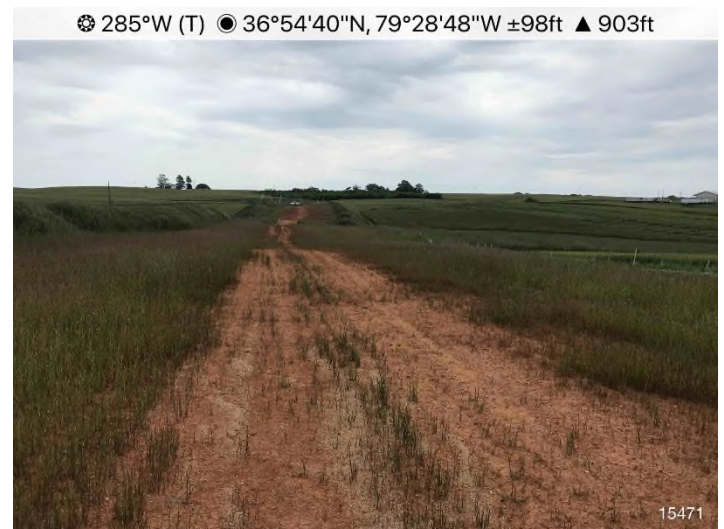
**Figure 4: STA 15471+00** – Controls in place and functioning properly. ROW stabilized, no erosion present within travel lane.
