## FIELD INSPECTION REPORT

| <b>Project Name:</b> | Mountain Valley Pipeline | <b>Inspector:</b> | Marshall Willis |
| <b>Spread H:<br/>Montgomery County</b> | STA 12298+39 – 12371+10<br>ATWS 1374<br>MVP-MN-276.03 | <b>Weather:</b> | Dry |

## FIELD INSPECTION PHOTO LOG

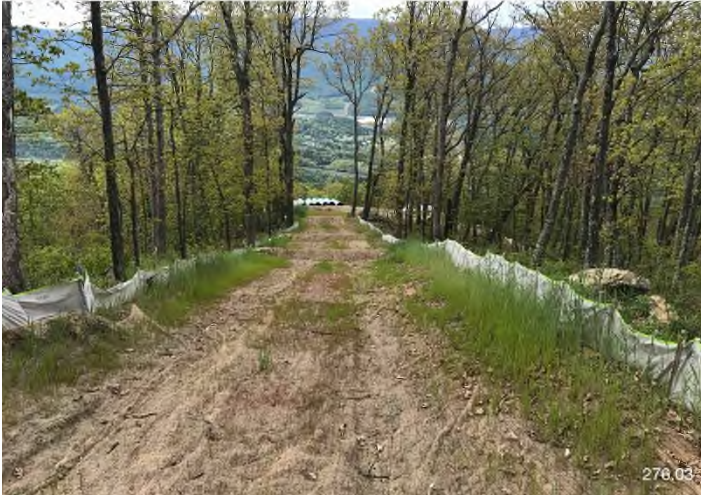
**Figure 1: MVP-MN-276.03** – Controls in place and functioning properly along MVP-MN-276.03. Area stabilized with erosion control matting.

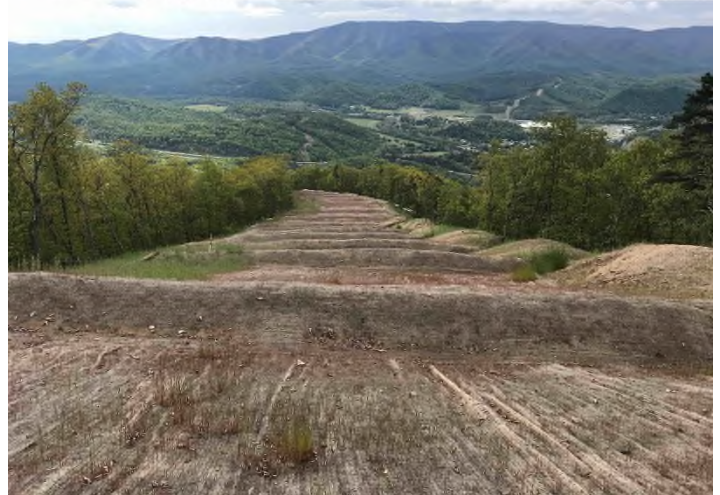
**Figure 2: STA 12300+00** – Controls in place and functioning properly. Area stabilized with erosion control matting.

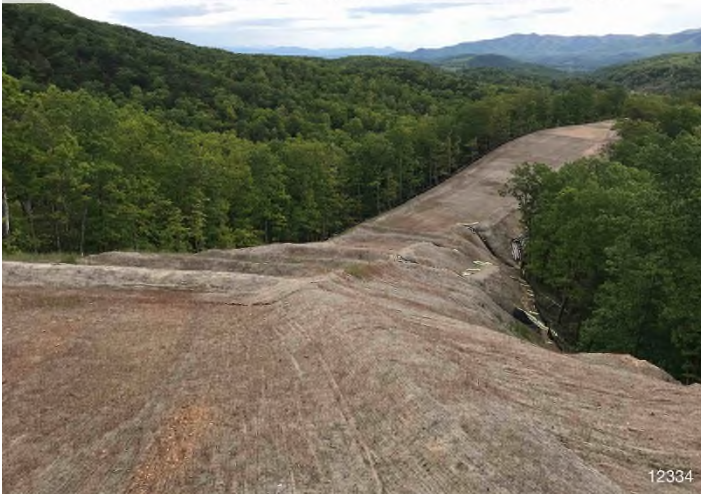
**Figure 3: STA 12334+00** – Controls in place and functioning properly. Area stabilized with erosion control matting.

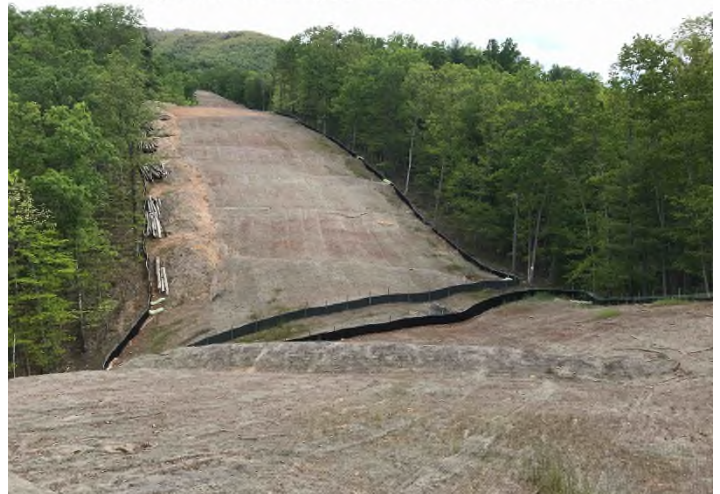
**Figure 4: STA 12363+00** – Controls in place and functioning properly. Area stabilized with erosion control matting.
