## FIELD INSPECTION REPORT

| Project Name: | Mountain Valley Pipeline | Inspector: | Marshall Willis |
| Inspection Date: | Monday, May 11, 2020 | Project Contact: | Brian Clauto, Cory Chalmers |
| Spread I:<br>Franklin County | STA 14845+68 – 14928+52<br>ATWS 375/376/540/541/377 | Weather: | Dry |

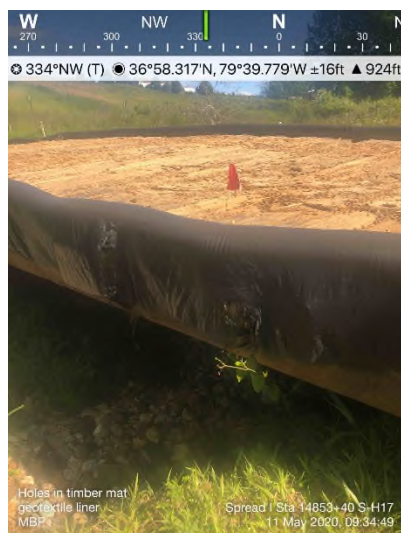
- STA 14853+40: Hole in bridge underlayment of S-H17 crossing. Repair needed.
- STA 14854+75: Hole in bridge underlayment of S-A7 crossing. Repair needed.
- STA 14901+00: End-treatment undermined. Repair needed.
- STA 14903+00: CFS at full capacity. Cleanout needed.

**Figure 1: STA 14853+40** – Bridge underlayment damaged at S-H17 crossing.

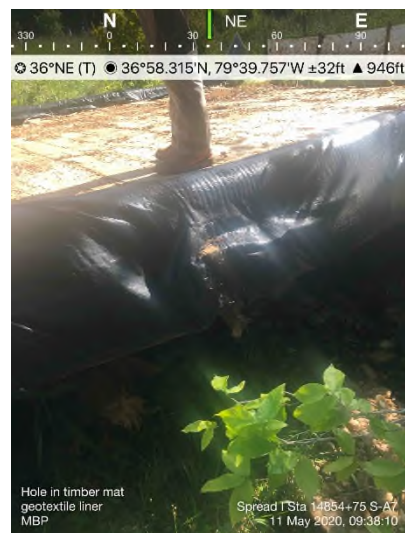
**Figure 2: STA 14854+75** – Bridge underlayment damaged at S-A7 crossing.

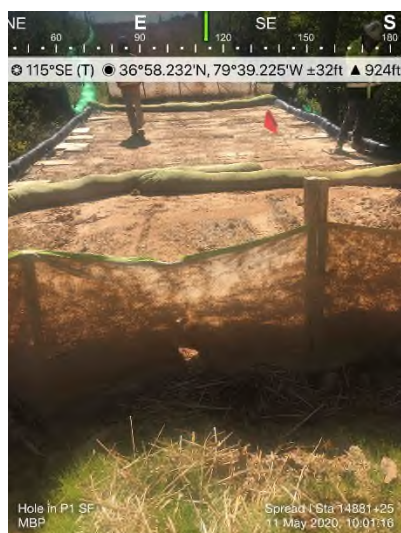
- STA 14881+25: Hole in P1. Maintenance needed.
- STA 14881+75: Hole in P1. Maintenance needed.

**Figure 3: STA 14881+25** – P1 damaged.

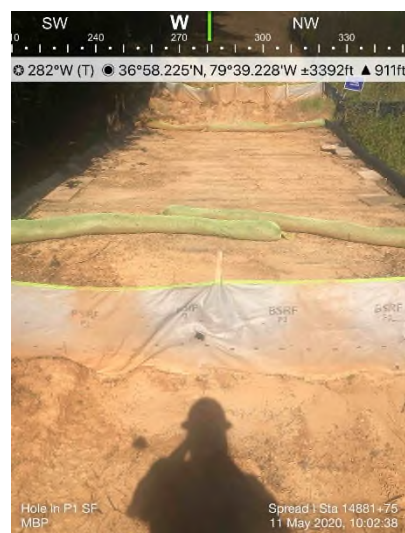
**Figure 4: STA 14881+75** – P1 damaged.

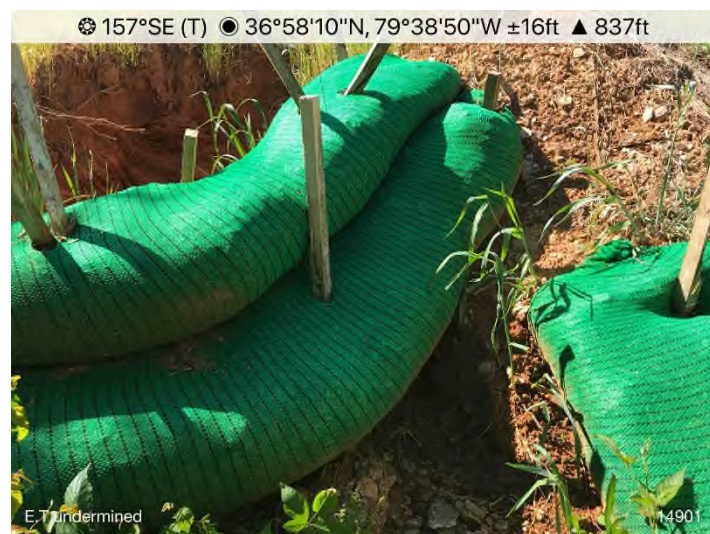
**Figure 5: STA 14901+00 – End-treatment undermined.**

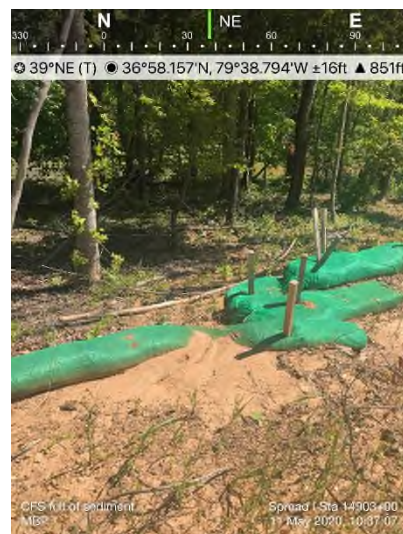
**Figure 6: STA 14903+00 – CFS at capacity.**
