## FIELD INSPECTION REPORT

| <b>Project Name:</b> | Mountain Valley Pipeline | <b>Inspector:</b> | Marshall Willis |
| <b>Spread H:<br/>Montgomery County</b> | STA 11996+69 – 12036+92<br>ATWS 473/473A/474/474A/1161<br>MVP-MN-268/268.01 | <b>Weather:</b> | Rainy |

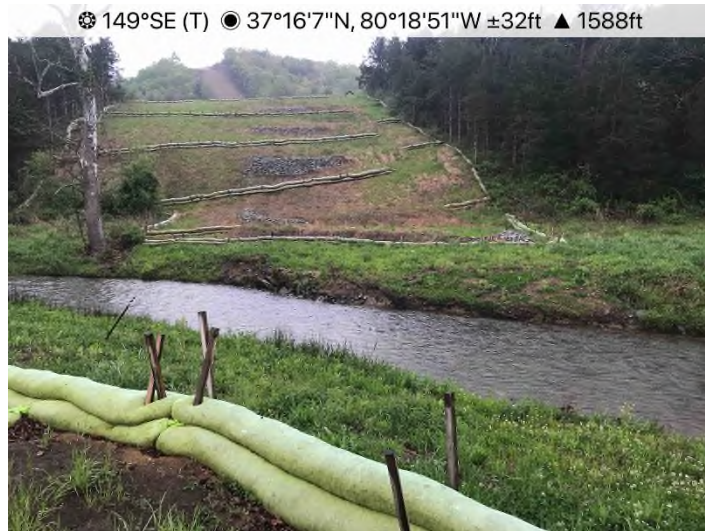
**Figure 1: Stream S-G36** – Controls in place and functioning properly along the North Fork Roanoke River.

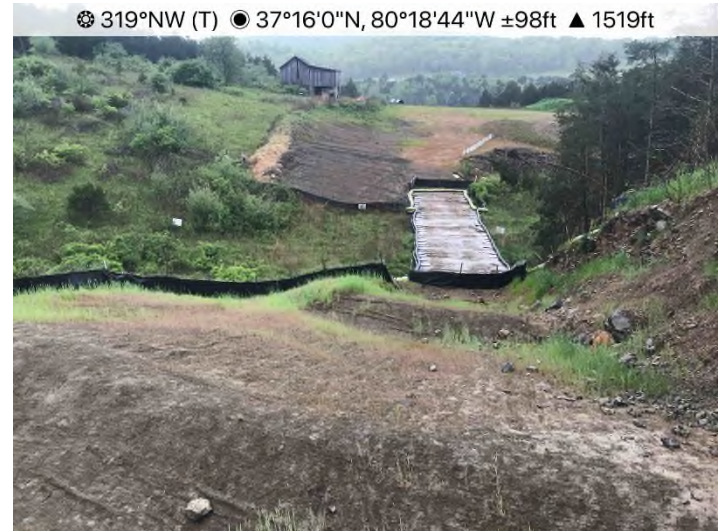
**Figure 2: STA 12016+29** – Controls in place and functioning properly around S-G38.

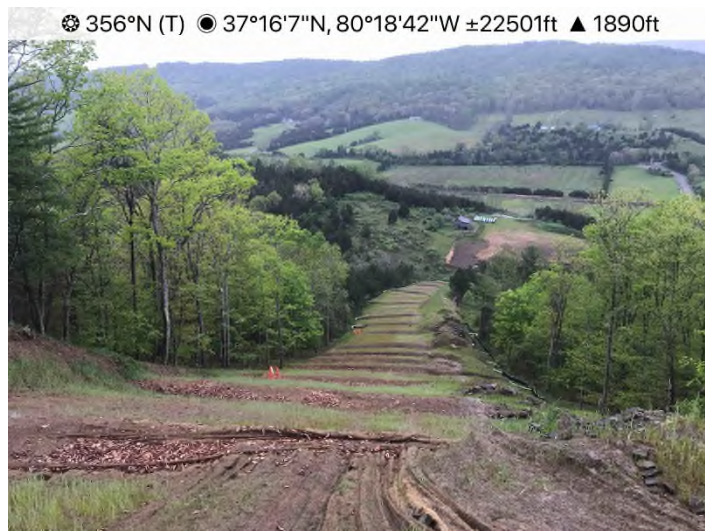
**Figure 3: STA 12025+00** – Controls in place and functioning properly.

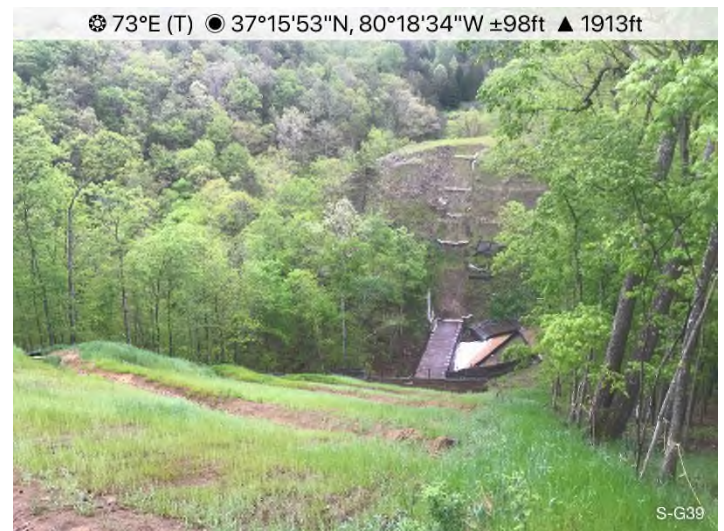
**Figure 4: STA 12026+84** – Controls in place and functioning properly.
