## FIELD INSPECTION REPORT

| Project Name: | Mountain Valley Pipeline | Inspector: | Marshall Willis |
| Inspection Date: | Monday, May 4, 2020 | Project Contact: | Brian Clauto, Cory Chalmers |
| Spread I:<br>Franklin County | STA 14333+27 – 14454+22<br>ATWS 1485/526/622/623/356/358 | Weather: | Dry |

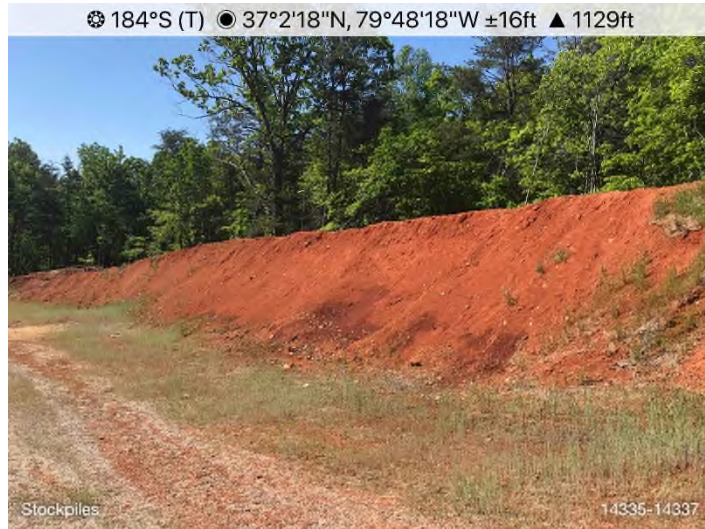
**Figure 1: STA 14335+00 – 14337+00 – Re-stabilize stockpile.**

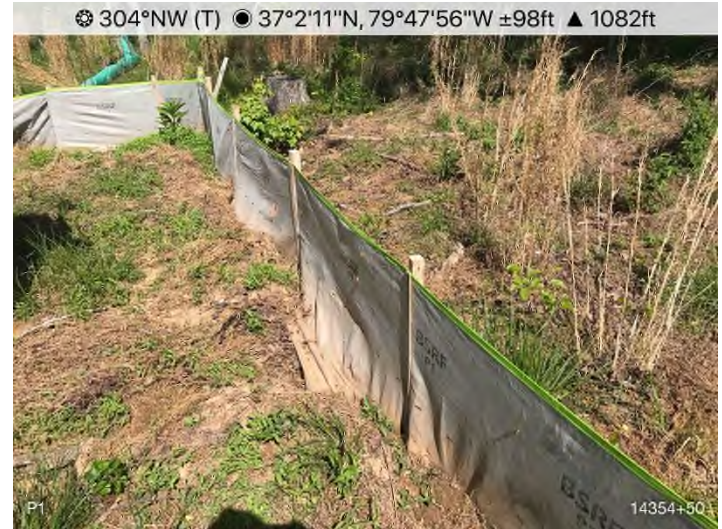
**Figure 2: STA 14354+50 – P1 undermined.**

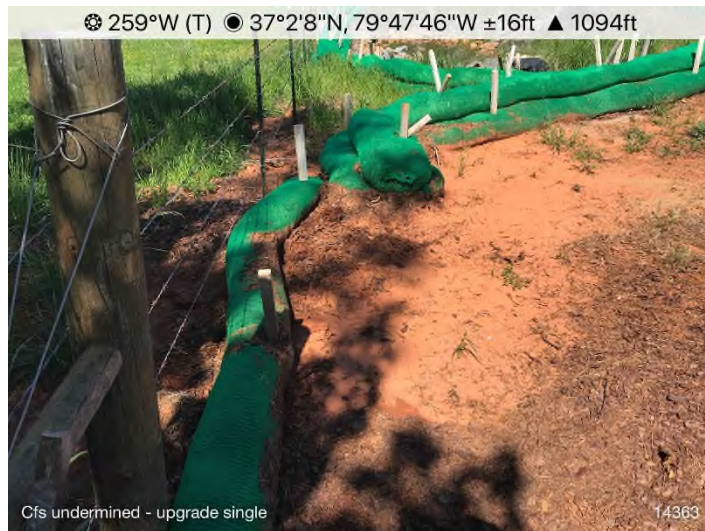
**Figure 3: STA 14363+00 – CFS undermined.**

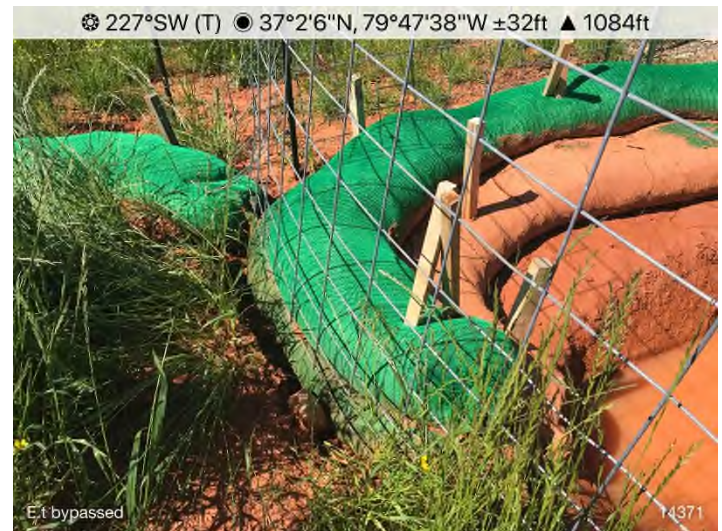
**Figure 4: STA 14371+00 – End treatment bypassed.**

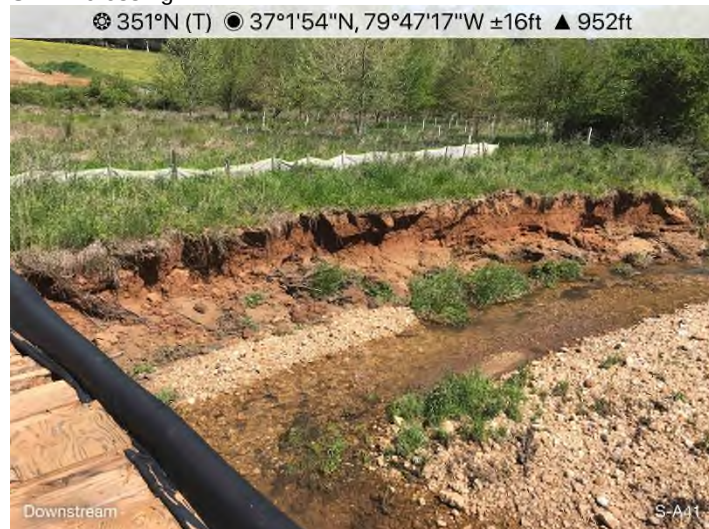
**Figure 5: STA 14391+30** – Stream bank erosion downstream of S-A41 crossing.

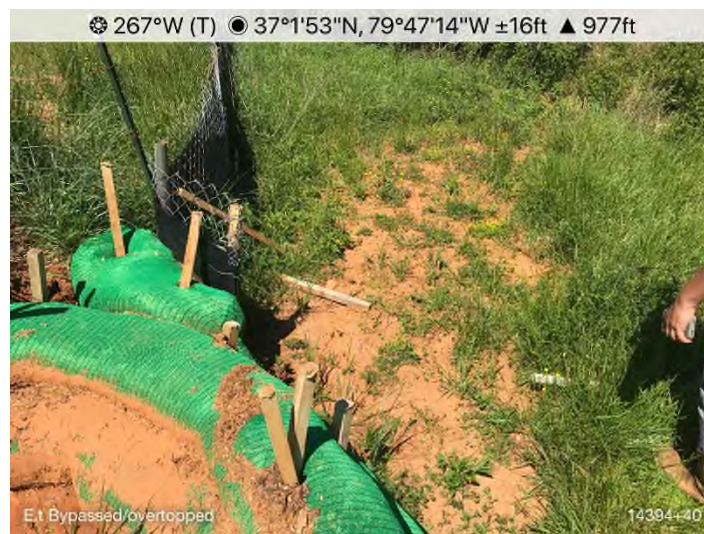
**Figure 6: STA 14394+40** – Sediment off ROW.

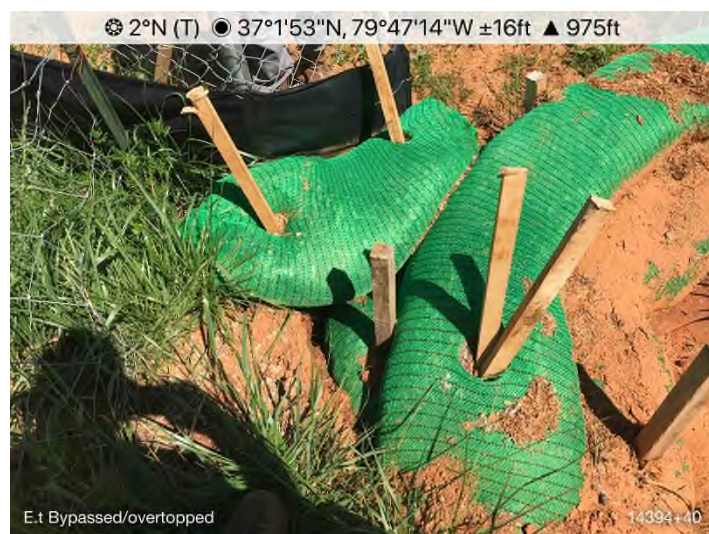
**Figure 7: STA 14394+40** – End treatment bypassed.

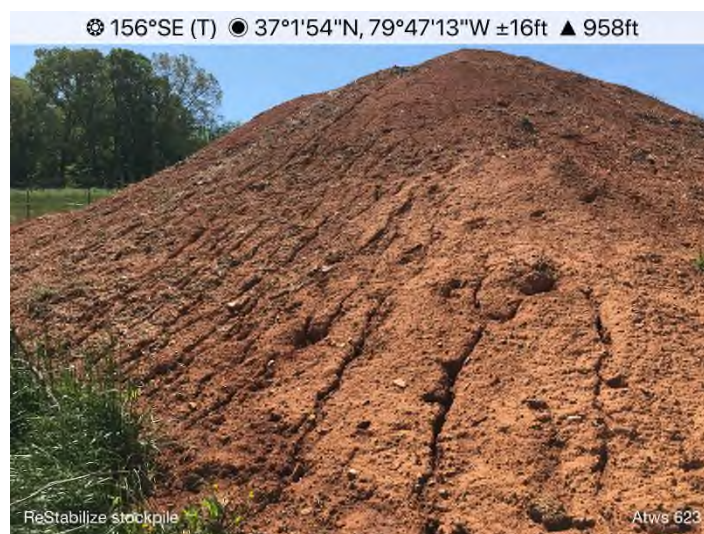
**Figure 8: STA 14394+50** – Re-stabilize stockpile in ATWS 623.

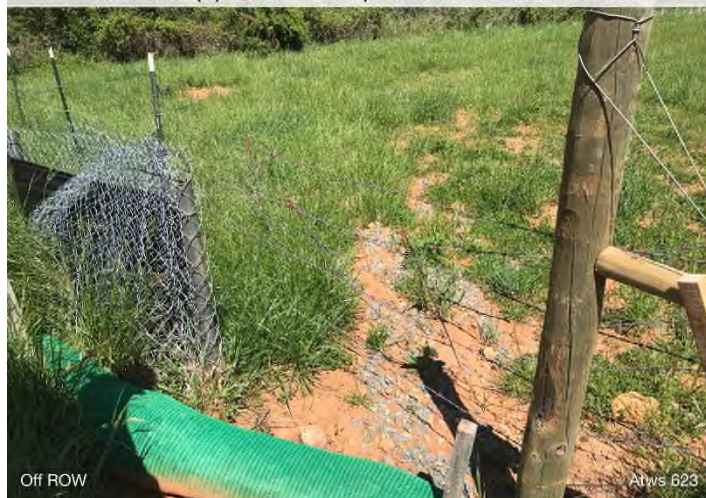
**Figure 9: STA 14395+00** – Sediment off ROW from landowner access road.

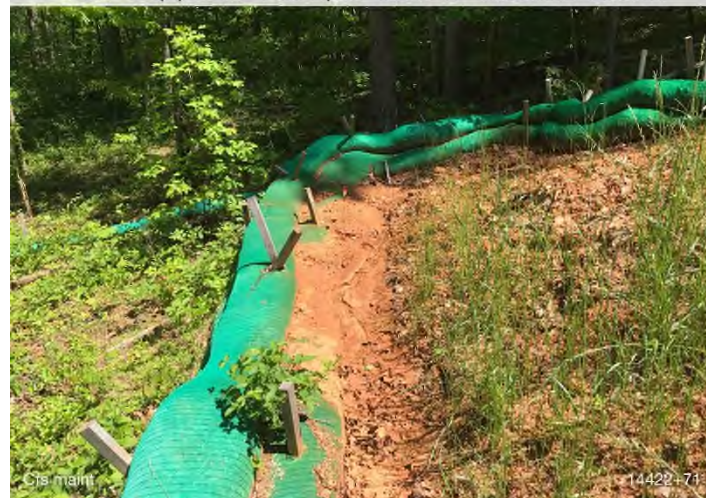
**Figure 10: STA 14422+71** – CFS maintenance needed.

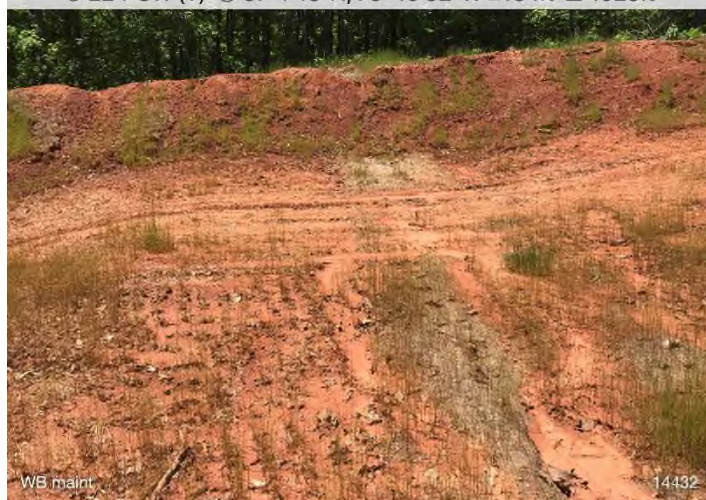
**Figure 11: STA 14432+00** – Waterbar maintenance needed.
