## COMPLAINT INVESTIGATION REPORT

| Project Name: | Mountain Valley Pipeline | Inspector: | Marshall Willis |
| Inspection Date: | Thursday, April 16, 2020 | Project Contact: | Brian Clauto, Cory Chalmers |
| Spread H:<br>Montgomery County | STA 12445+19 – 12544+06<br>MVP-MN-278.01 | Weather: | Dry |

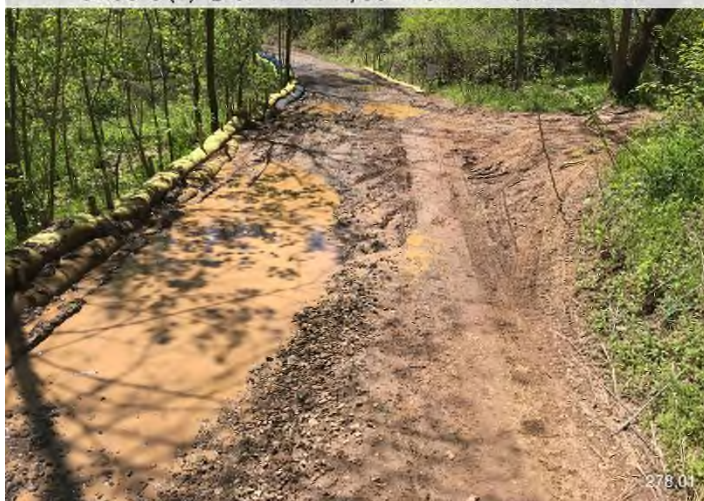
- Approximately 2.8” precipitation accumulation on 4/12 and 4/13 recorded in the area prior to inspection.
- Several maintenance items were noted during the inspection.
- MVP has not completed installation of access road MVP-MN-278.01 to date. Roadway previously damaged by access to logging operation up slope of the MVP ROW.
- 3x CFS along MVP-MN-278.01 was damaged/overwhelmed during 4/13 rain event allowing sediment and run-on from upslope area to discharge off the roadway.
- Sediment discharged off ROW cause by breach/failure of controls along roadway. Sediment source appears to be from roadway as well as landowner access adjacent to breach.

**Figure 1: MVP-MN-278.01** – Maintain access road to prevent sediment discharge from roadway. Rutting, water ponding and sediment deposition evident. Sediment source to roadway likely from erosion of landowner access adjacent to road.

- MVP-MN-278.01: Maintain access road.
- STA 13533+00: Re-stabilize area between CFS and rock check dam.

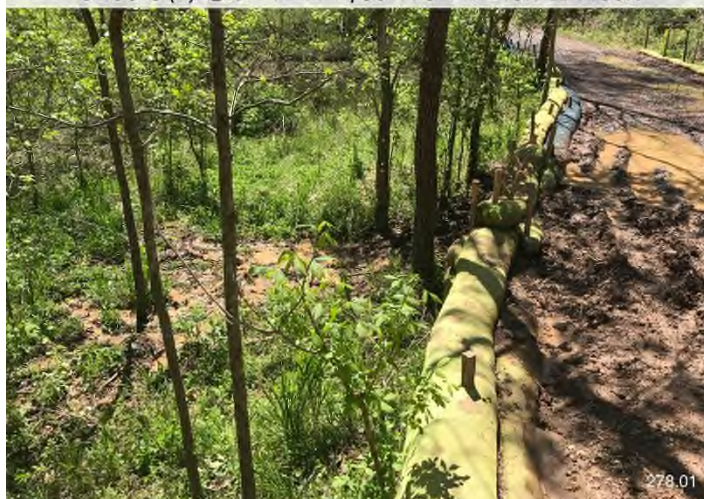
**Figure 2: MVP-MN-278.01** – Stabilize sediment deposited within ROW due to CFS control overtopped/damaged from private road.

- MVP-MN-278.01: Stabilize sediment deposited within ROW.
- MVP-MN-278.01: Sediment off ROW due to CFS failure.
- STA 13533+00: CFS at capacity.

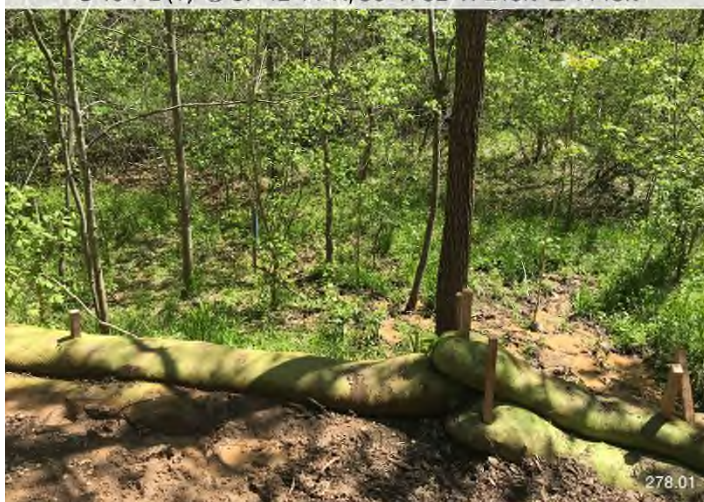
**Figure 3: MVP-MN-278.01** – Sediment off ROW due to CFS control overtopped/damaged from private road. Retrieve measureable sediment and stabilize.

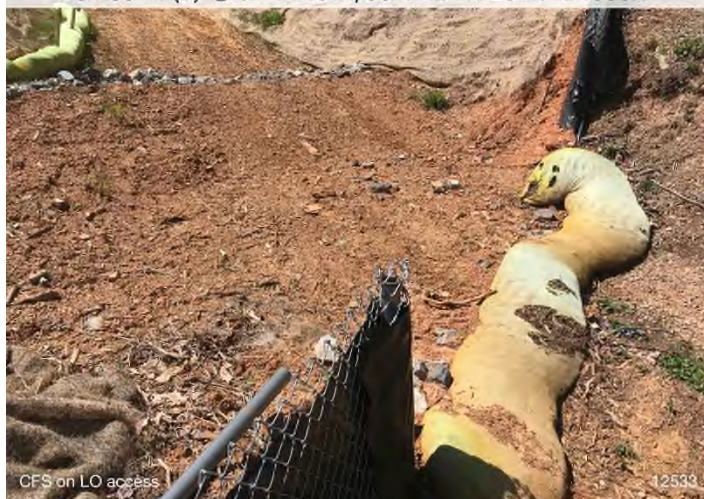
**Figure 4: STA 12533+00** – CFS Maintenance needed. Sock at capacity and torn from landowner access.

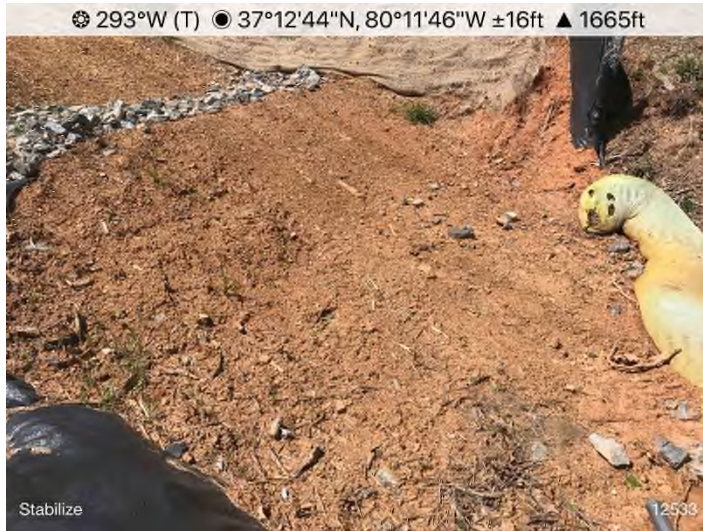
**Figure 5: STA 12533+00** – Re-stabilize denuded area for landowner access below checkdam.
