## FIELD INSPECTION

| Project Name: | Mountain Valley Pipeline | Inspector: | Marshall Willis |
| Spread H:<br>Franklin County | STA 13197+55 – 13316+13<br>MVP-FR-293.01 | Weather (Wet/Dry/Rain): | Wet |

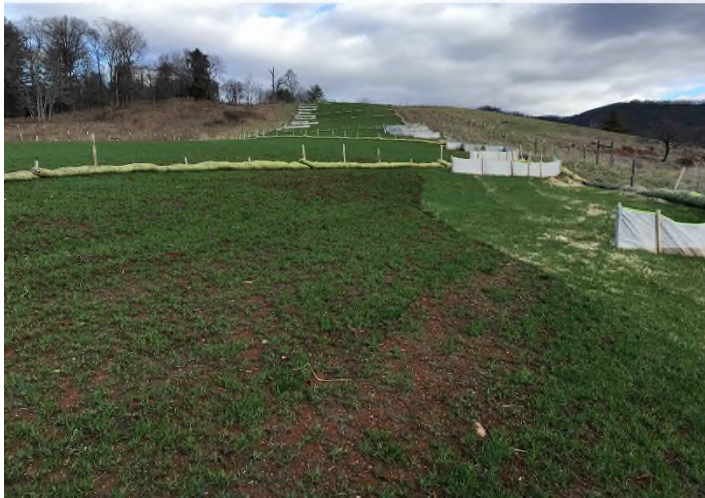
Fig. 1: **STA 13306+00** – Controls in place and properly functioning. Area stabilized.

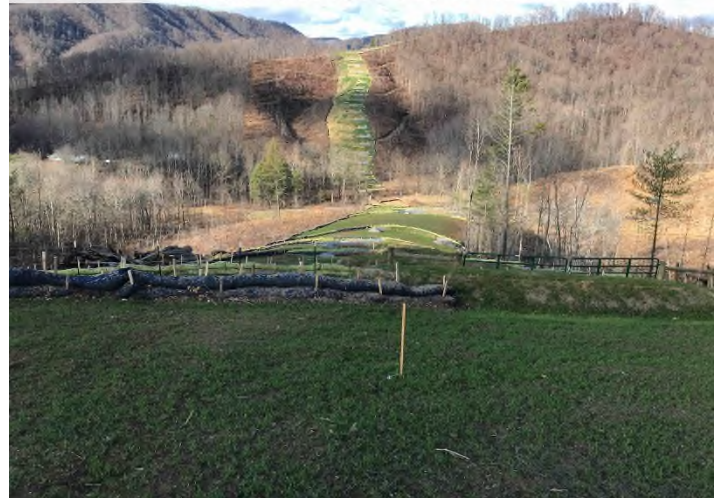
Fig. 2: **STA 13273+00** – Controls in place and properly functioning. Area stabilized.

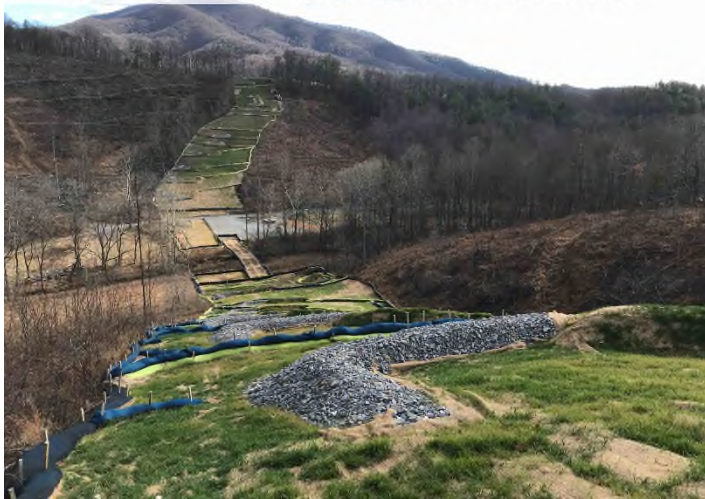
Fig. 3: **STA 13254+00** – Controls in place and properly functioning. Area stabilized.

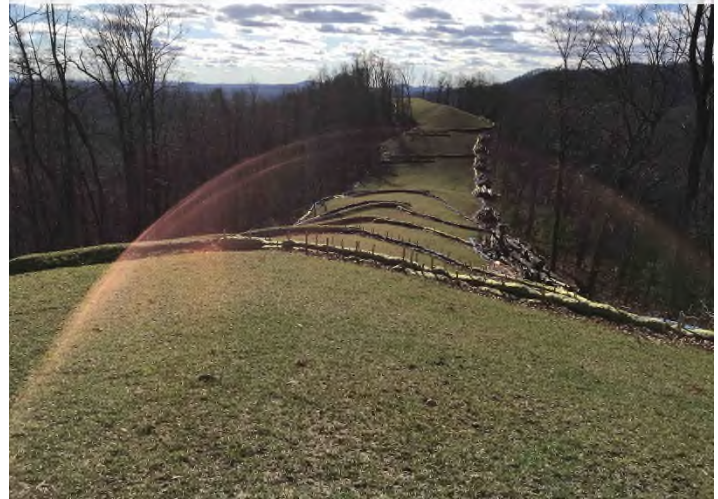
Fig. 4: **STA 13230+00** – Controls in place and properly functioning. Area stabilized.
