## FIELD INSPECTION

| Project Name: | Mountain Valley Pipeline | Inspector: | Marshall Willis |
| Inspection Date: | Monday, December 30, 2019 | Project Contact: | Brian Clauto, Cory Chalmers |
| Spread I:<br>Franklin County | STA 13415+51 – 13541+66<br>MVP-FR-293.02/294 | Weather (Wet/Dry/Rain): | Wet |

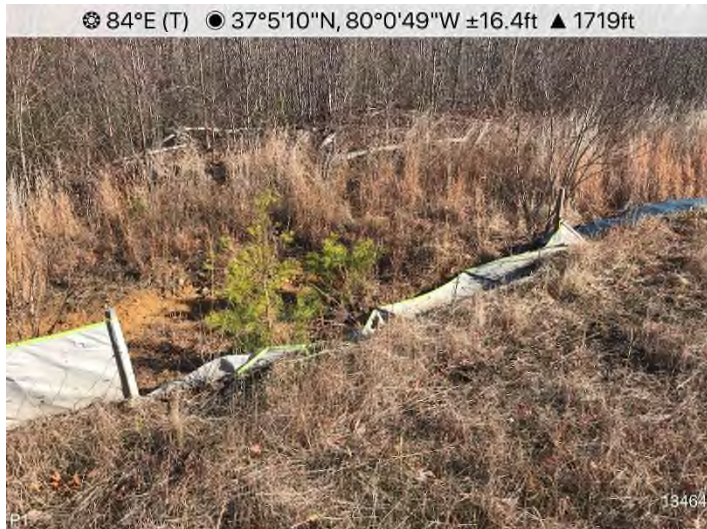
Fig. 1: **STA 13464+00** – P1 maintenance needed.

**Recommended Corrective Action:** Maintain and install all controls per the approved plans and PSS&S.

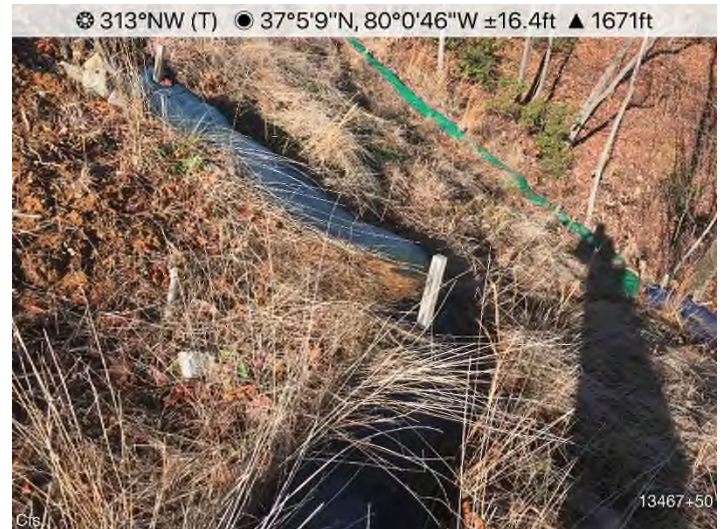
Fig. 2: **STA 13467+50** – CFS maintenance needed.

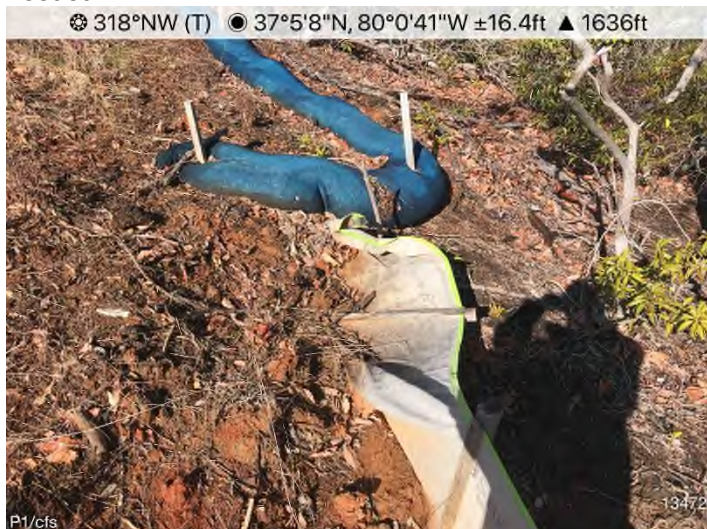
Fig. 3: **STA 13472+00** – P1 and CFS maintenance needed.

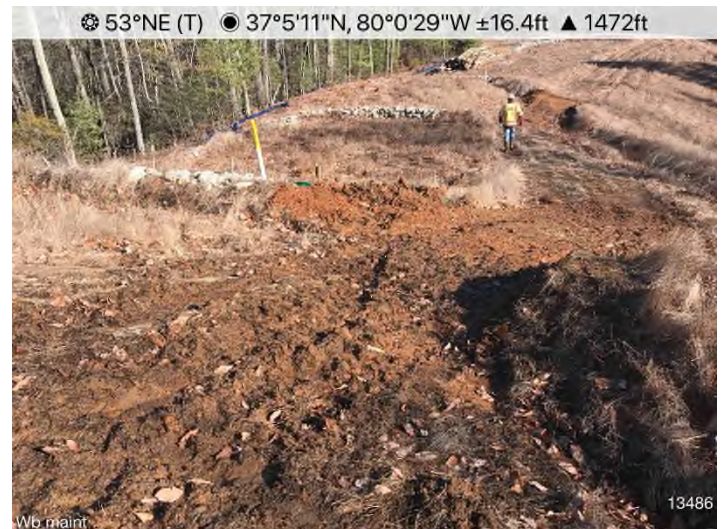
Fig. 4: **STA 13485+50** – Waterbar maintenance needed.

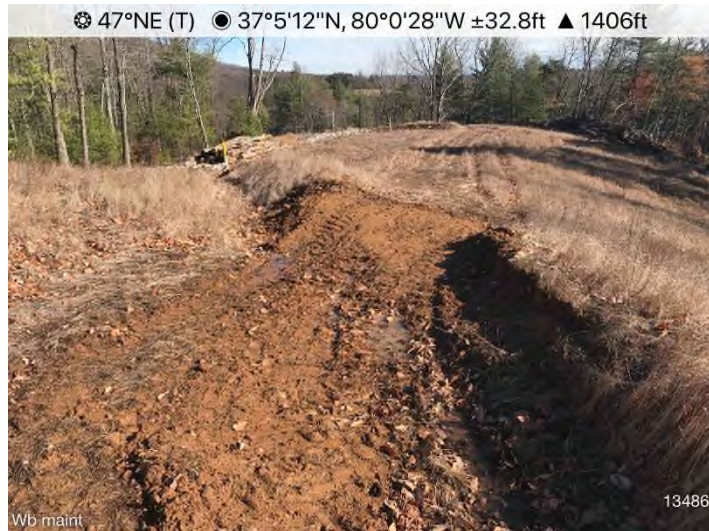
Fig. 5: **STA 13486+00** – Waterbar maintenance needed.

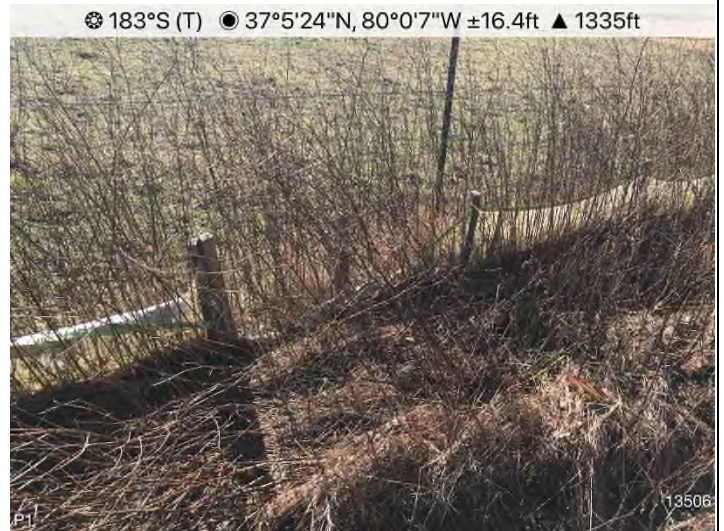
Fig. 6: **STA 13506+00** – P1 maintenance needed.
