## FIELD INSPECTION

| Project Name: | Mountain Valley Pipeline | Inspector: | Marshall Willis |
| Inspection Date: | Friday, December 27, 2019 | Project Contact: | Brian Clauto, Cory Chalmers |
| Spread H:<br>Franklin County | STA 13316+13 – 13415+51<br>ATWS 1352 | Weather (Wet/Dry/Rain): | Dry |

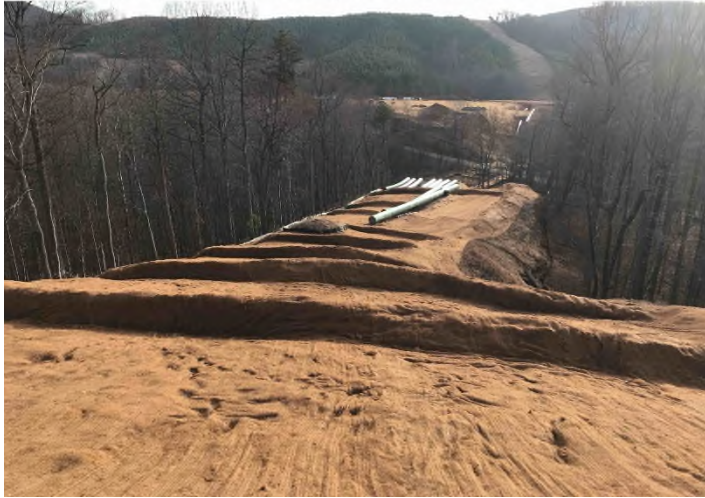
Fig. 1: **STA 13403+00** – Controls in place and properly functioning. Area stabilized with erosion matting.

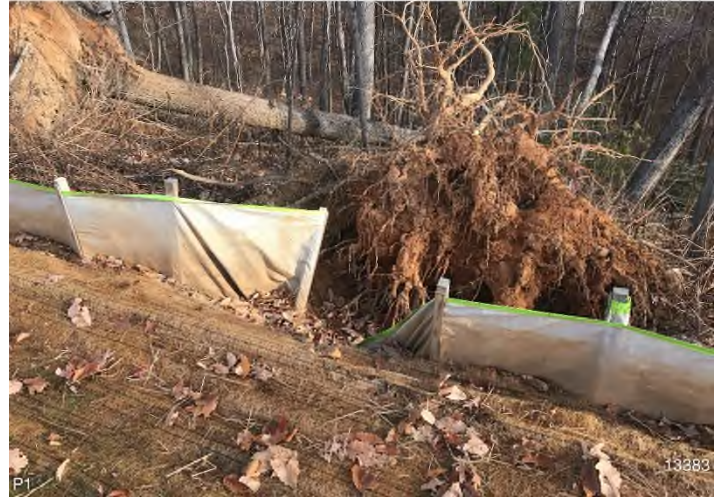
- STA 13383+00: P1 maintenance needed.

Fig. 2: **STA 13383+00** – P1 maintenance needed.

**Recommended Corrective Action:** Maintain and install all controls per the approved plans and PSS&S.

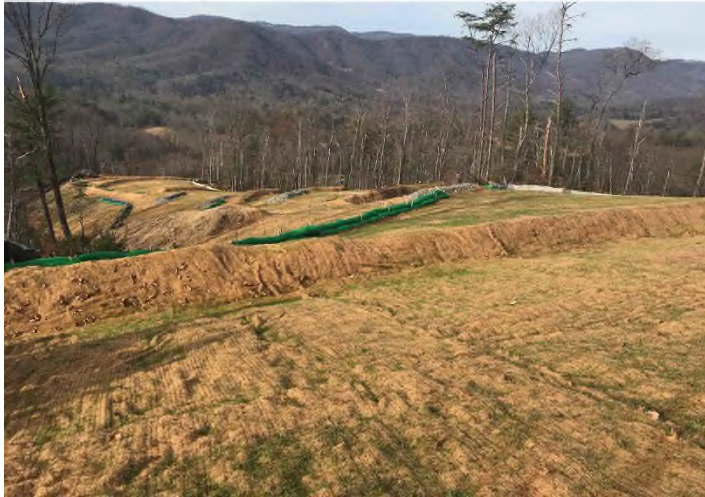
Fig. 3: **STA 13371+00** – Controls in place and functioning. Area stabilized with erosion matting.

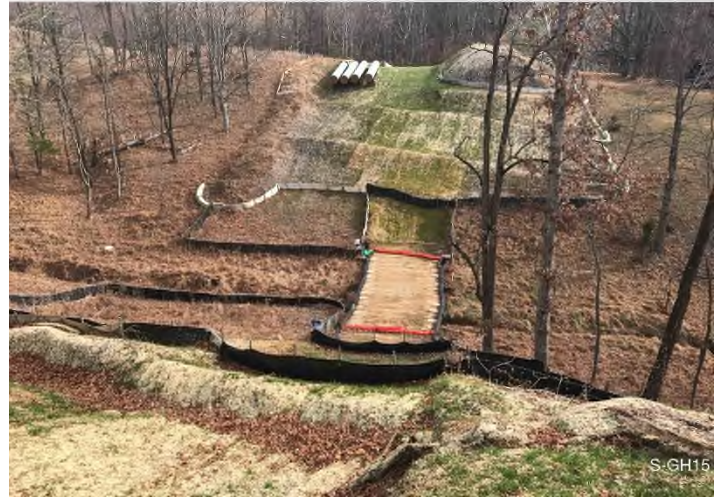
Fig. 4: **Stream S-GH15**– Controls in place and properly functioning along stream S-GH15. Area stabilized with erosion matting.
