## FIELD INSPECTION

| <b>Project Name:</b> | Mountain Valley Pipeline | <b>Inspector:</b> | Marshall Willis |
| <b>Inspection Date:</b> | Thursday, December 12, 2019 | <b>Project Contact:</b> | Brian Clauto, Cory Chalmers |

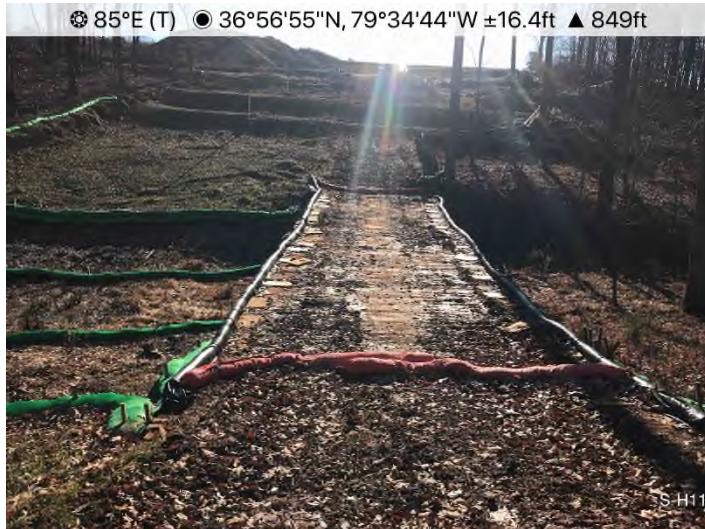
Fig. 1: **Stream S-H11** – Controls in place and properly functioning. Area stabilized with Earth Guard.

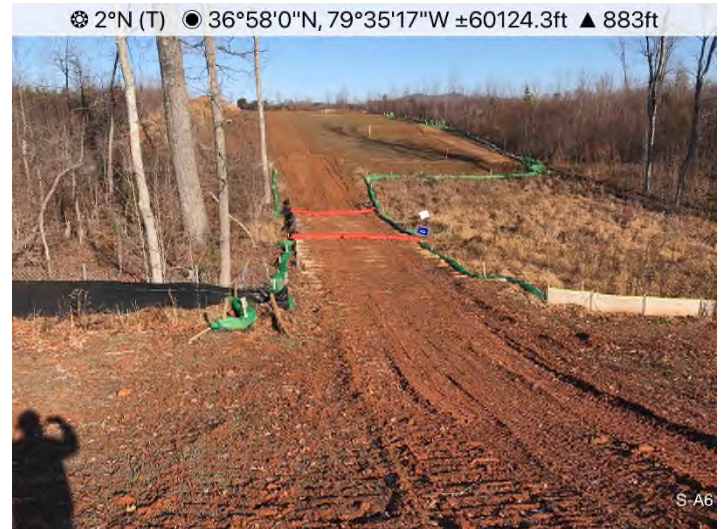
Fig. 2: **Stream S-A6** – Controls in place and properly functioning. Area stabilized with Earth Guard.

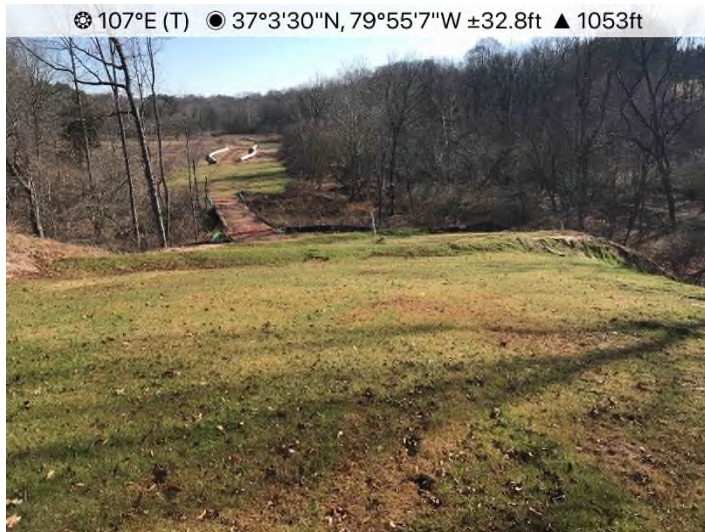
Fig. 3: **STA 13860+00** – Controls in place and functioning above Stream S-C17. Area stabilized with vegetation.

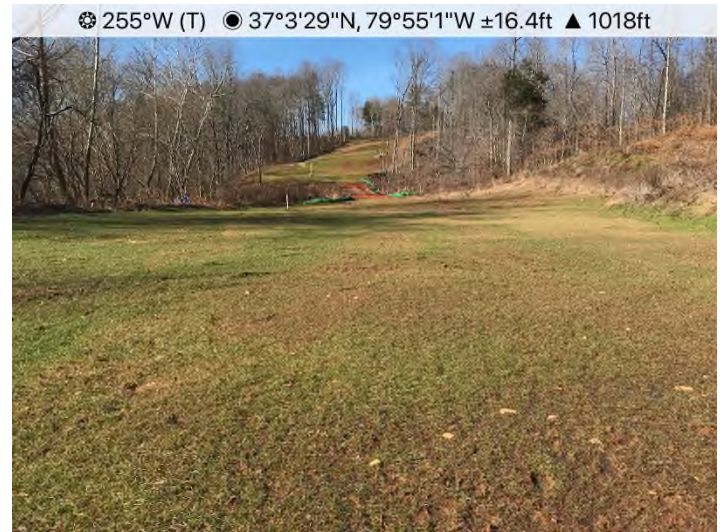
Fig. 4: **STA 13867+57** – Controls in place and properly functioning. Area stabilized with vegetation.
