## FIELD INSPECTION

| <b>Project Name:</b> | Mountain Valley Pipeline | <b>Inspector:</b> | Marshall Willis |
| <b>Inspection Date:</b> | Tuesday, December 10, 2019 | <b>Project Contact:</b> | Brian Clauto, Cory Chalmers |
| <b>Spread H:<br/>Montgomery County</b> | STA 12175+00 – 12190+85<br>ATWS 703<br>MVP-MN-274 | <b>Weather (Wet/Dry/Rain):</b> | Rainy |

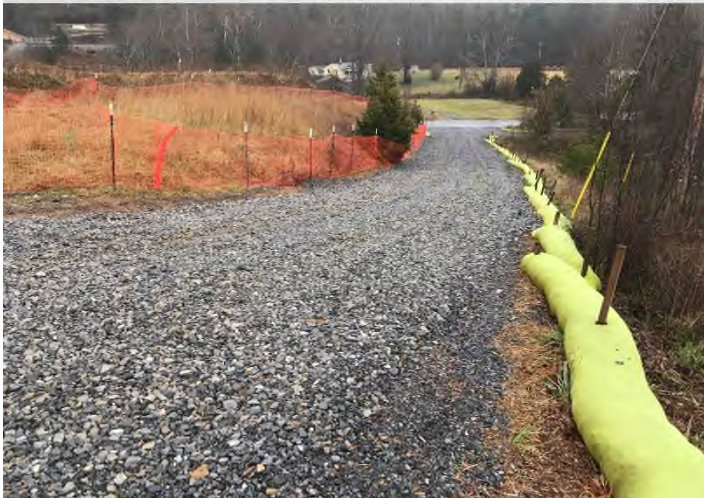
Fig. 1: **MVP-MN-273** – Controls in place and properly functioning along MVP-MN-273.

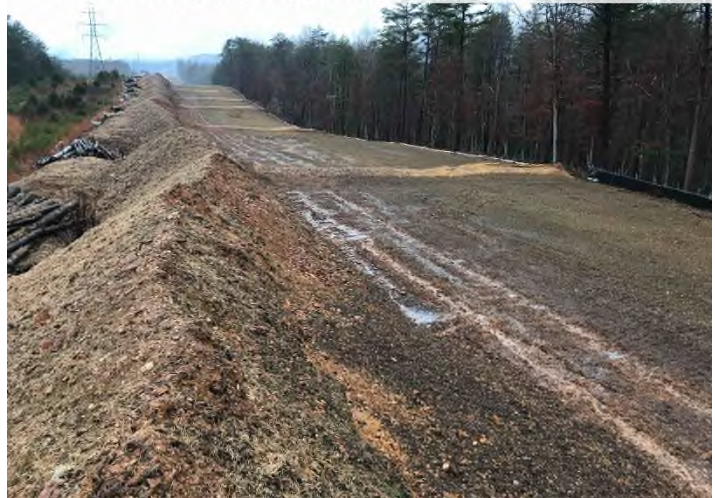
Fig. 2: **STA 12178+00** – Controls in place and functioning properly. Area stabilized with hydro-mulch and erosion fabric.

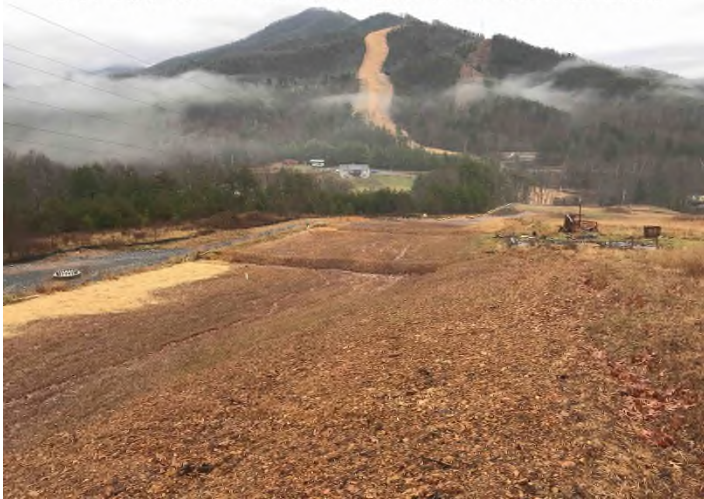
Fig. 3: **STA 12183+33** – Controls in place and functioning. Area stabilized with seed, straw and hydro-mulch.

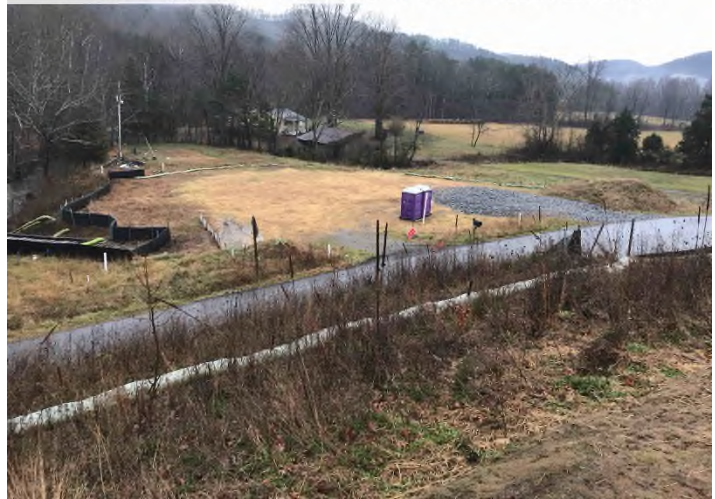
Fig. 4: **Bradshaw Road** – Controls in place and properly functioning along Bradshaw Road.
