## FIELD INSPECTION

| <b>Project Name:</b> | Mountain Valley Pipeline | <b>Inspector:</b> | Marshall Willis |
| <b>Inspection Date:</b> | Thursday, November 7, 2019 | <b>Project Contact:</b> | Brian Clauto, Cory Chalmers |
| <b>Spread I:</b><br>Franklin County<br>Pittsylvania County | STA 14928+52 – 15063+85 | <b>Weather (Wet/Dry/Rain):</b> | Wet |

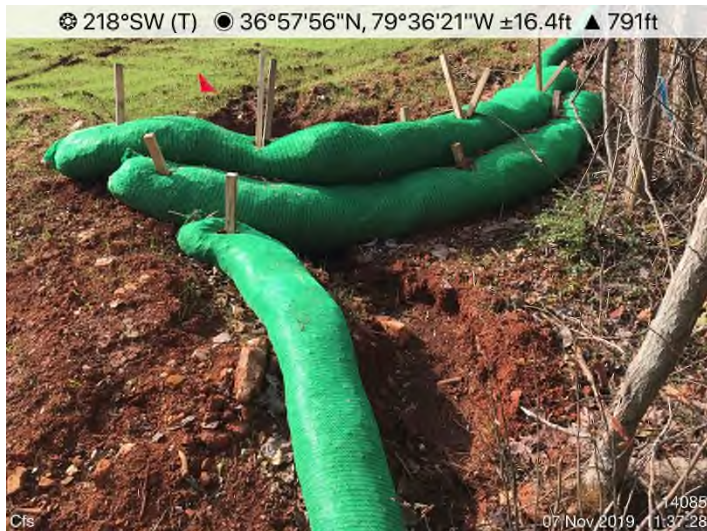
Fig. 1: **STA 15025+00** – CFS undermined. Maintenance needed.

**Recommended Corrective Action:** Maintain and install all controls per the approved plans and PSS&S.

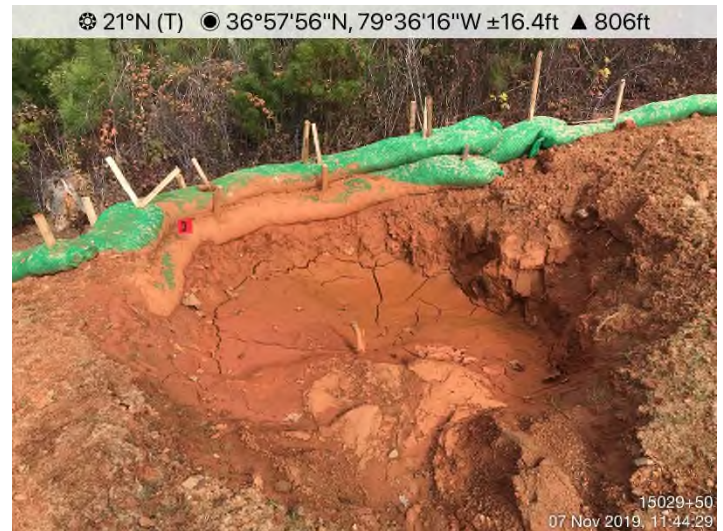
Fig. 2: **STA 15029+50** – Sump maintenance needed.

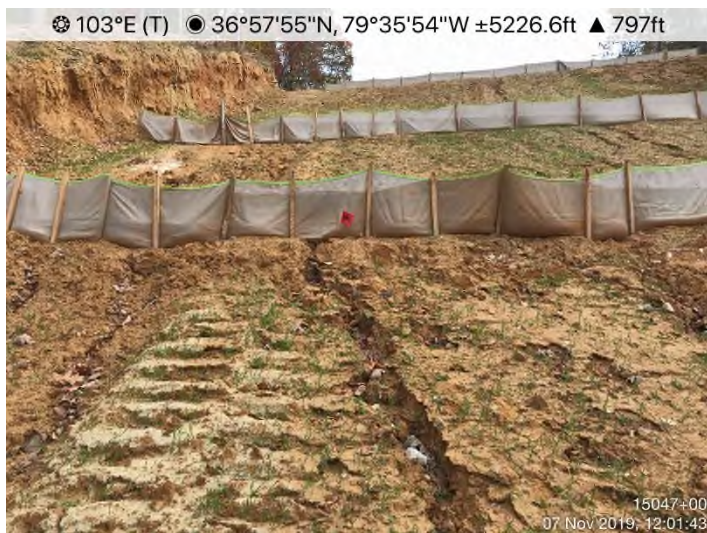
Fig. 3: **STA 15047+00 to 15048+00** – P1 undermined in several locations. Maintenance needed.

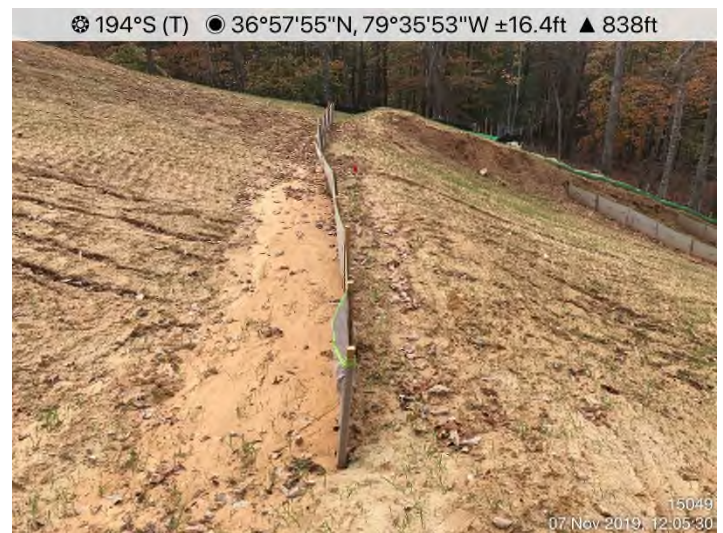
Fig. 4: **STA 15049+00** – Waterbar filled with sediment. Maintenance needed.

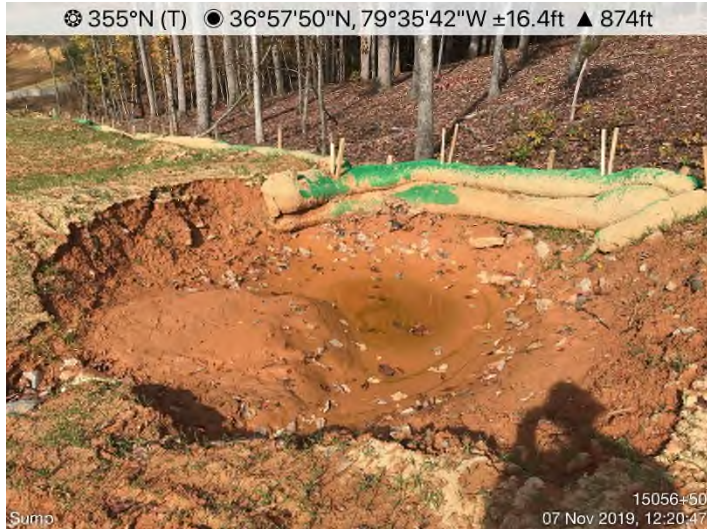
Fig. 5: **STA 15056+00** – Sump maintenance needed.
