## FIELD INSPECTION

| <b>Project Name:</b> | Mountain Valley Pipeline | <b>Inspector:</b> | Marshall Willis |
| <b>Inspection Date:</b> | Thursday, November 21, 2019 | <b>Project Contact:</b> | Brian Clauto, Cory Chalmers |

## FIELD INSPECTION PHOTO LOG

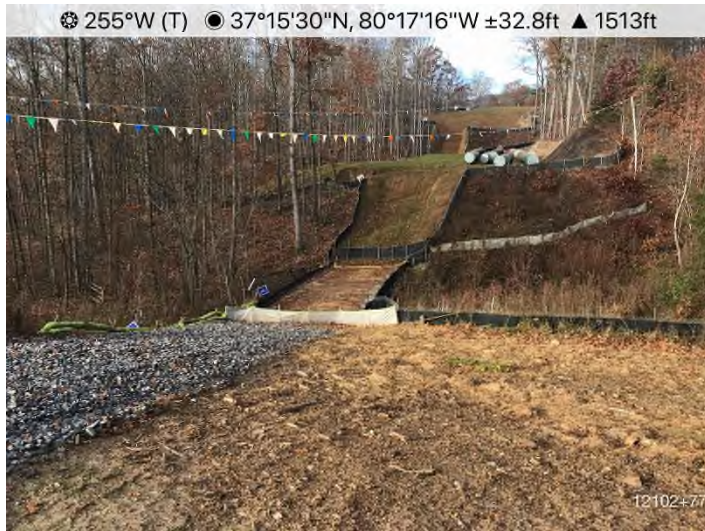
Fig. 1: **STA 12102+77** – Controls in place and functioning. Area stabilized.

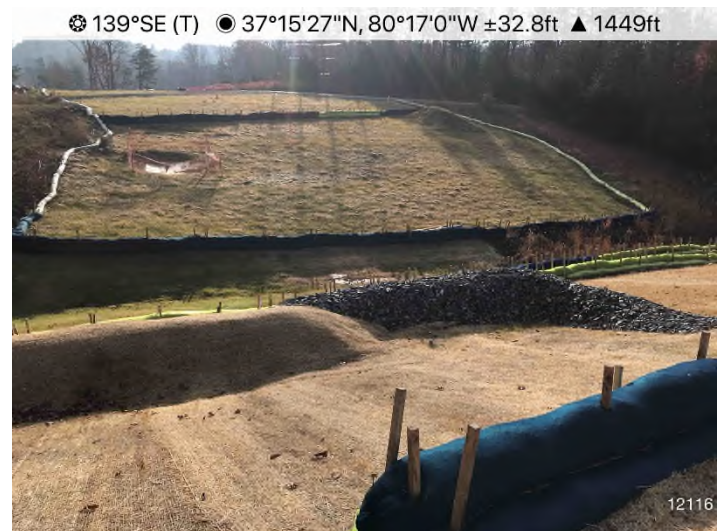
Fig. 2: **STA 12115+00** – Controls in place. Area stabilized with straw and erosion control matting.

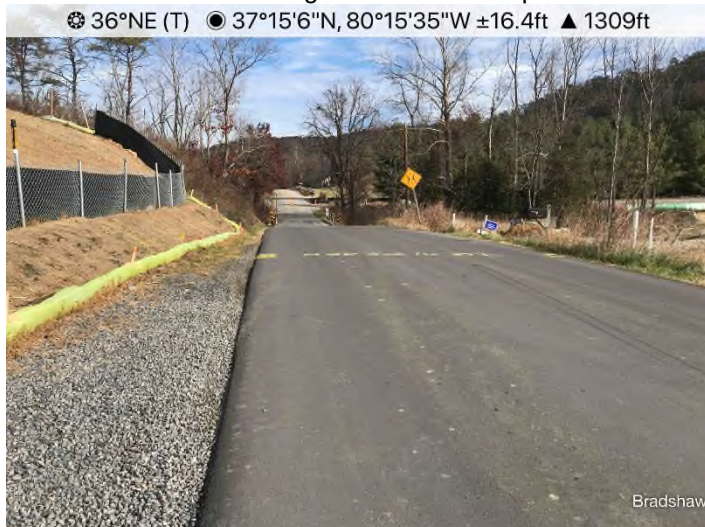
Fig. 3: **STA 12190+85** – Controls in place along Bradshaw Road. Controls functioning at the time of inspection.

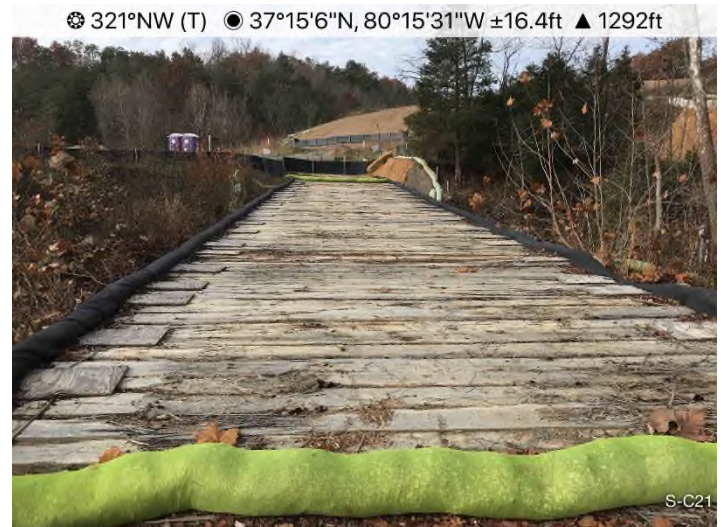
Fig. 4: **S-C21** – Controls in place and functioning along Bradshaw Creek.
