## FIELD INSPECTION

| <b>Project Name:</b> | Mountain Valley Pipeline | <b>Inspector:</b> | Matthew Grant |
| <b>Inspection Date:</b> | Thursday, November 21, 2019 | <b>Project Contact:</b> | Brian Clauto |

## FIELD INSPECTION PHOTO LOG

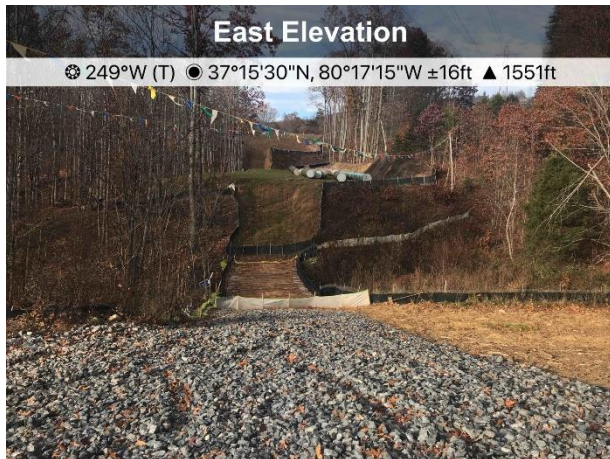
- Fig. 1. Above designated stream S-MM11, ECD's in place and functioning.

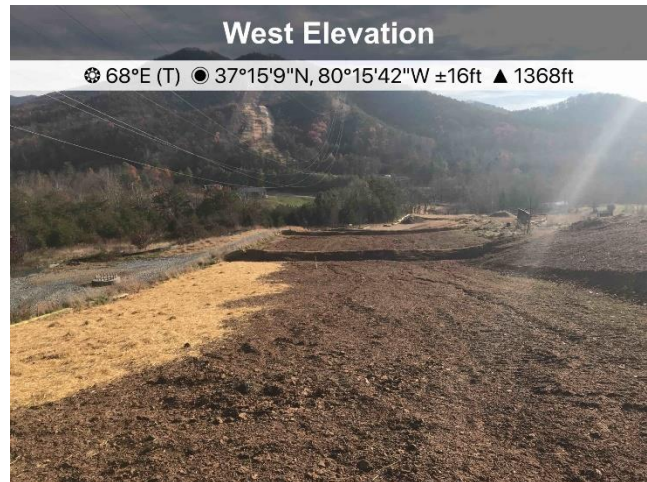
- Fig. 2. Near MP 230.6 area has been stabilized with straw and propanics.

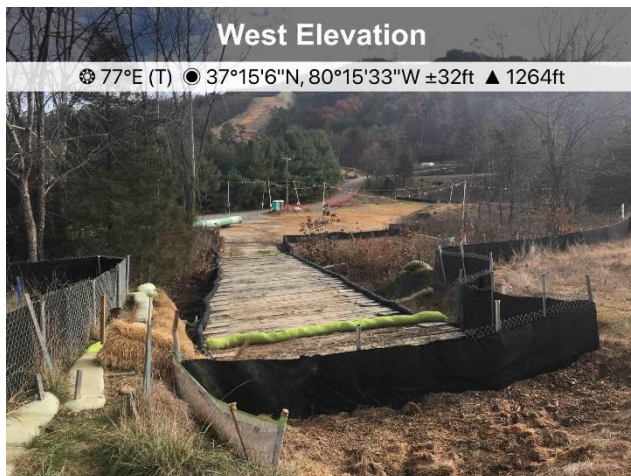
- Fig. 3. At designated stream S-C21, ECD's are in place and functioning.

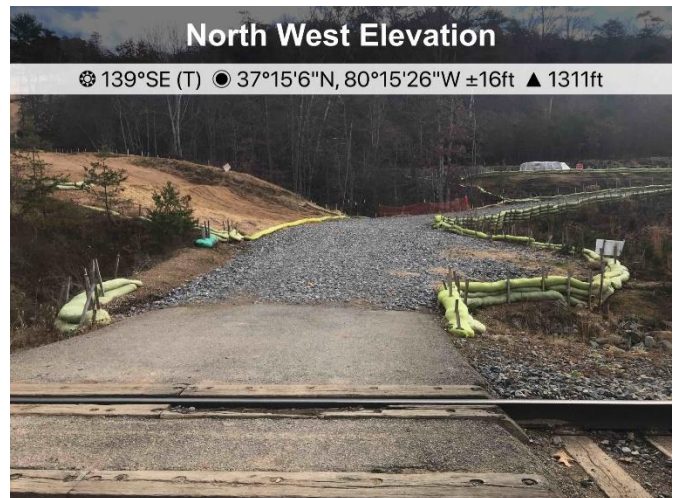
- Fig. 4. Near MP 230.8 ECD's are in place and functioning.
