## FIELD INSPECTION

| <b>Project Name:</b> | Mountain Valley Pipeline | <b>Inspector:</b> | Marshall Willis |
| <b>Spread I:<br/>Franklin County</b> | STA 13644+82 – 13690+91<br>MVP-FR-293.02<br>ATWS 1342/1343 | <b>Weather (Wet/Dry/Rain):</b> | Rainy |

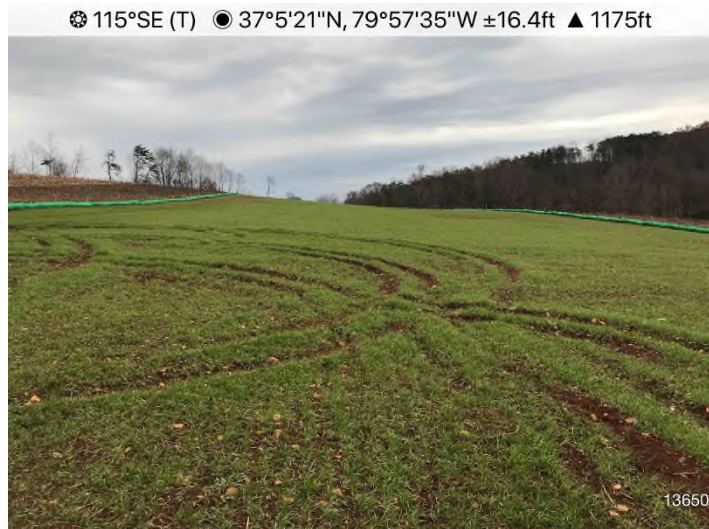
Fig. 1: **STA 13650+00** – Controls in place. Area adequately stabilized.

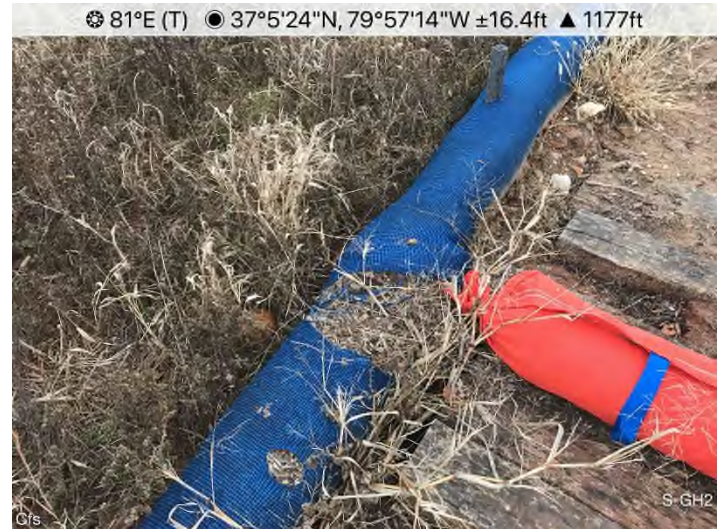
STA 13666+50: CFS maintenance needed.

Fig. 2: **STA 13666+50** – CFS maintenance needed.

**Recommended Corrective Action:** Maintain and install all controls per the approved plans and PSS&S.

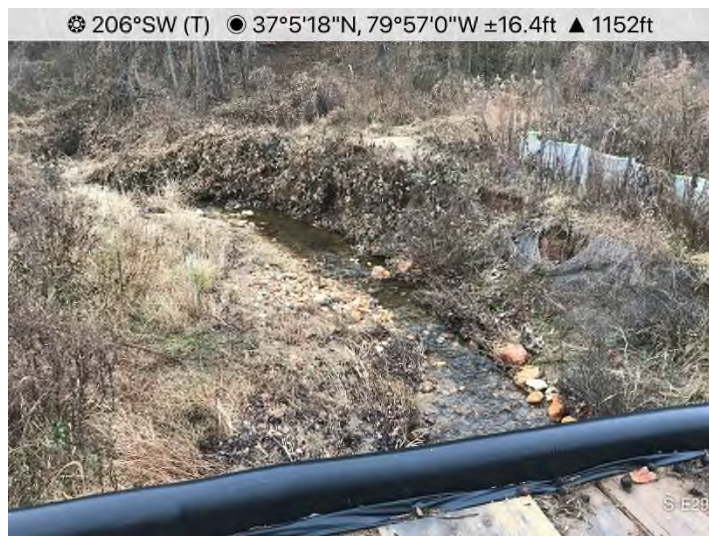
Fig. 3: **Stream S-E29** – Controls in place along resource and functioning properly.

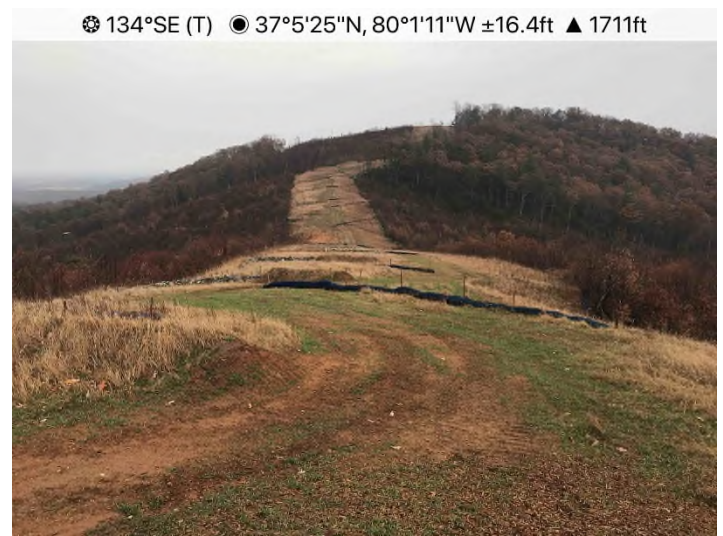
Fig. 4: **STA 13438+31** – Controls in place and functioning properly. Area stabilized.
