## FIELD INSPECTION

| Project Name: | Mountain Valley Pipeline | Inspector: | Marshall Willis |
| Inspection Date: | Monday, December 2, 2019 | Project Contact: | Brian Clauto, Cory Chalmers |
| Spread I:<br>Franklin County | STA 14411+04 – 14546+75<br>MVP-FR-315 | Weather (Wet/Dry/Rain): | Wet |

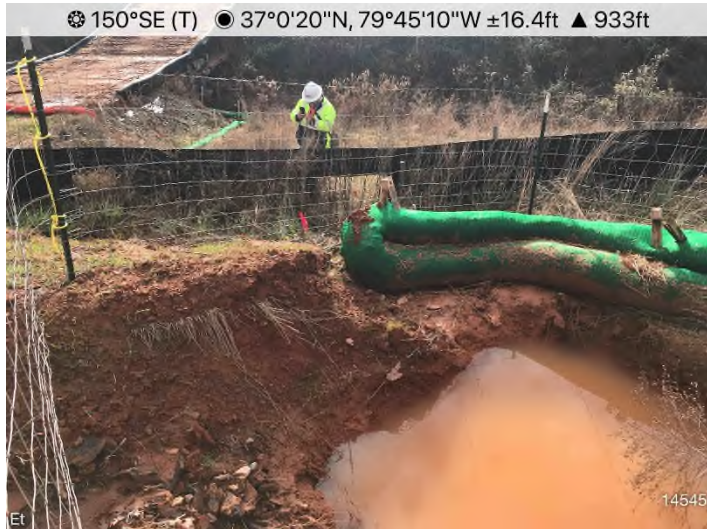
Fig. 1: **STA 14545+00** – Discharge bypassing CFS end-treatment. Maintenance needed.

**Recommended Corrective Action:** Maintain and install all controls per the approved plans and PSS&S.

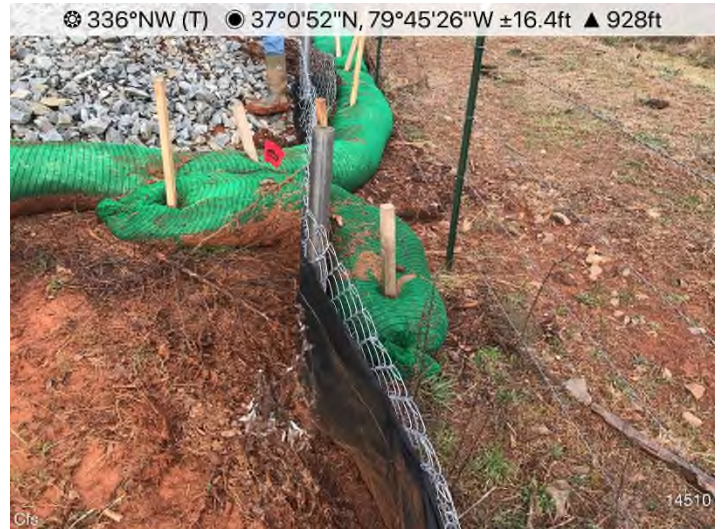
Fig. 2: **STA 14510+00** – CFS undermined. Maintenance needed.

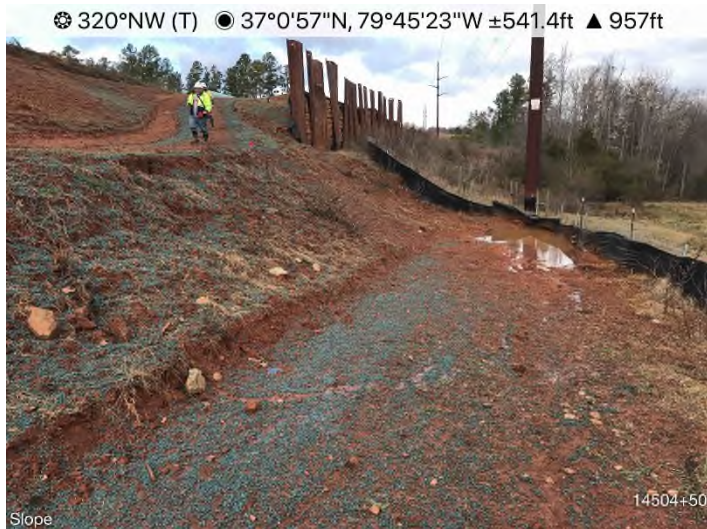
Fig. 3: **STA 14504+50** – Erosion control matting needed on steep slope.

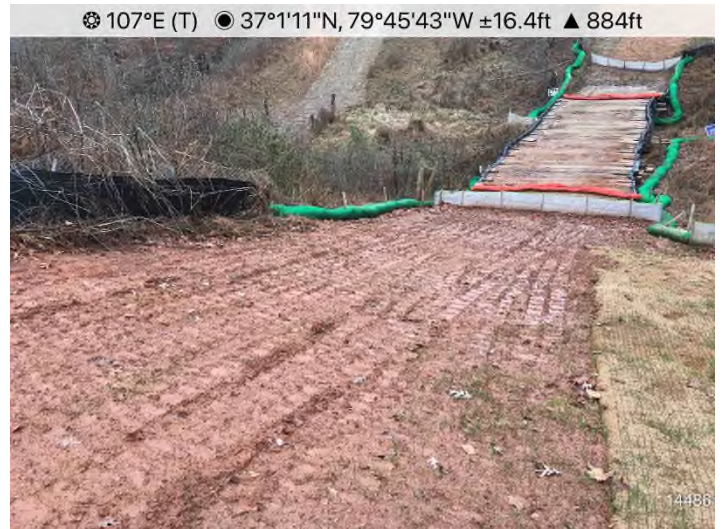
Fig. 4: **STA 14486+00** – Stabilization needed on CIS slope of Stream S-G22.
