## FIELD INSPECTION

| Project Name: | Mountain Valley Pipeline | Inspector: | Marshall Willis |
| Inspection Date: | Friday, December 6, 2019 | Project Contact: | Brian Clauto, Cory Chalmers |
| Spread I:<br>Franklin County | STA 14831+61 – 14981+55<br>ATWS 540/541, 377/378, 1364, 380 | Weather (Wet/Dry/Rain): | Wet |

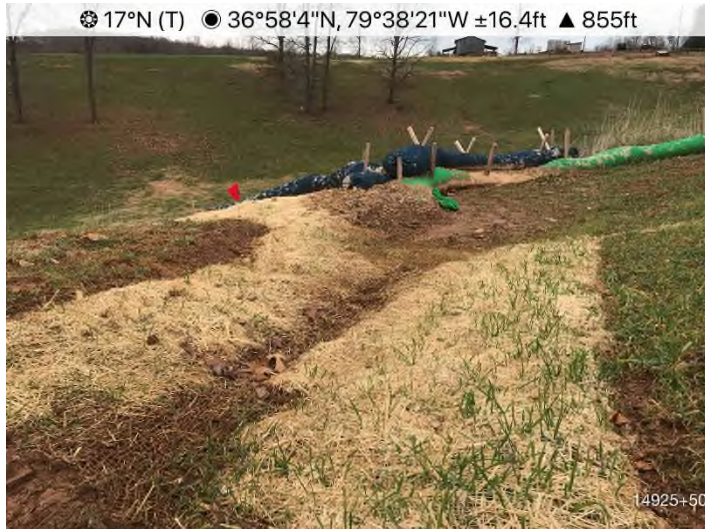
- STA 14925+50 – Waterbar maintenance needed.
- STA 14892+00 – CFS maintenance needed.
- STA 14861+50 to 14907+50 – Travel lane stabilization needed.

Fig. 1: **STA 14925+50** – Waterbar maintenance needed. CFS end-treatment higher than waterbar.

**Recommended Corrective Action:** Maintain and install all controls per the approved plans and PSS&S.

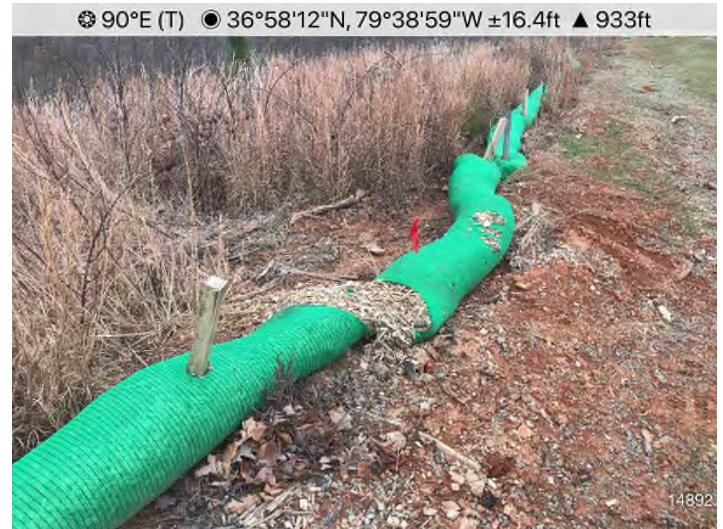
Fig. 2: **STA 14892+00** – CFS maintenance needed.

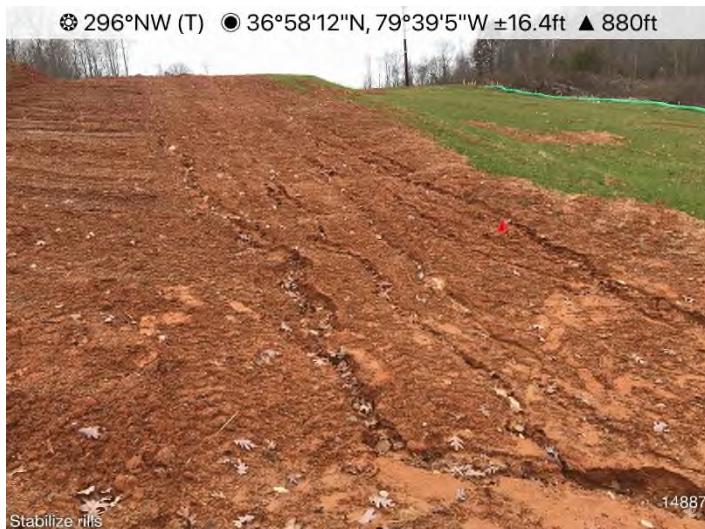
Fig. 3: **STA 14861+50 to 14907+50** – Stabilization of travel lane needed.

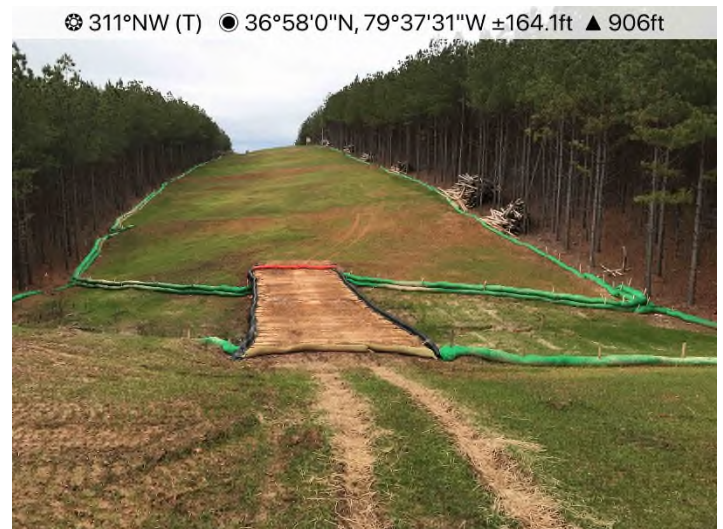
Fig. 4: **STA 14960+00** – Controls in place and functioning. Area stabilized with vegetative cover.
