## FIELD INSPECTION

| <b>Project Name:</b> | Mountain Valley Pipeline | <b>Inspector:</b> | Marshall Willis |
| <b>Inspection Date:</b> | Wednesday, December 4, 2019 | <b>Project Contact:</b> | Brian Clauto, Cory Chalmers |
| <b>Spread H:</b><br>Montgomery County<br>Roanoke County | STA 12545+19 – 12544+06<br>MVP-MN-278.01/RO-270.01<br>MVP-MLV-AR-28 | <b>Weather (Wet/Dry/Rain):</b> | Wet |

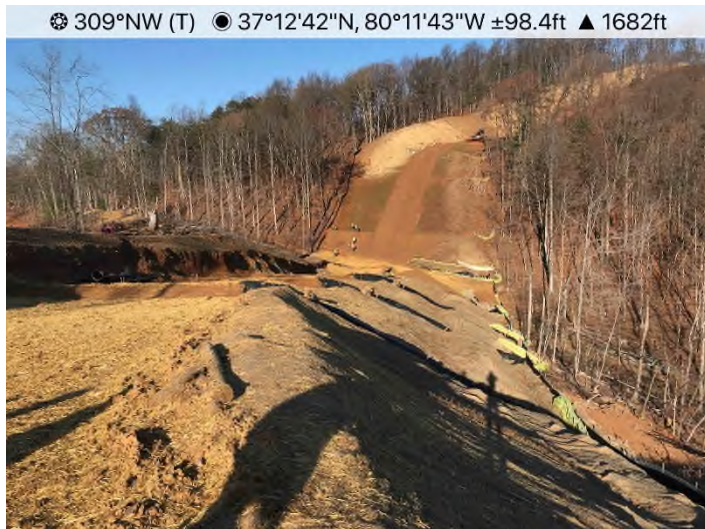
Fig. 1: **STA 12536+50** – Controls in place and functioning properly.

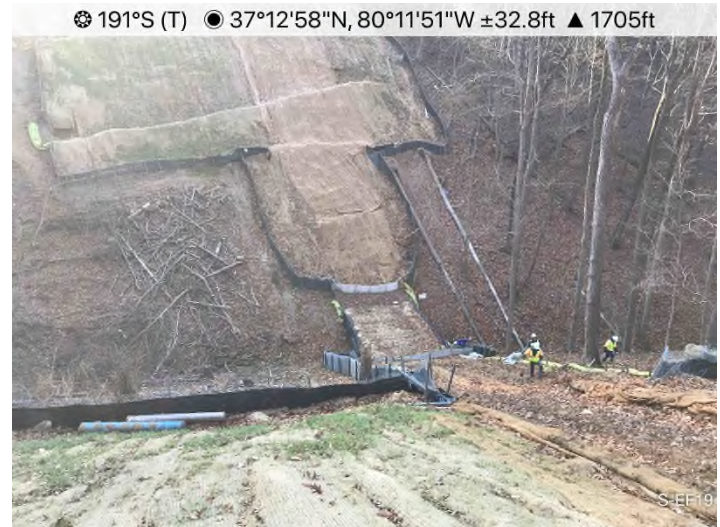
Fig. 2: **STA 12518+50** – Controls in place along Stream S-EF19.

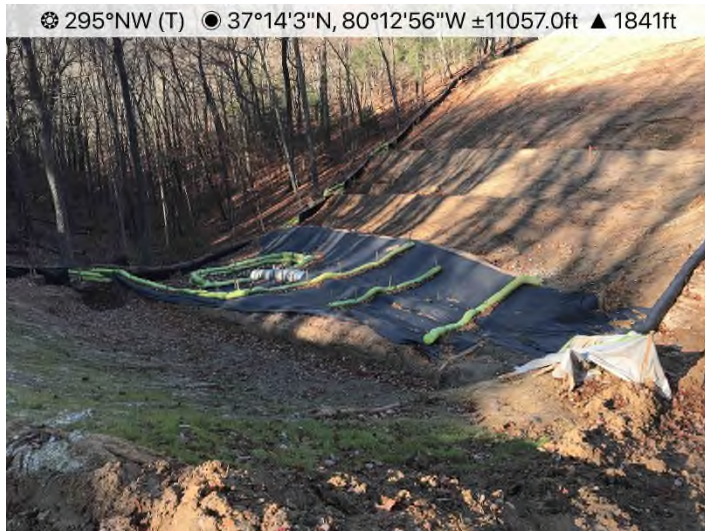
Fig. 3: **STA 12502+00** – Controls in place and functioning properly.

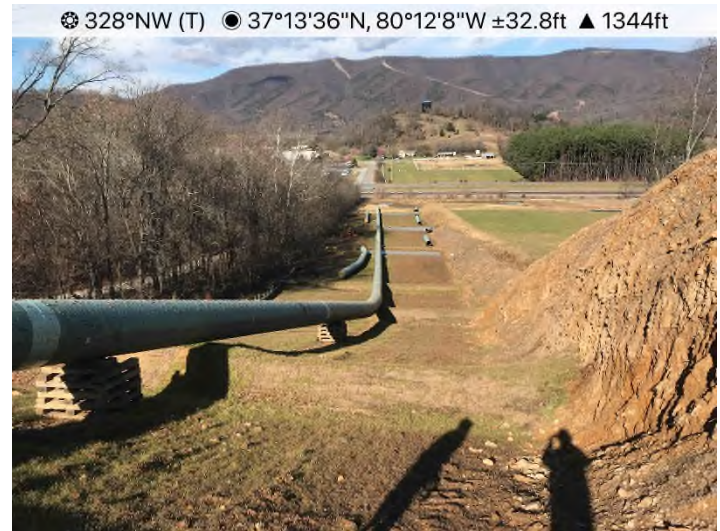
Fig. 4: **STA 12471+00** – Controls in place and functioning properly.
