## FIELD INSPECTION

| <b>Project Name:</b> | Mountain Valley Pipeline | <b>Inspector:</b> | Matthew Grant |
| <b>Inspection Date:</b> | Wednesday, December 4, 2019 | <b>Project Contact:</b> | Brian Clauto |

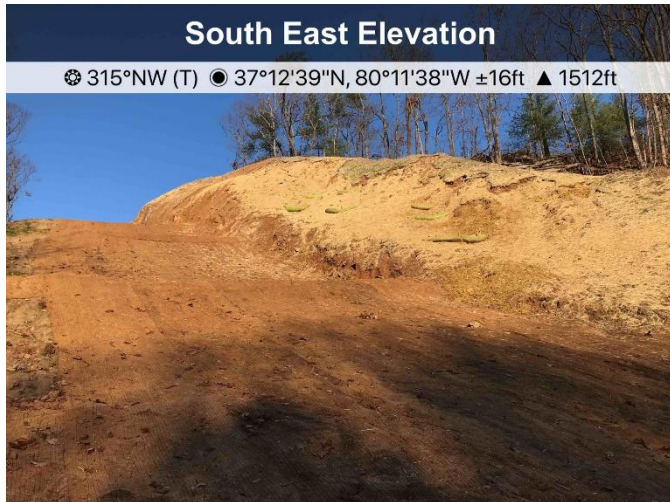
- Fig. 1. Near MP 237.5 stockpiles have been stabilized.

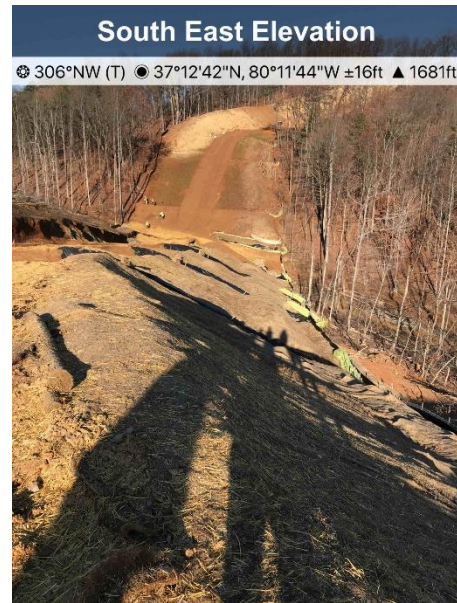
- Fig. 2. Near MP 237.2 slope drains are functioning and ECD maintenance is being conducted.

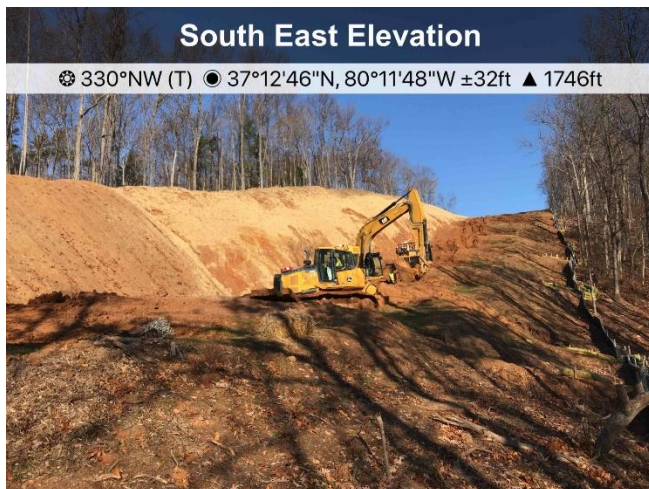
- Fig. 3. Near MP 237.3 ECD maintenance was being conducted.

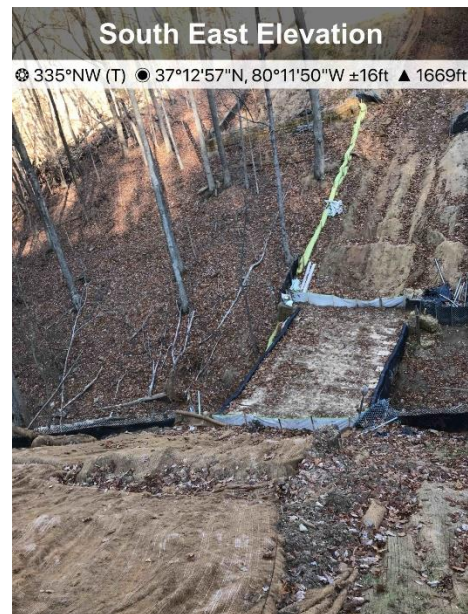
- Fig. 4. Above designated stream S-EF19, ECD's are in place and functioning.
