## FIELD INSPECTION

| <b>Project Name:</b> | Mountain Valley Pipeline | <b>Inspector:</b> | Marshall Willis |
| <b>Inspection Date:</b> | Wednesday, November 6, 2019 | <b>Project Contact:</b> | Brian Clauto, Cory Chalmers |
| <b>Spread I:<br/>Franklin County</b> | STA 13920+00 – 13939+50<br>STA 14018+47 – 14062+17<br>MVP-FR-305 | <b>Weather (Wet/Dry/Rain):</b> | Wet |

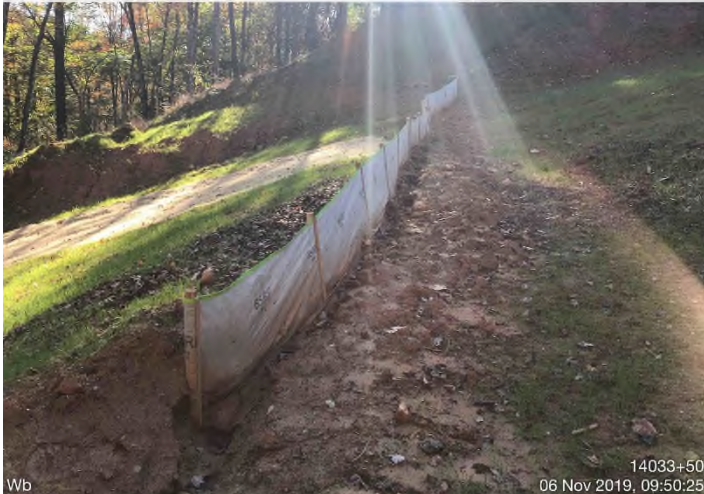
STA 14033+50: Waterbar maintenance needed.

Fig. 3: **STA 14033+50** – Waterbar maintenance needed.

**Recommended Corrective Action:** Maintain and install all controls per the approved plans and PSS&S.

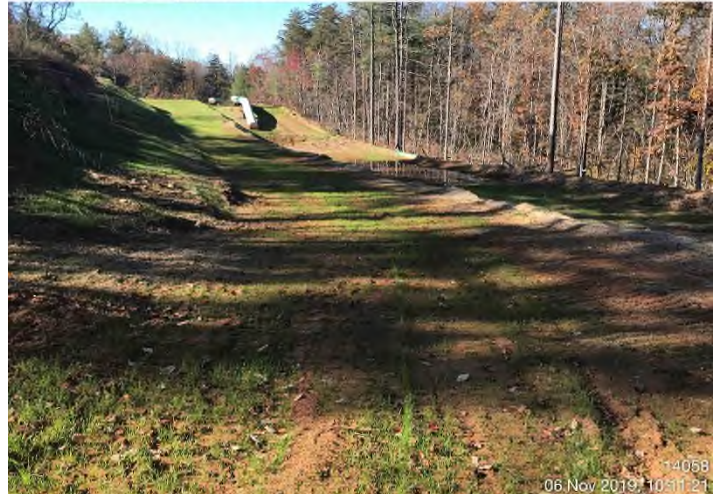
Fig. 4: **STA 14058+00** – Controls in place and functioning properly. Area adequately stabilized.
