## FIELD INSPECTION

| <b>Project Name:</b> | Mountain Valley Pipeline | <b>Inspector:</b> | Marshall Willis |
| <b>Inspection Date:</b> | Thursday, October 31, 2019 | <b>Project Contact:</b> | Brian Clauto, Cory Chalmers |
| <b>Spread I:<br/>Franklin County</b> | STA 13958+31 – 14102+00<br>ATWS 1299/1466<br>MVP-FR-306.02/306.03 | <b>Weather (Wet/Dry/Rain):</b> | Rainy |

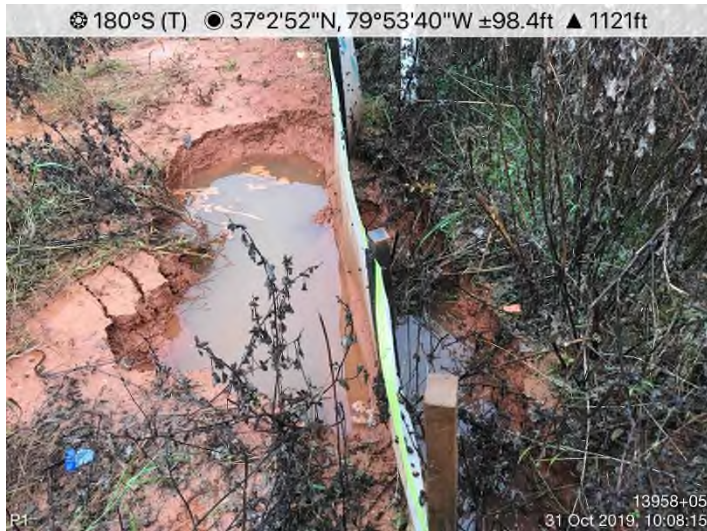
STA 13958+01: P1 maintenance needed.  
 STA 13963+00: End-treatment causing scour outside LOD.  
 STA 13965+00: CFS maintenance needed. CFS undermined.  
 STA 13970+00: CFS maintenance needed. CFS undermined.  
 STA 13972+00: CFS maintenance needed. CFS undermined.

Fig. 1: **STA 13958+01** – P1 maintenance needed.

**Recommended Corrective Action:** Maintain and install all controls per the approved plans and PSS&S.

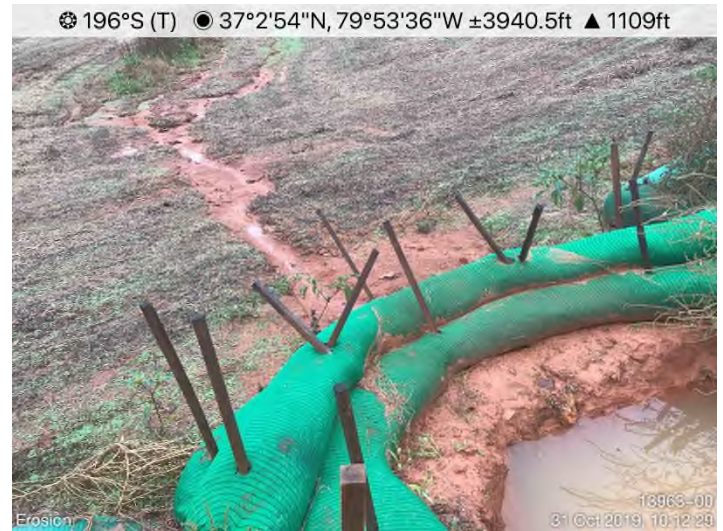
Fig. 2: **STA 13963+00** – End treatment causing scour outside of LOD.

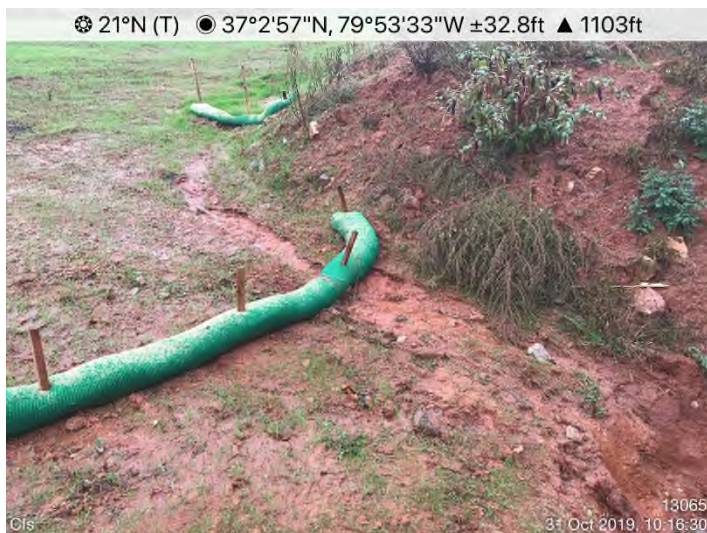
Fig. 3: **STA 13965+00** – CFS maintenance needed.

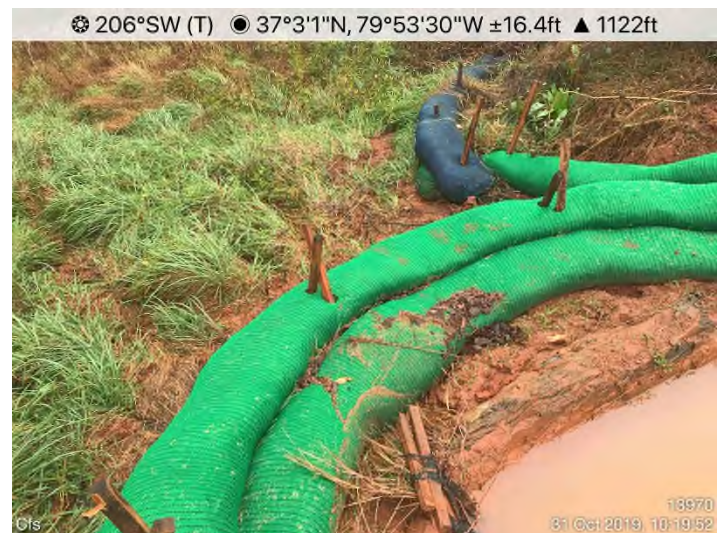
Fig. 4: **STA 13970+00** – CFS maintenance needed.

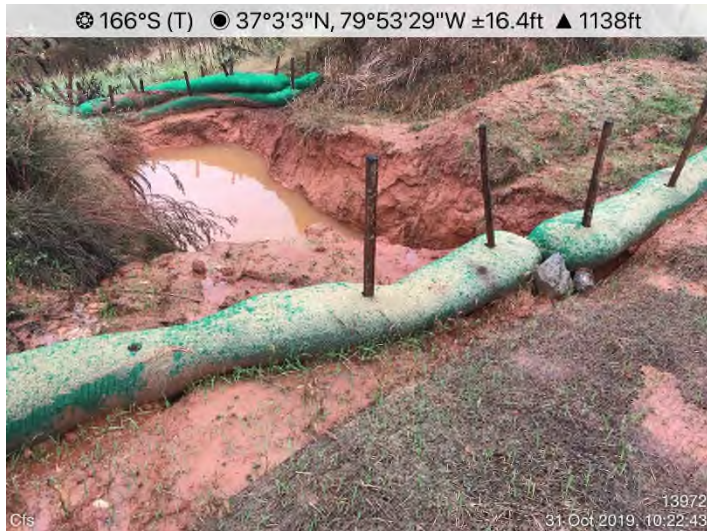
Fig. 5: **STA 13972+00** – CFS maintenance needed.
