## FIELD INSPECTION

| <b>Project Name:</b> | <b>Mountain Valley Pipeline</b> | <b>Inspector:</b> | <b>Marshall Willis</b> |
| <b>Inspection Date:</b> | <b>Wednesday, October 30, 2019</b> | <b>Project Contact:</b> | <b>Brian Clauto, Cory Chalmers</b> |
| <b>Spread I:<br/>Franklin County</b> | <b>STA 14845+68 – 14928+52</b> | <b>Weather (Wet/Dry/Rain):</b> | <b>Rainy</b> |

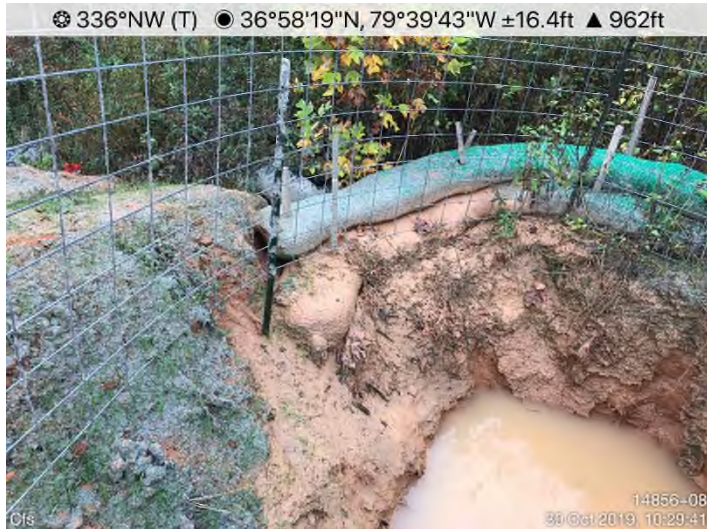
Fig. 1: **STA 14856+08** – End-treatment undermined. Maintenance needed.

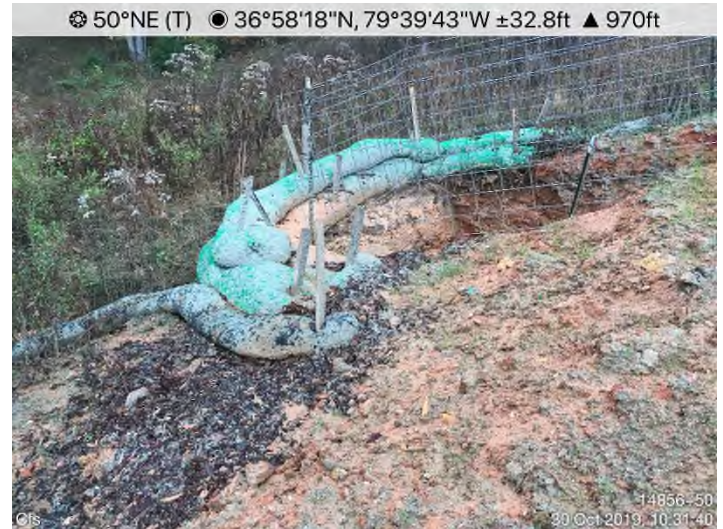
Fig. 2: **STA 14856+50** – Waterbar lower than CFS end-treatment. Discharge unable to get off ROW.

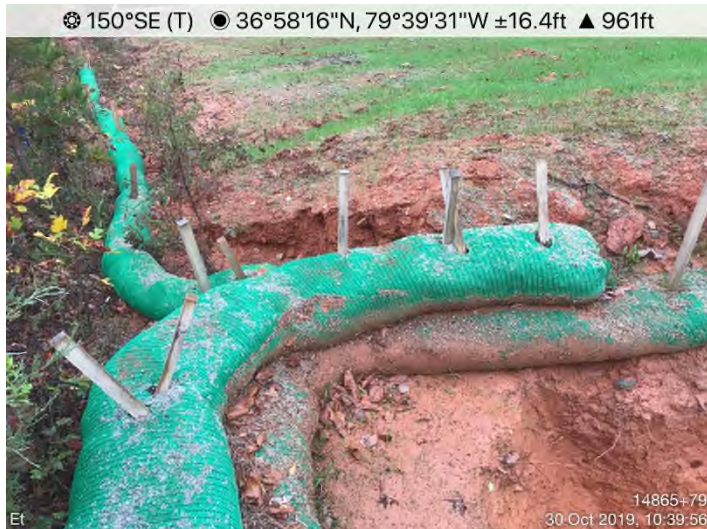
Fig. 3: **STA 14867+00** – End-treatment bypassed. Maintenance needed.

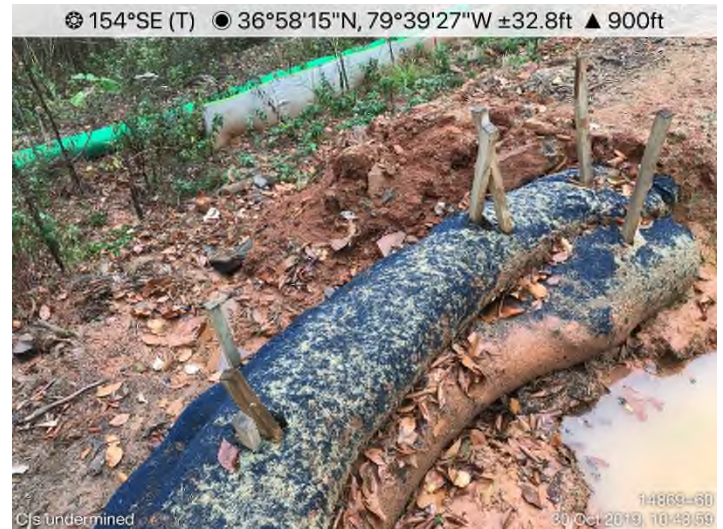
Fig. 4: **STA 14869+60** – End-treatment undermined. Maintenance needed.

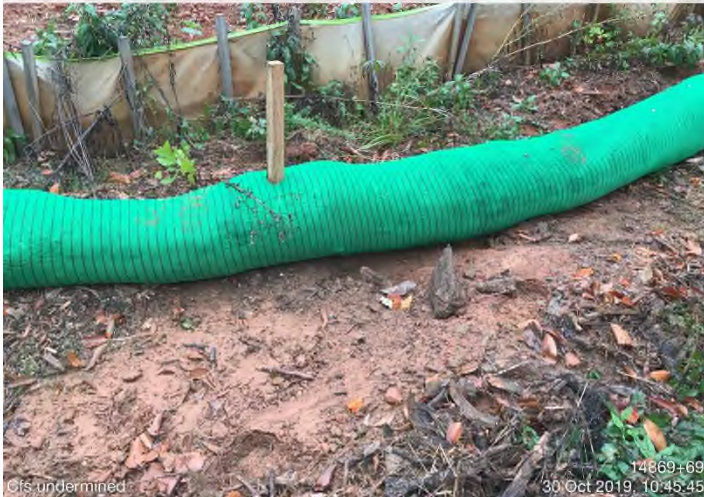
Fig. 5: **STA 14869+69** – CFS undermined. Maintenance needed.

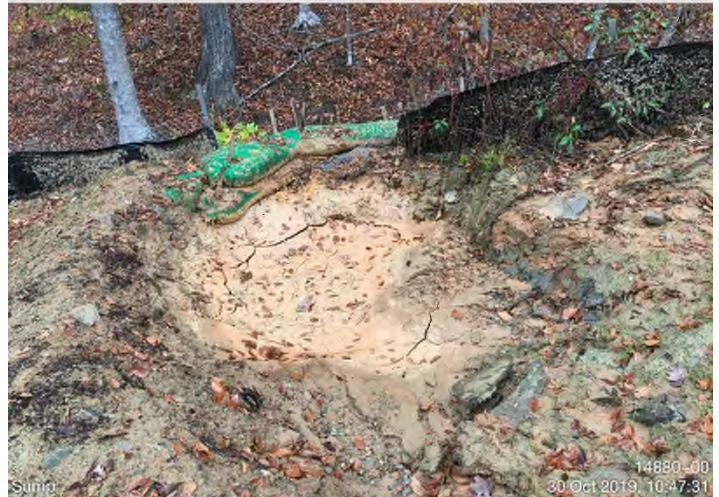
Fig. 6: **STA 14872+00** – Sump maintenance needed.

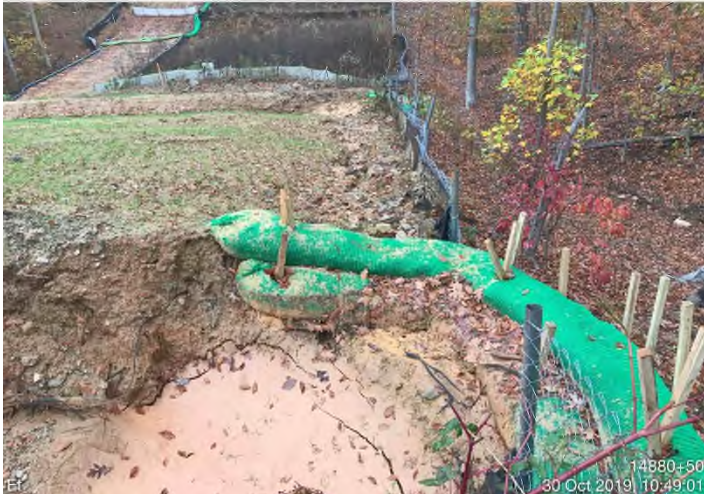
Fig. 7: **STA 14872+50** – End-treatment discharges onto ROW. Maintenance needed.

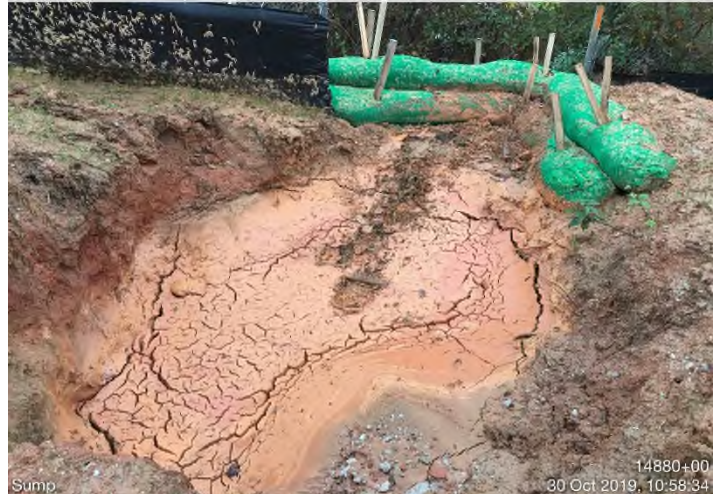
Fig. 8: **STA 14880+00** – Sump maintenance needed.

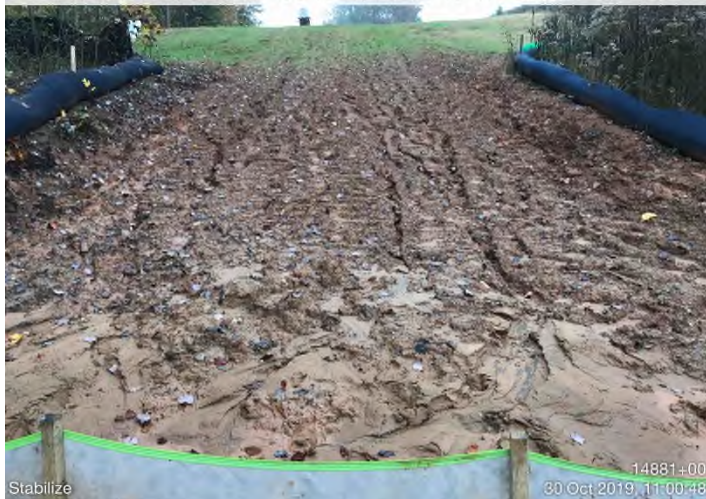
Fig. 9: **STA 14881+00** – Stabilize slope/repair erosion adjacent to S-CD8.

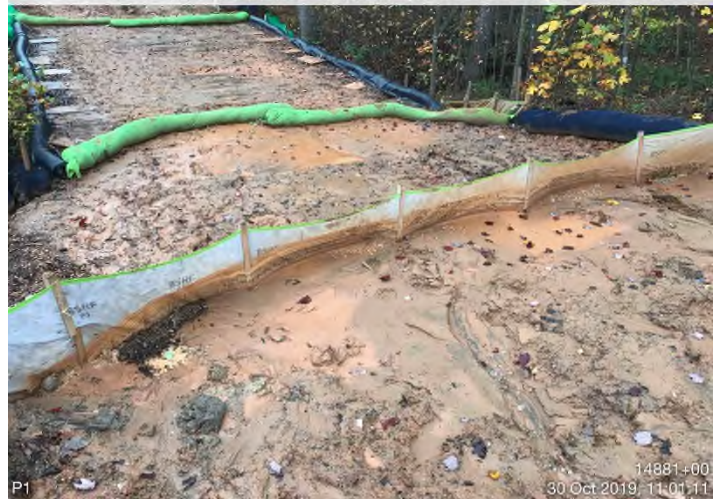
Fig. 10: **STA 14881+00** – P1 maintenance needed.

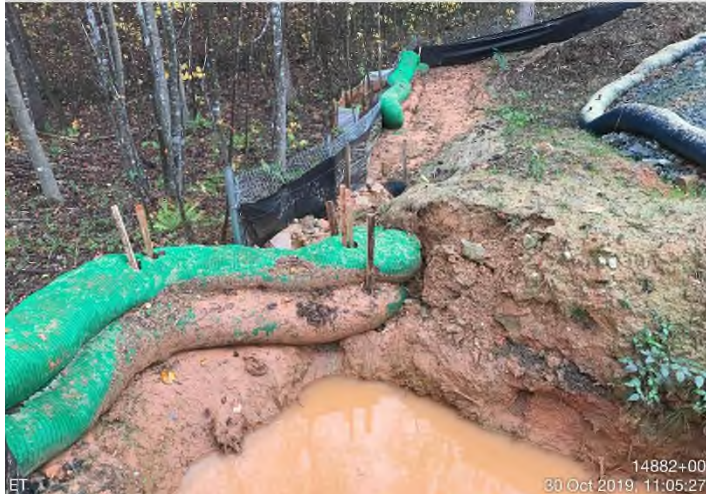
Fig. 11: **STA 14882+00** – CFS undermined. End-treatment discharges onto ROW.

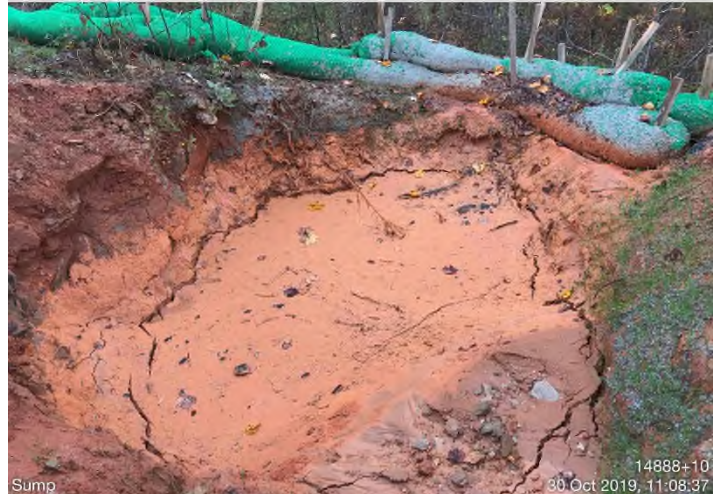
Fig. 12: **STA 14888+10** – Sump maintenance needed.

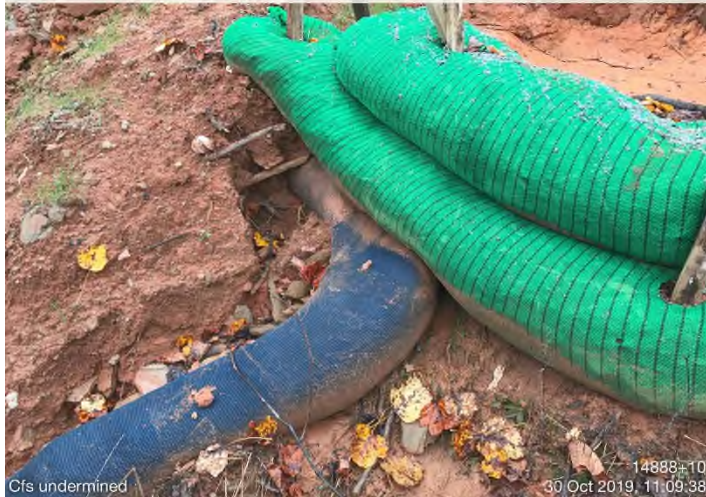
Fig. 13: **STA 14888+10** – CFS undermined. End-treatment discharges onto ROW.

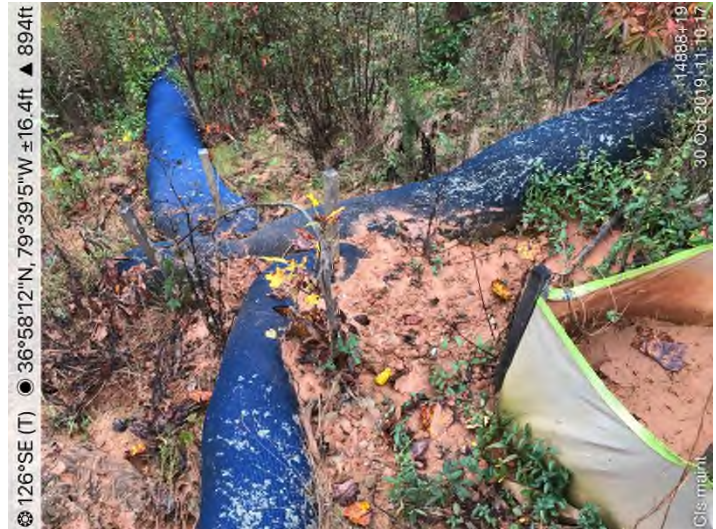
Fig. 14: **STA 14888+19** – CFS maintenance needed.

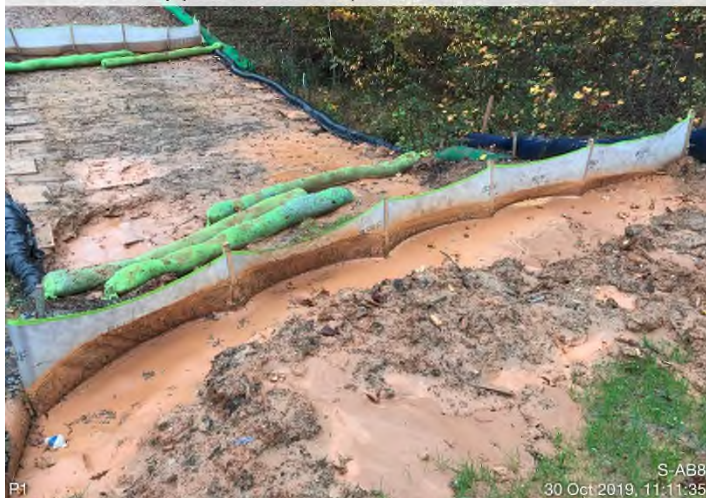
Fig. 15: **STA 14888+60**– P1 maintenance needed.

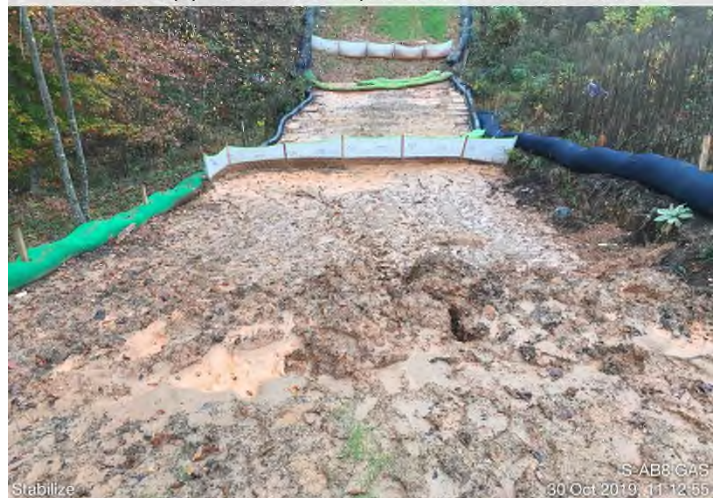
Fig. 16: **STA 14888+75** – Stabilize slope/repair erosion adjacent to S-AB8.

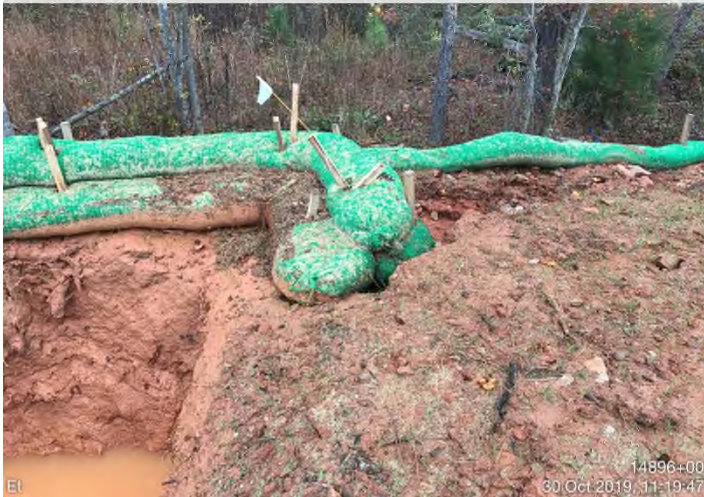
Fig. 17: **STA 14896+00** – Waterbar does not extend length of ROW.

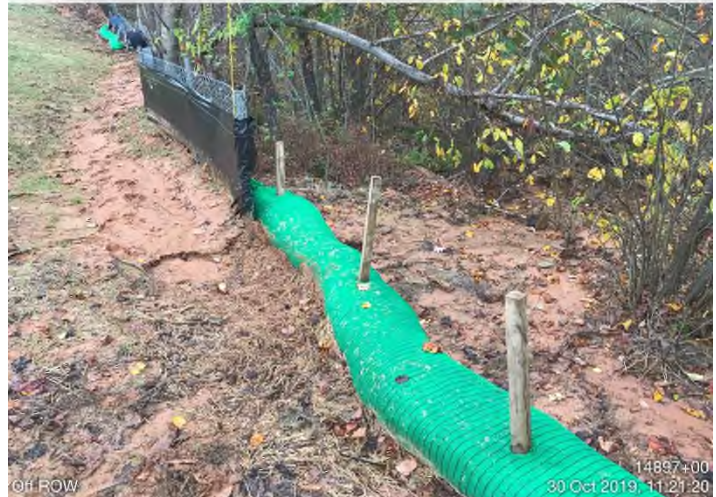
Fig. 18: **STA 14897+00** – Sediment off ROW.

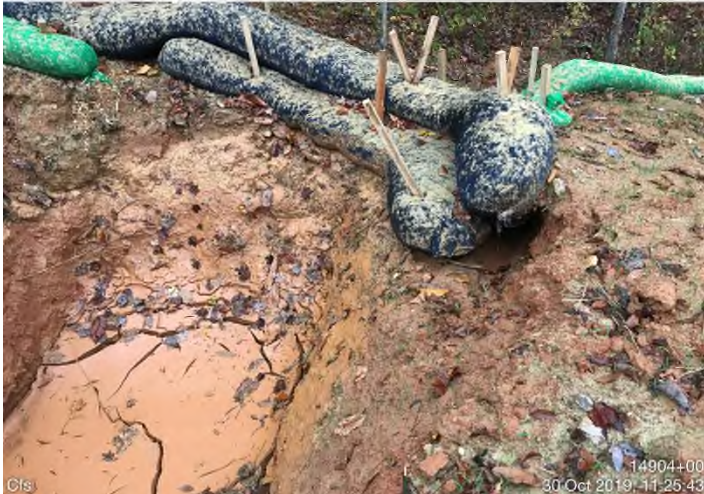
Fig. 19: **STA 14904+00** – CFS undermined. Maintenance needed.

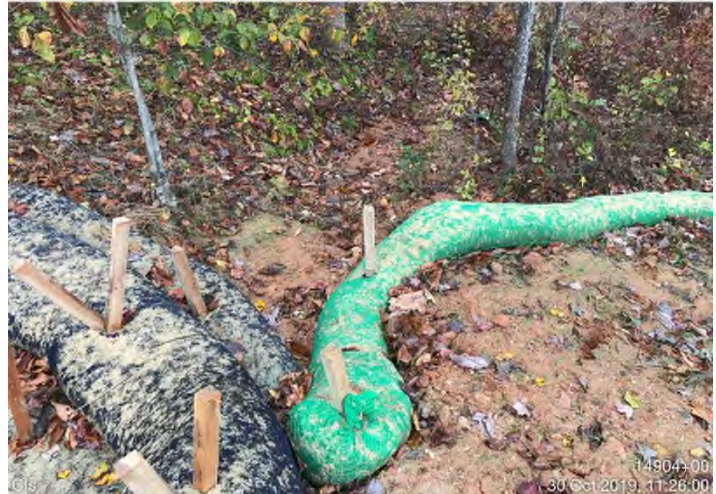
Fig. 20: **STA 14904+00** – Sediment off ROW.

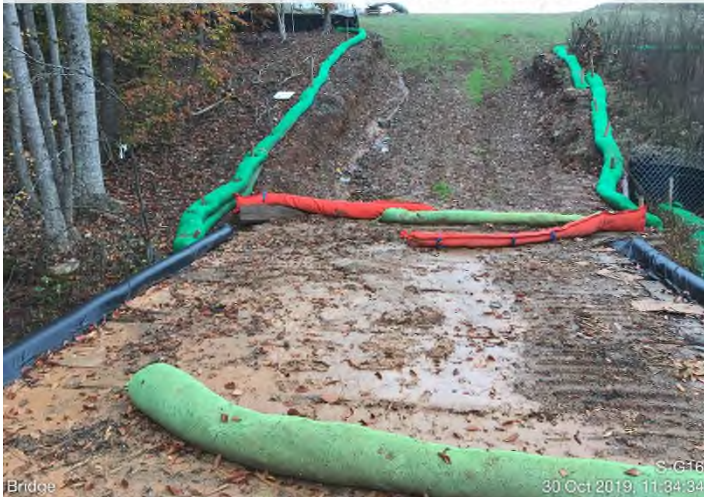
Fig. 21: **STA 14916+26** – Clean sediment off bridge. Stabilize and repair slope adjacent to S-G16.

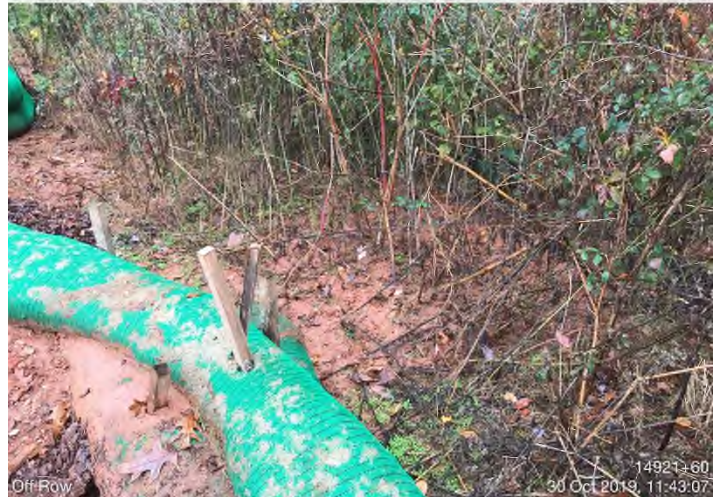
Fig. 22: **STA 14921+60** – Sediment off ROW.

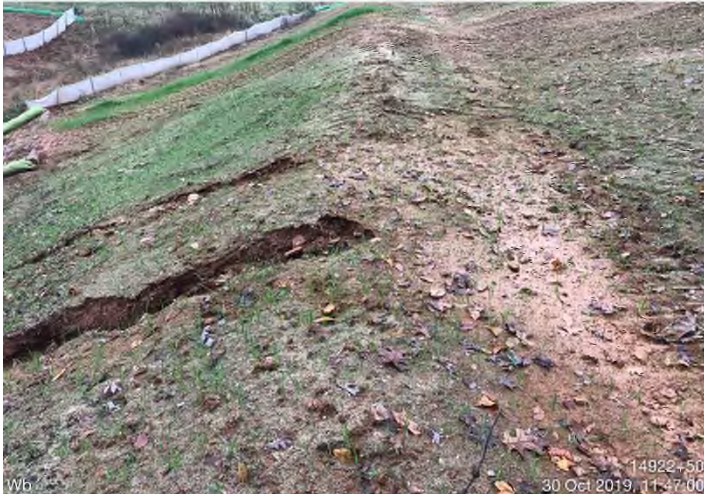
Fig. 23: **STA 14922+50** – Waterbar maintenance needed.

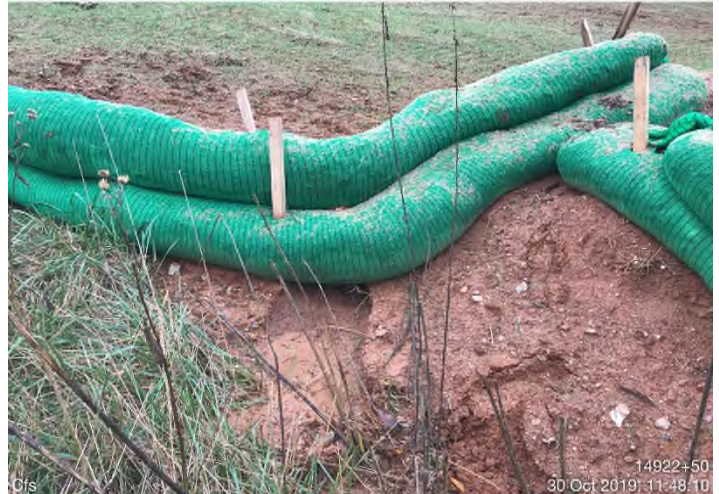
Fig. 24: **STA 14922+50** – CFS undermined. Maintenance needed.

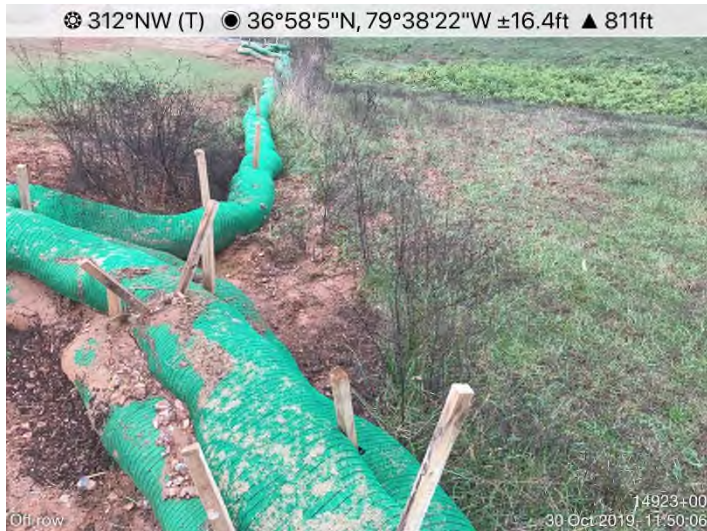
Fig. 25: **STA 14923+00** – Sediment off ROW.

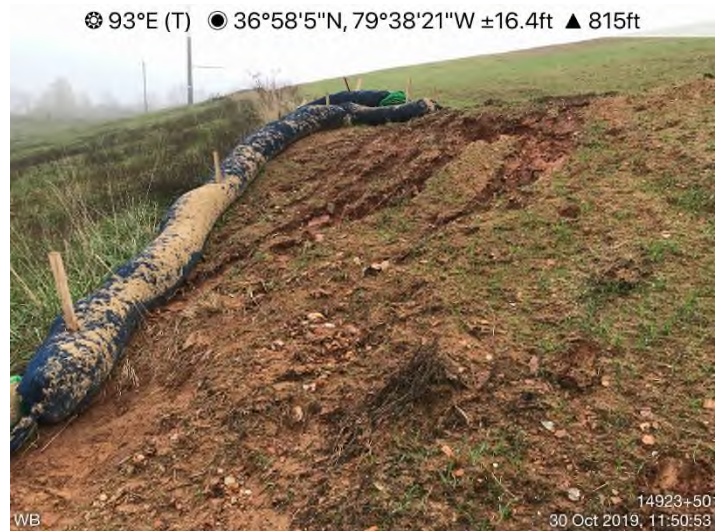
Fig. 26: **STA 14923+50** – Waterbar maintenance needed.
