## FIELD INSPECTION

| <b>Project Name:</b> | <b>Mountain Valley Pipeline</b> | <b>Inspector:</b> | <b>Marshall Willis</b> |
| <b>Inspection Date:</b> | <b>Tuesday, October 29, 2019</b> | <b>Project Contact:</b> | <b>Brian Clauto, Cory Chalmers</b> |
| <b>Spread I:</b><br><b>Pittsylvania County</b> | <b>STA 15113+00 – 15221+11</b> | <b>Weather (Wet/Dry/Rain):</b> | <b>Wet</b> |

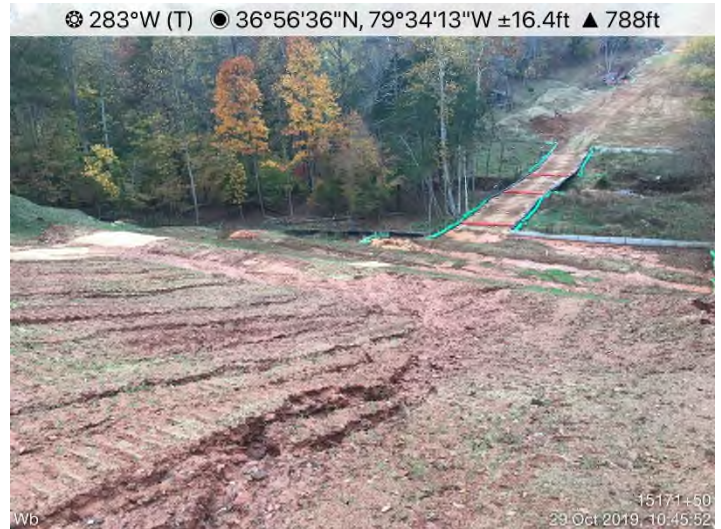
Fig. 2: **STA 15171+50 to 15169+58** – Waterbar maintenance needed.

**Recommended Corrective Action:** Maintain and install all controls per the approved plans and PSS&S.

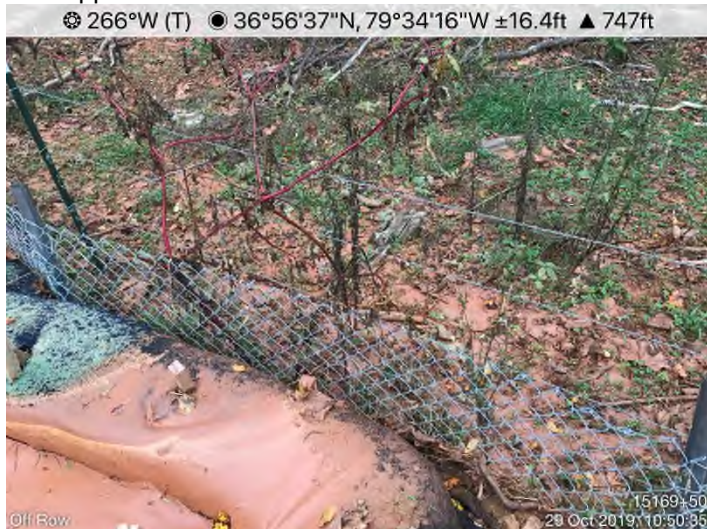
Fig. 3: **STA 15169+58** – Sediment off ROW. Controls overtopped.

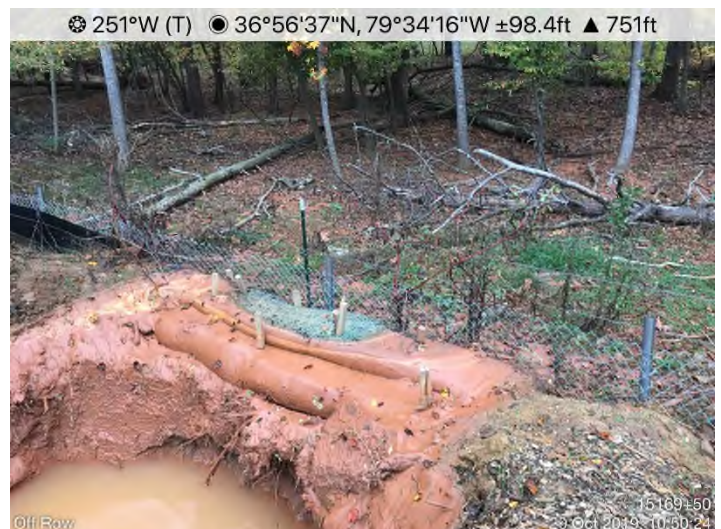
Fig. 4: **STA 15169+58** – CFS overtopped. Maintenance needed.

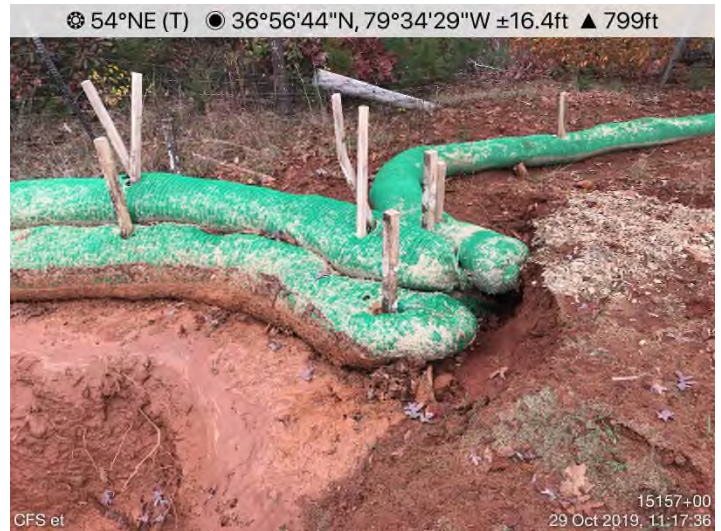
Fig. 10: **STA 15157+00** – CFS end-treatment bypassed. Maintenance needed.

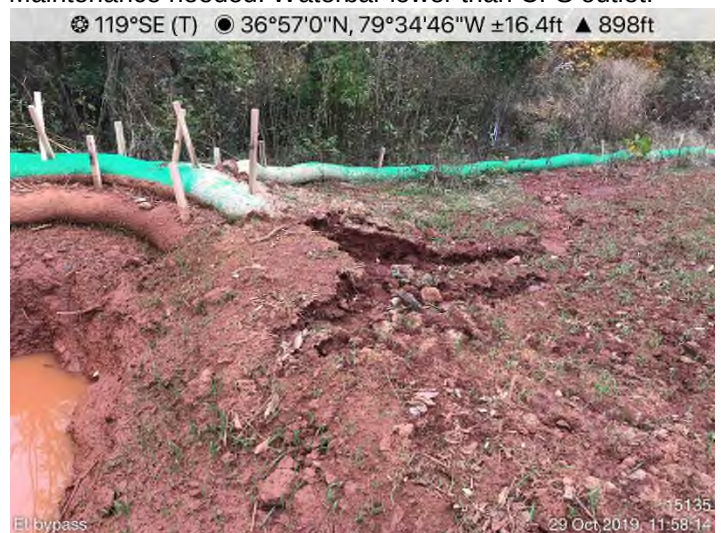
Fig. 12: **STA 15135+00** – CFS end-treatment bypassed. Maintenance needed. Waterbar lower than CFS outlet.

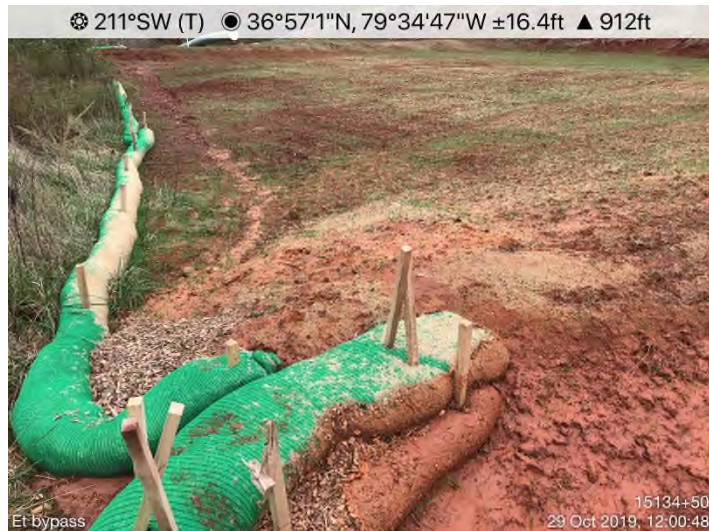
Fig. 13: **STA 15134+50** – CFS end-treatment bypassed. Maintenance needed. Waterbar lower than CFS outlet.

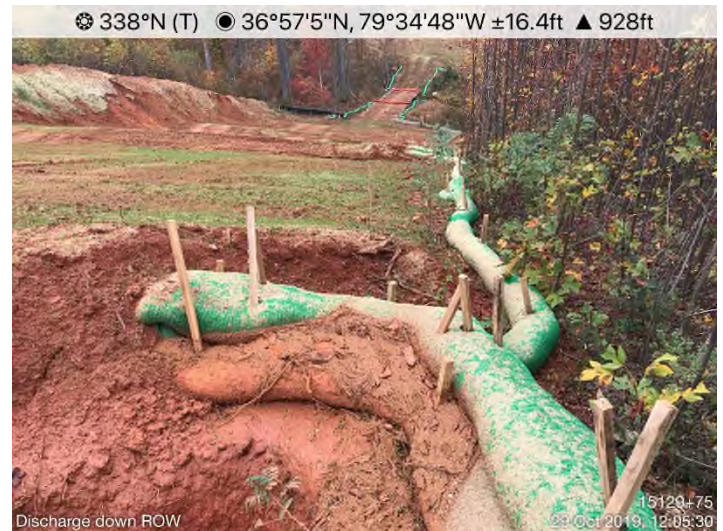
Fig. 14: **STA 15128+71** – Waterbar does not discharge off ROW. Maintenance needed.

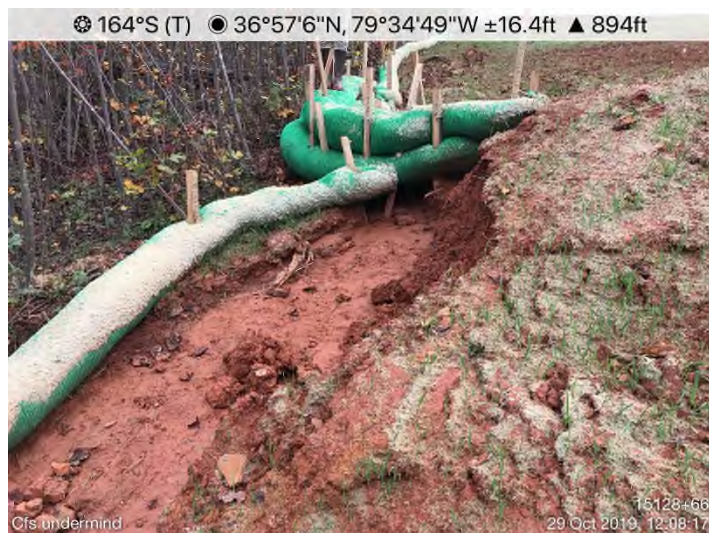
Fig. 15: **STA 15128+65** – CFS undermined. Maintenance needed.

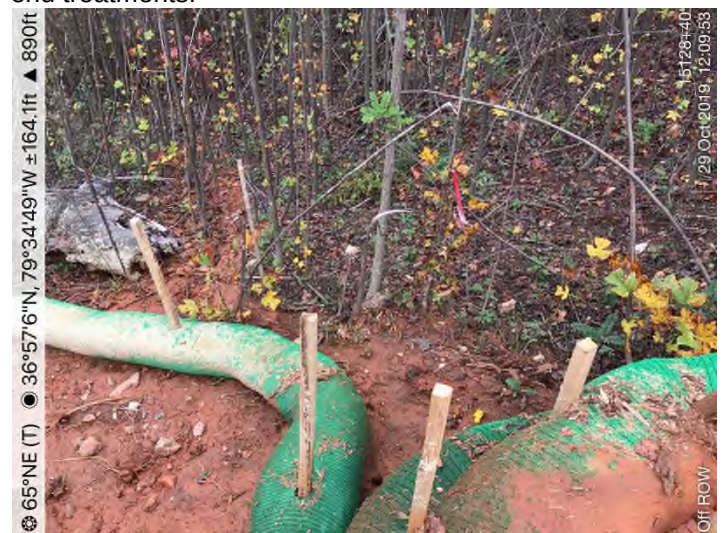
Fig. 16: **STA 15128+40** – Sediment off ROW due to upslope control failure and incorrect installation of waterbar end treatments.

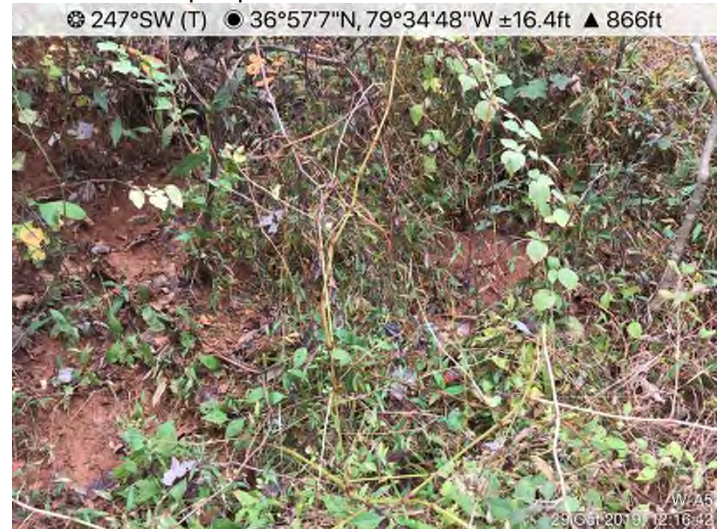
Fig. 18: **Wetland W-A5** – Sediment off ROW impacting wetland W-A5 due to control failure and incorrect installation of upslope controls.

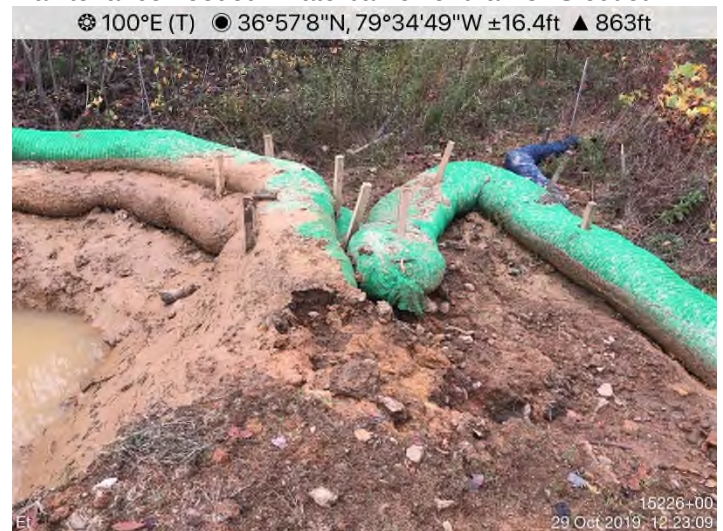
Fig. 20: **STA 15126+00** – CFS end-treatment bypassed. Maintenance needed. Waterbar lower than CFS outlet.

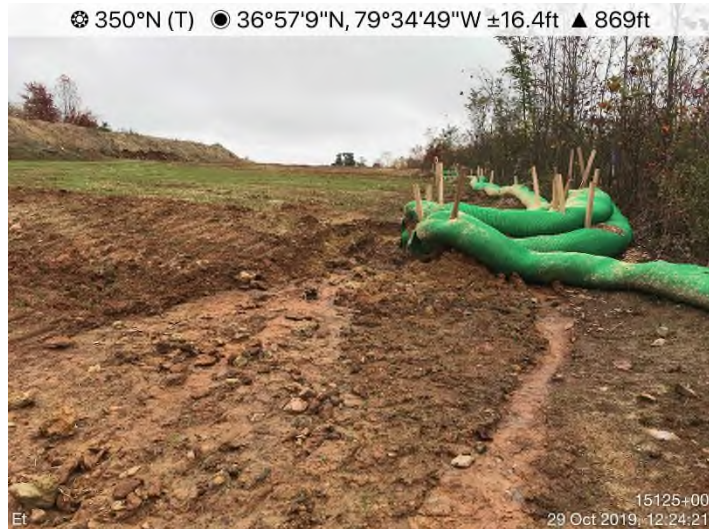
Fig. 21: **STA 15125+00** – CFS end-treatment bypassed. Maintenance needed. Waterbar lower than CFS outlet.

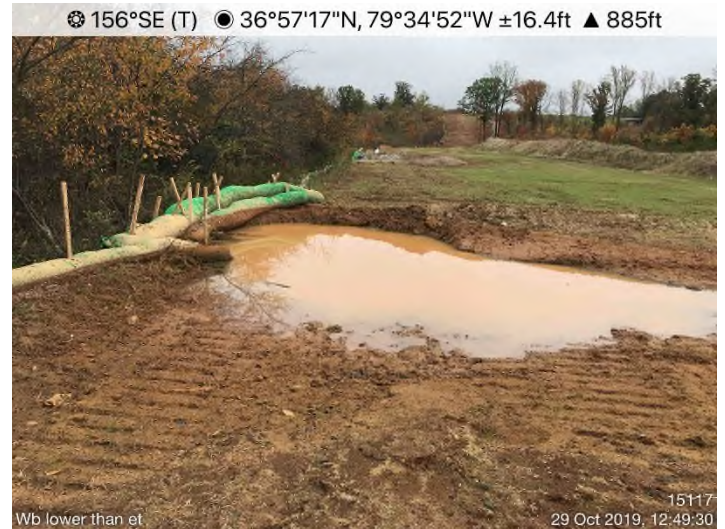
Fig. 22: **STA 15117+00** – CFS end-treatment bypassed. Maintenance needed. Waterbar lower than CFS outlet.
