## FIELD INSPECTION

| <b>Project Name:</b> | Mountain Valley Pipeline | <b>Inspector:</b> | Matthew Grant |
| <b>Inspection Date:</b> | Wednesday, October 23, 2019 | <b>Project Contact:</b> | Brian Clauto |

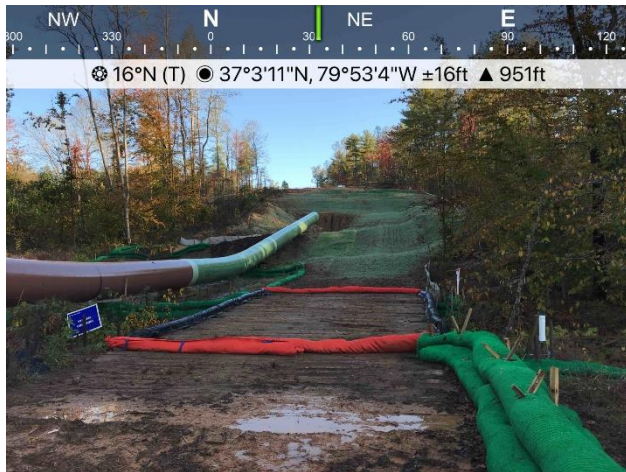
- Fig. 1. At designated stream S-KL36, ECD's are in place and area has been stabilized.

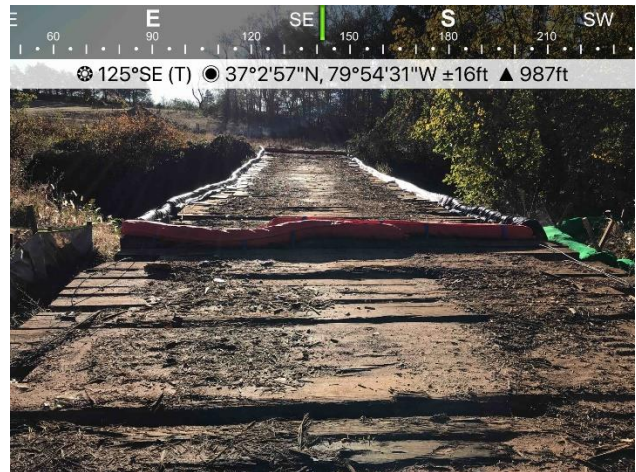
- Fig. 2 At designated stream S-II2, ECD's are in place and functioning.

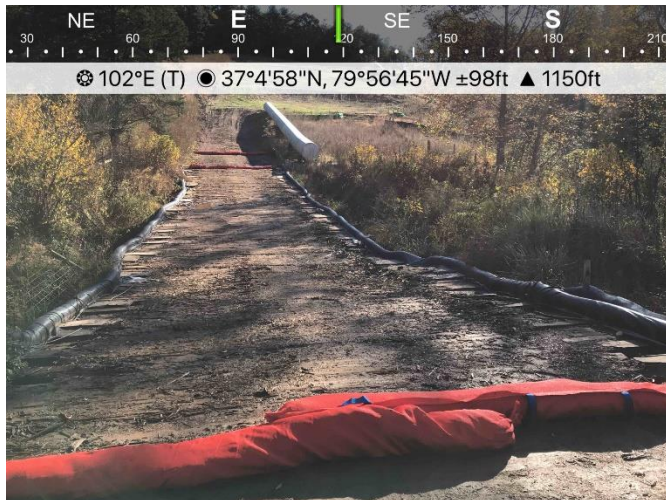
- Fig. 3 At designated stream S-E29, ECD's are in place and functioning.

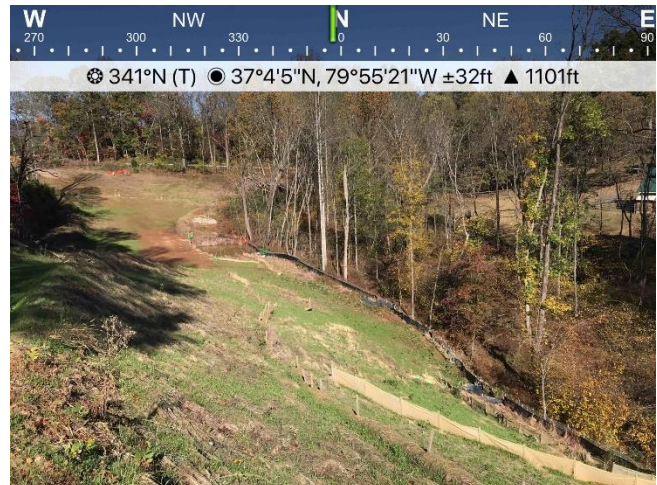
- Fig. 4 Near St13820+00 slope is stabilized.
