## FIELD INSPECTION

| Project Name: | Mountain Valley Pipeline | Inspector: | Marshall Willis |
| Spread H:<br>Franklin County | STA 13342+67 – 13415+51 | Weather (Wet/Dry/Rain): | Dry |

## FIELD INSPECTION PHOTO LOG

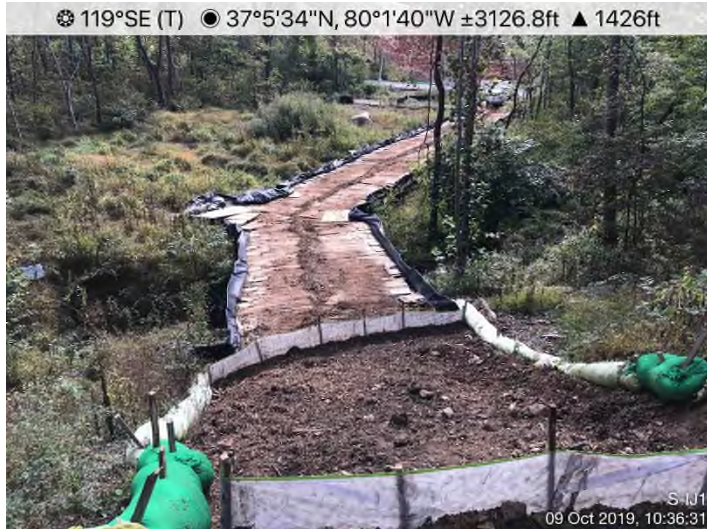
Fig. 1: **Stream S-IJ1**– Controls in place and functioning properly at stream and wetland crossing.

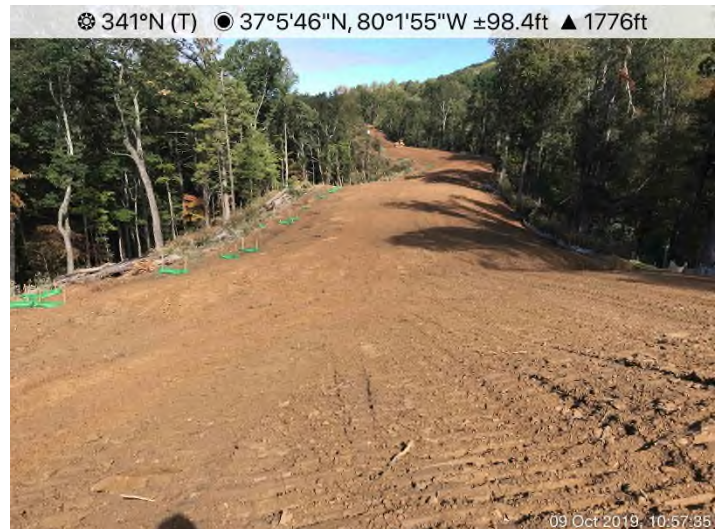
Fig. 2: **STA 13395+00** – Controls in place. Area actively being graded back to subgrade.

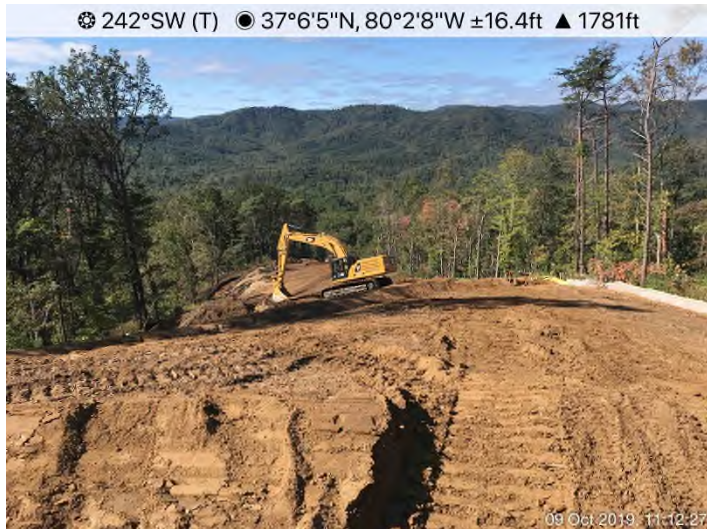
Fig. 3: **STA 13370+00** – Controls in place. Area actively being graded back to subgrade.

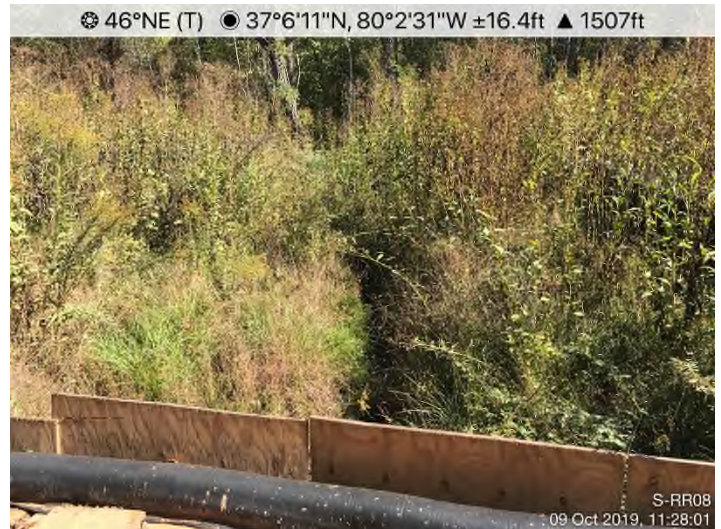
Fig. 4: **Stream S-RR08** – Controls in place at stream crossing and functioning properly.
