## FIELD INSPECTION

| Project Name: | Mountain Valley Pipeline | Inspector: | Marshall Willis |
| Inspection Date: | Tuesday, October 8, 2019 | Project Contact: | Brian Clauto, Cory Chalmers |

## FIELD INSPECTION PHOTO LOG

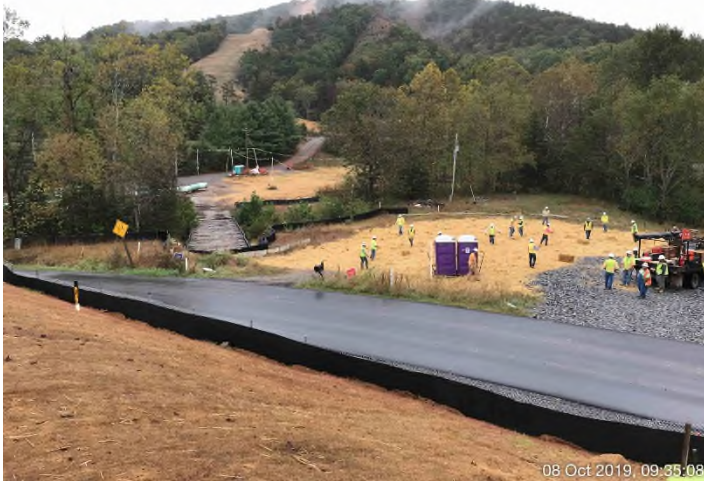
Fig. 1: **STA 12190+00** – Controls in place in place at Bradshaw Road.

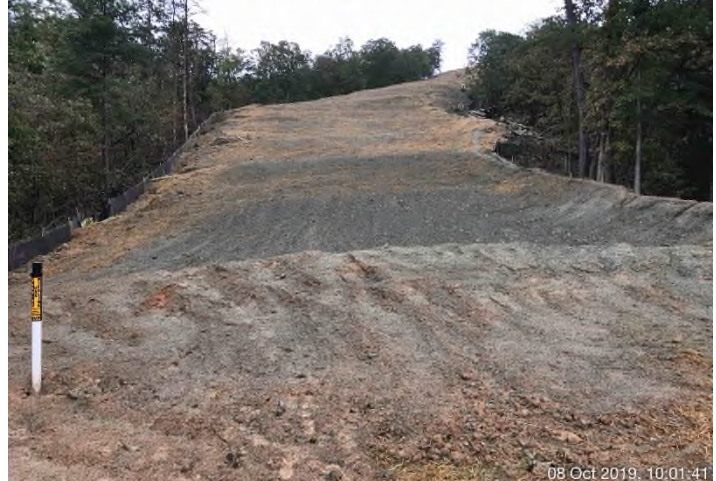
Fig. 2: **STA 12200+00** – Controls in place. Area stabilized with hydraulic mulch and straw.

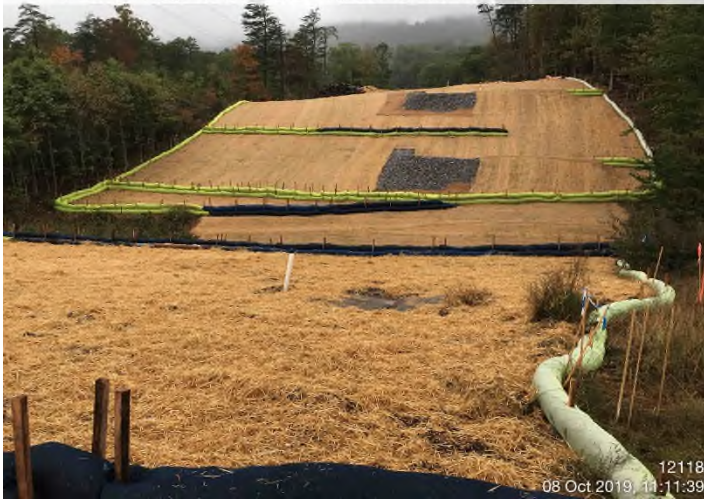
Fig. 3: **STA 12117+62** – Controls in place. Area stabilized with straw and erosion matting.

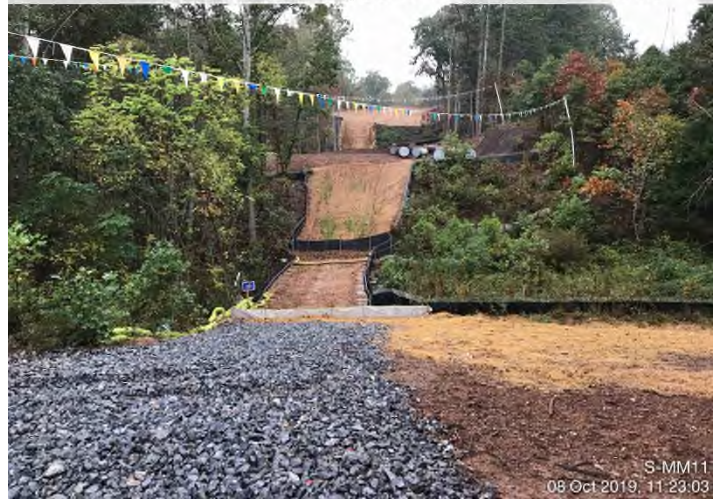
Fig. 4: **Stream S-MM11** – Controls in place. Area stabilized with straw and erosion matting.
