## FIELD INSPECTION

| Project Name: | Mountain Valley Pipeline | Inspector: | Marshall Willis |
| Inspection Date: | Tuesday, September 24, 2019 | Project Contact: | Brian Clauto, Cory Chalmers |
| Spread I:<br>Franklin County | STA 13892+55 – 13940+00<br>MVP-FR-305 | Weather (Wet/Dry/Rain): | Dry |

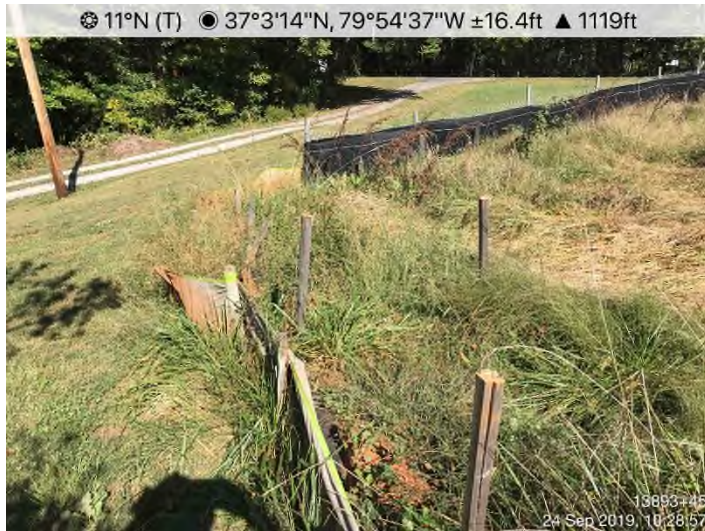
- At the time of inspection, ECDs within the MVP LOD were installed per the approved plans and appeared to be functioning as designed.
- Perimeter controls at STA 13894+12 were upgraded from 12" CFS (ESCP Sheet 14.55) to include an additional row of P1 after the CFS (Figure 1).

Fig. 1: **STA 13894+12** – Controls in place. Controls have been upgraded to include row of P1 after 12" CFS.

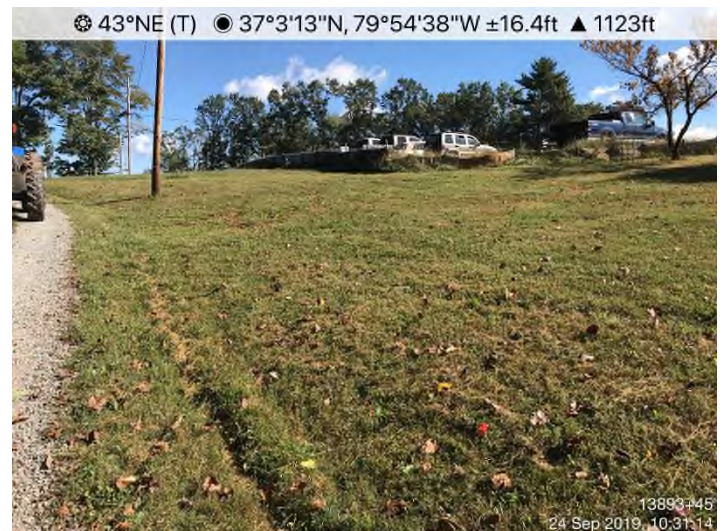
- Stormwater discharge from MVP controls along ROW causing driveway erosion at approx. STA 13894+12 (Figures 1, 2 and 3).
- Stormwater discharge from MVP controls may have caused a "sinkhole" depression off ROW adjacent to the Blackwater River (Figure 4)

Fig. 2: **OFF ROW** – Angle driveway looking NE towards discharge point at STA 13894+12.

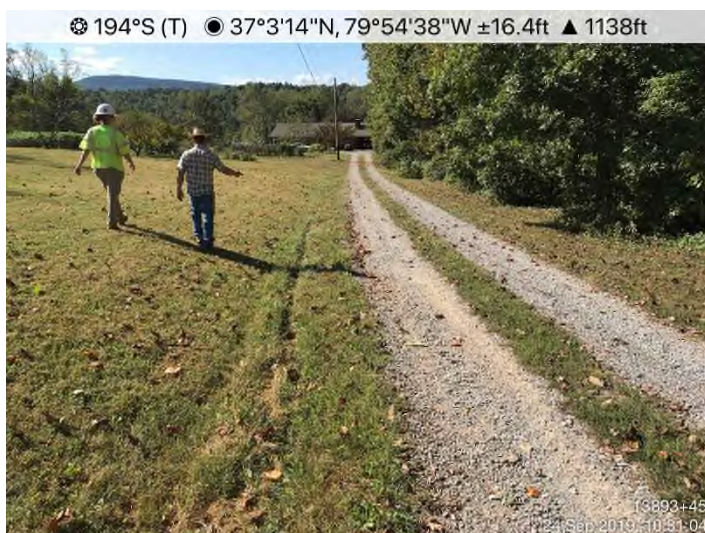
Fig. 3: **OFF ROW** – Angle driveway down gradient from stormwater discharge at STA 13894+12.

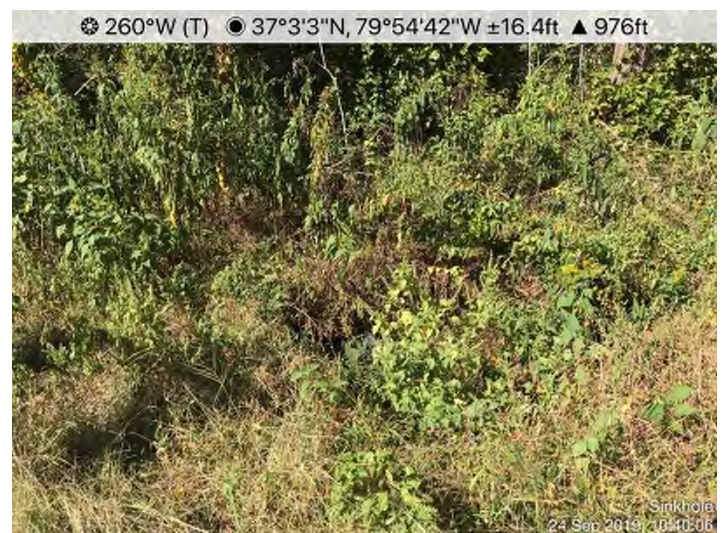
- STA 13904+50 to 13905+00: SSF maintenance needed.
  - STA 13906+55: SSF maintenance needed.
- Causation of the "sinkhole" off ROW adjacent to the Blackwater River (Figure 4) was unable to be determined during the investigation. There was no evidence of sedimentation or scour in this area.

Fig. 4: **OFF ROW** – "Sinkhole" depression adjacent to Blackwater River off MVP ROW.

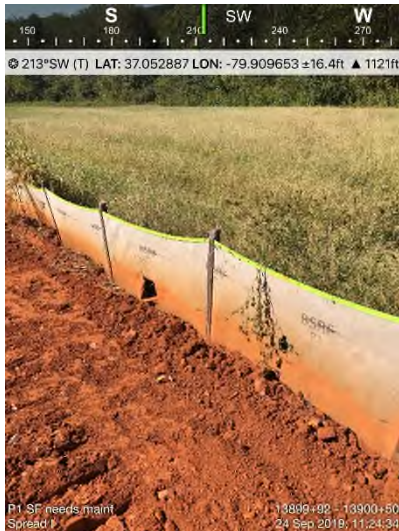
- Following meeting with Angle, three routine maintenance items were noted during the inspection for repair (Figures 5, 6 and 7):
  - STA 13899+92 to 13890+50: P1 maintenance needed.

Fig. 5: **STA 13899+92 to 13900+50** – P1 maintenance needed.

**Recommended Corrective Action:** Install and maintain all controls per the approved plans and PSS&S.

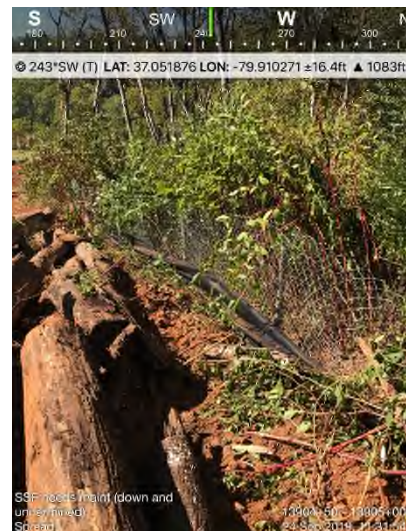
Fig. 6: **STA 13904+50 to 13905+00** – SSF maintenance needed.

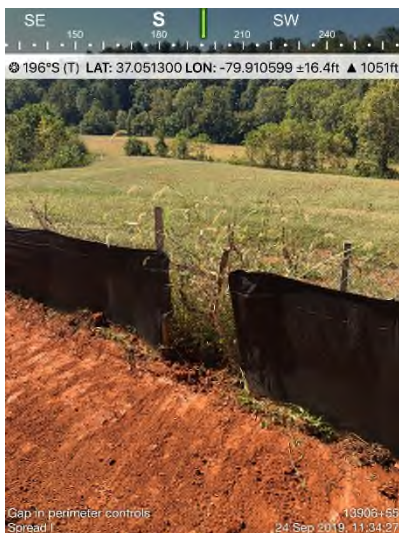
Fig. 7: **STA 13906+55** – SSF maintenance need.

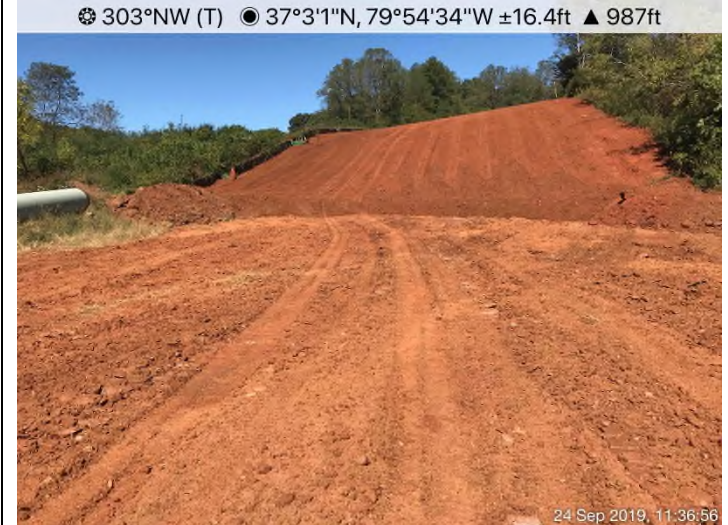
Fig. 8: **STA 13908+00** – Final grading in progress. Spreading topsoil and re-establishing grade to existing contours.
