## FIELD INSPECTION

| <b>Project Name:</b> | Mountain Valley Pipeline | <b>Inspector:</b> | Matthew Grant |
| <b>Inspection Date:</b> | Thursday, September 19, 2019 | <b>Project Contact:</b> | Brian Clauto |
| <b>Spread: Franklin Co. MP267.9-265.9</b> | Spread I | <b>Weather (Wet/Dry/Rain):</b> | Dry |

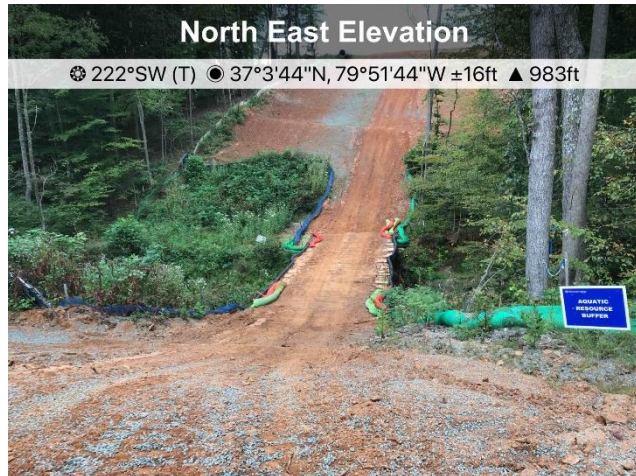
- Fig. 1 At designated stream S-KL48, contractors were in the area working on stabilization,

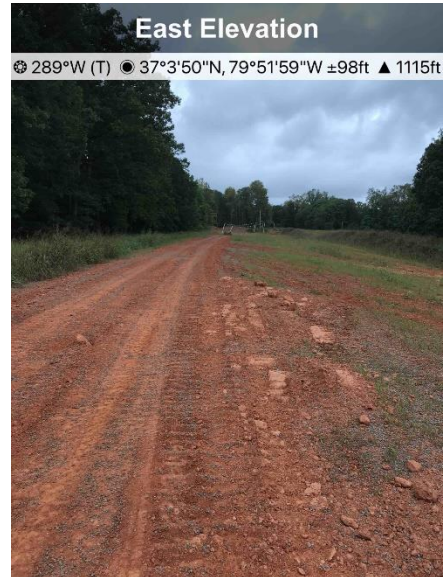
- Fig. 2 Near St14091+00 area has been stabilized with earthguard.

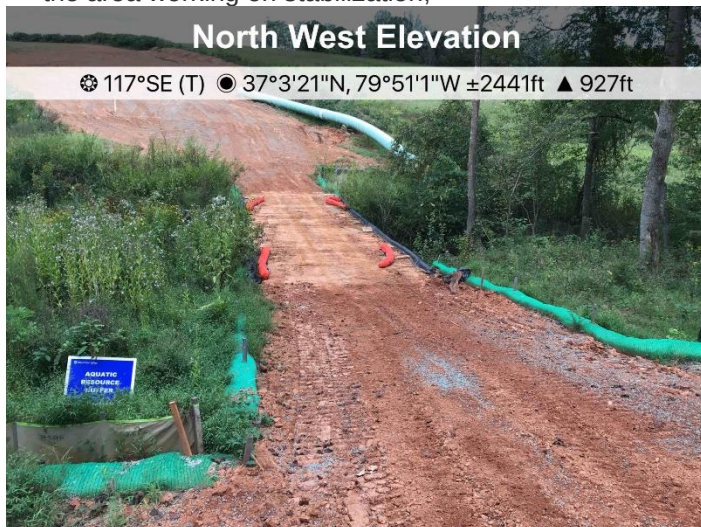
- Fig. 3 At designated stream S-KL51 contractors were in the area working on stabilization,

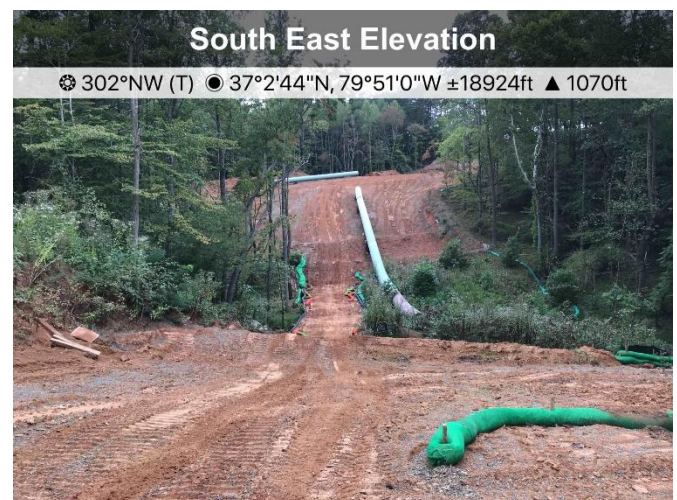
- Fig. 4 At designated stream S-C8 contractors were in the area working on stabilization,
