## FIELD INSPECTION

| <b>Project Name:</b> | Mountain Valley Pipeline | <b>Inspector:</b> | Matthew Grant |
| <b>Inspection Date:</b> | Wednesday, September 18, 2019 | <b>Project Contact:</b> | Brian Clauto |

## FIELD INSPECTION PHOTO LOG

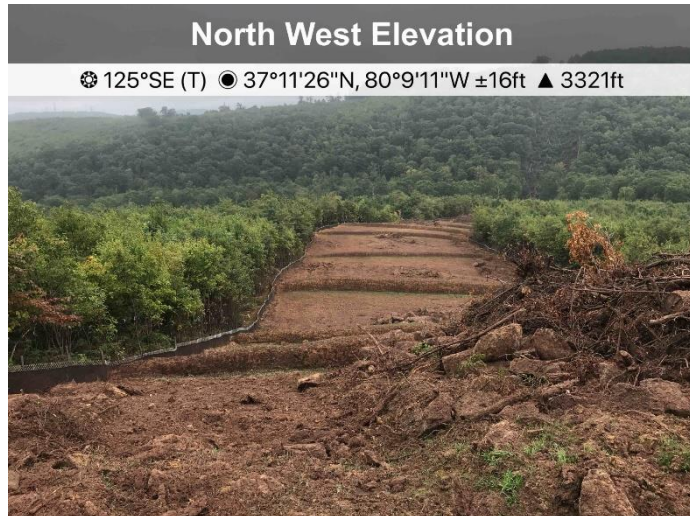
- Fig. 1 Near St12702 stabilization has been applied by helicopter and waterbars have been matted.

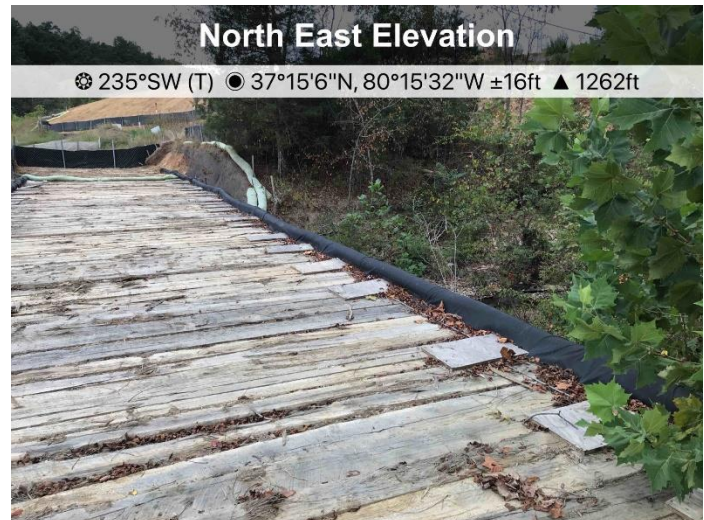
- Fig. 2. At designated stream SC-21 ECD's are in place and functioning.

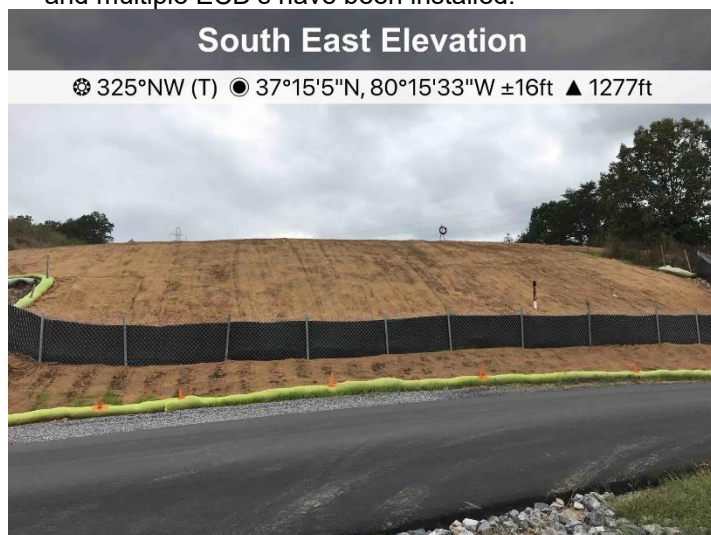
- Fig. 3 Near St12191+00 Bradshaw Rd crossing, matting and multiple ECD's have been installed.

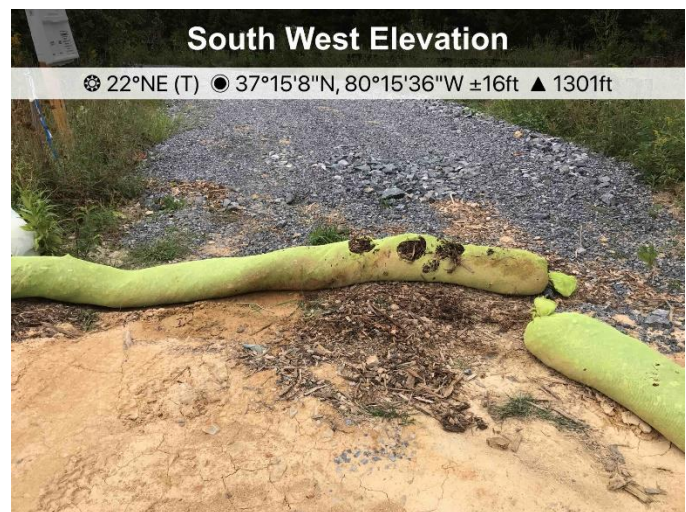
- Inspected designated streams included: S-OO11, S-C21
- ECD's were in place for active construction and functioning at designated streams.
- St12188+00 CFS requires replacement/ maintenance.

- Fig. 4 St12188+00 CFS requires repair/ replacement.

**Recommend Corrective Action:** Maintain and install all controls per the approved plan and specs
