## FIELD INSPECTION

| <b>Project Name:</b> | Mountain Valley Pipeline | <b>Inspector:</b> | Marshall Willis |
| <b>Inspection Date:</b> | Friday, September 13, 2019 | <b>Project Contact:</b> | Brian Clauto, Cory Chalmers |
| <b>Spread H:</b><br>Montgomery County<br>Roanoke County | STA 12422+32 – 12435+16<br>STA 12437+00 – 12448+00<br>MVP-RO-279.01 | <b>Weather (Wet/Dry/Rain):</b> | Rainy |

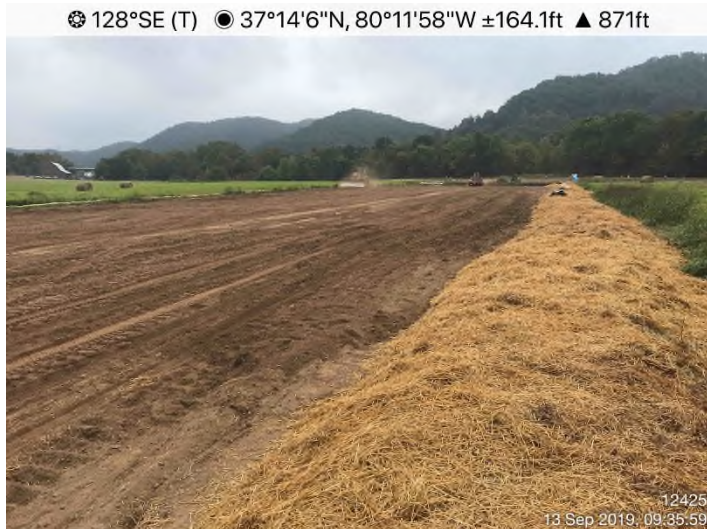
Fig. 1: **STA 12425+00** – Controls installed. Diversion berm stabilized. ROW stabilization and seeding in progress.

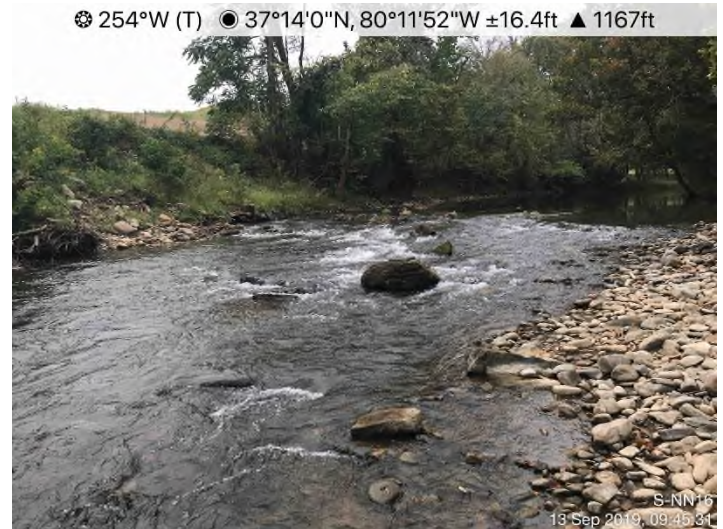
Fig. 2: **Stream S-NN16** – Roanoke River crossing. No disturbance.

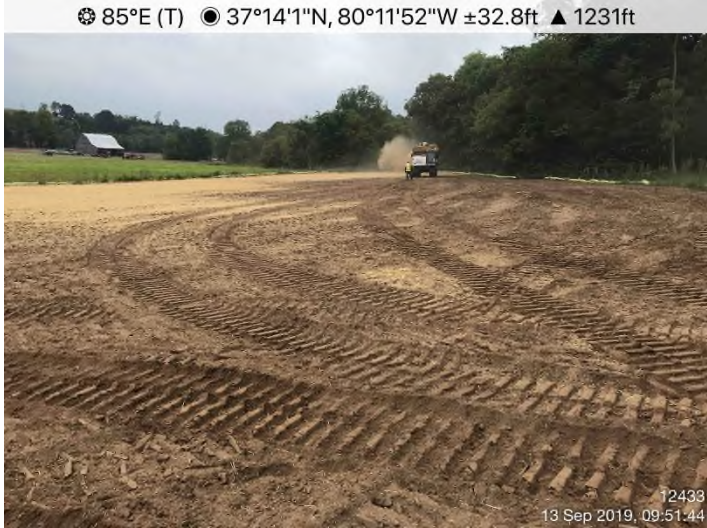
Fig. 3: **STA 12433+00** – Stabilization in progress in ATWS 725.

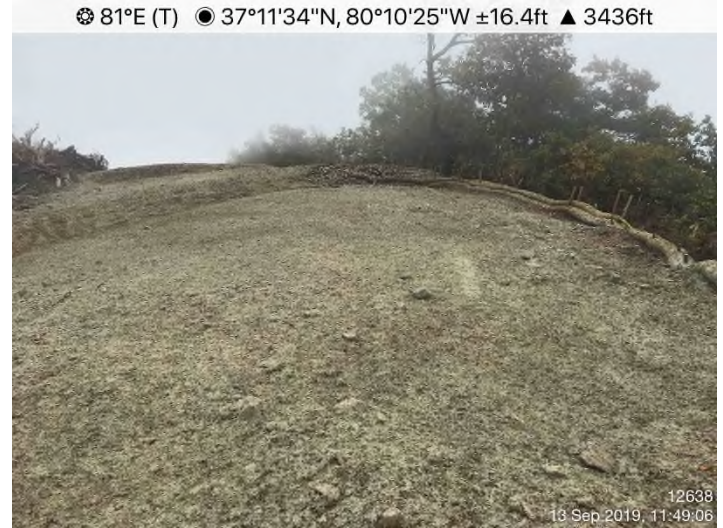
Fig. 4: **STA 12638+00** – Controls in place. Area stabilized with hydro-mulch and erosion blanket.
