## FIELD INSPECTION

| <b>Project Name:</b> | Mountain Valley Pipeline | <b>Inspector:</b> | Marshall Willis |
| <b>Inspection Date:</b> | Thursday, September 12, 2019 | <b>Project Contact:</b> | Brian Clauto, Cory Chalmers |

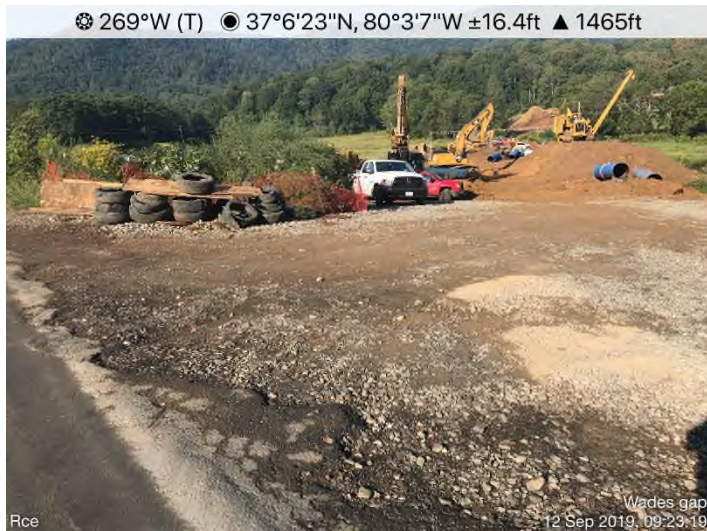
Fig. 1: **STA 13316+06** – RCE maintenance needed.

STA 13316+06: Maintain RCE.  
 STA 13309+09: Repair crossing fabric underlayment.  
 STA 13061+44: Properly store fertilizer per SWPPP.  
 STA 12995+00: Properly store fertilizer per SWPPP.

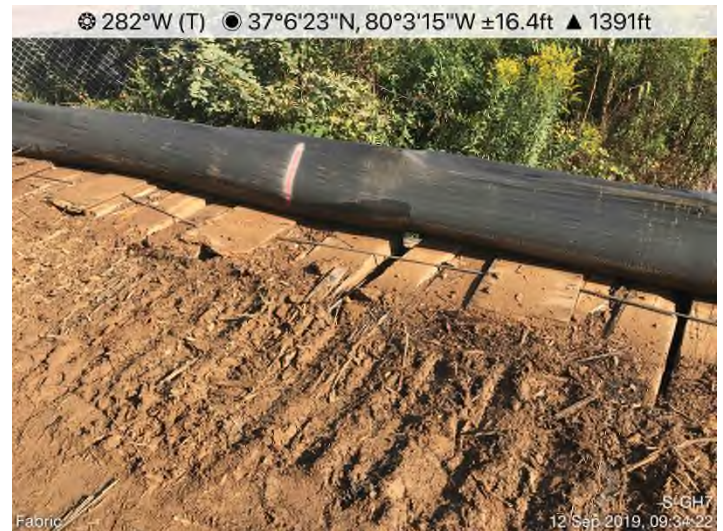
Fig. 2: **STA 13309+09** – Damaged fabric on stream S-GH7 crossing.

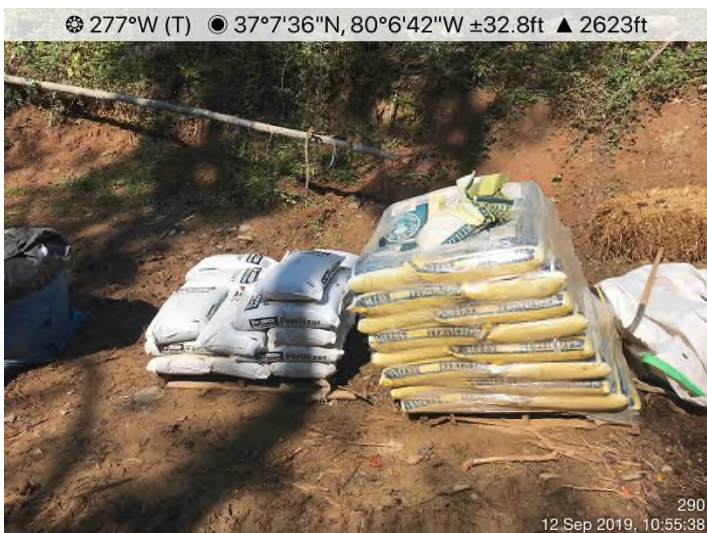
Fig. 3: **STA 13061+44** – Open bags of fertilizer, not in use.

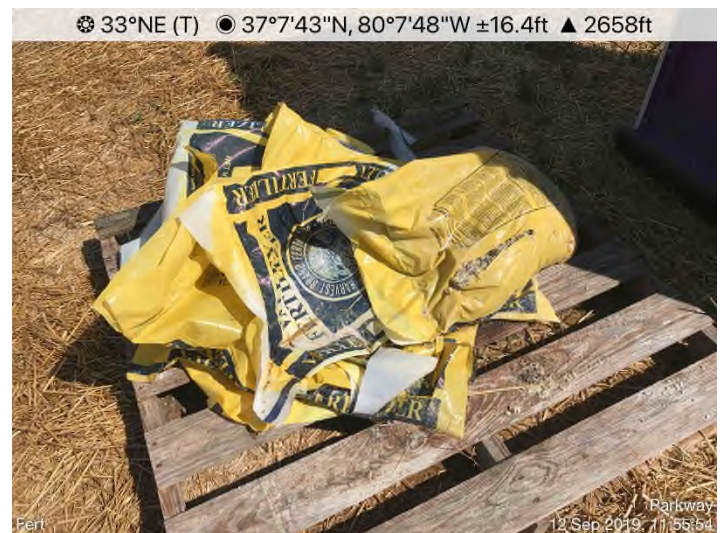
Fig. 4: **STA 12995+00** – Open bags of fertilizer, not in use.
