## FIELD INSPECTION

| <b>Project Name:</b> | Mountain Valley Pipeline | <b>Inspector:</b> | Marshall Willis |
| <b>Inspection Date:</b> | Wednesday, September 11, 2019 | <b>Project Contact:</b> | Brian Clauto, Cory Chalmers |
| <b>Spread I:<br/>Franklin County</b> | STA 13415+51 – 13444+93<br>MVP-FR-293.02<br>STA 13892+45 – 13949+00 | <b>Weather (Wet/Dry/Rain):</b> | Dry |

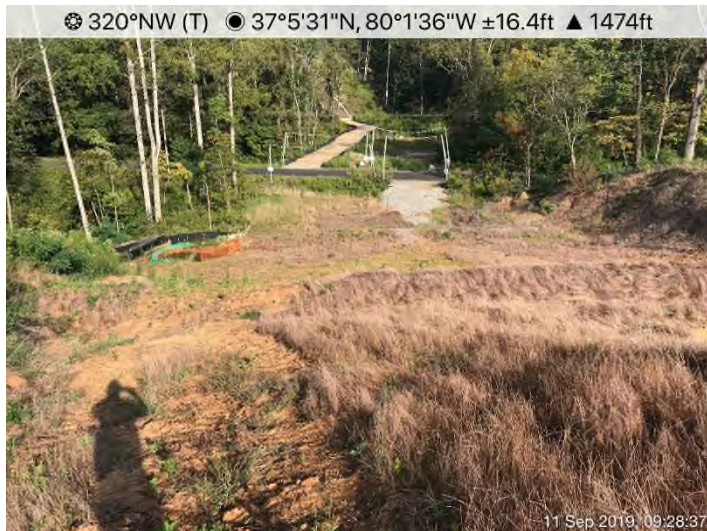
Fig. 1: **STA 13420+00** – Controls in place. Area stabilized.

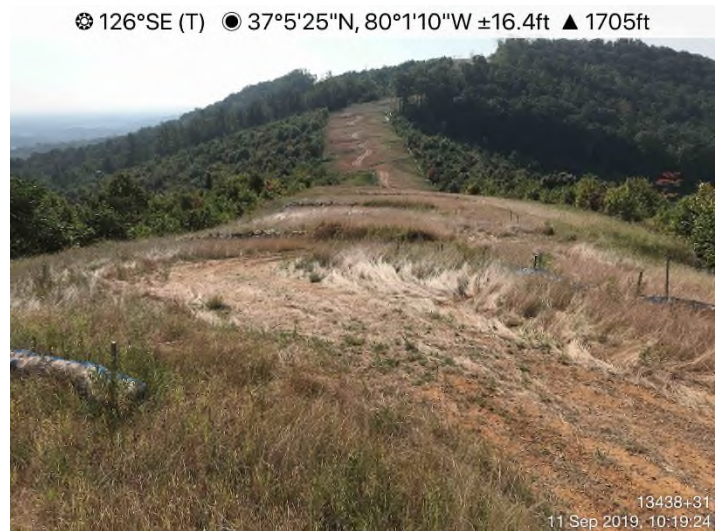
Fig. 2: **STA 13438+31** – Controls in place. Area stabilized.

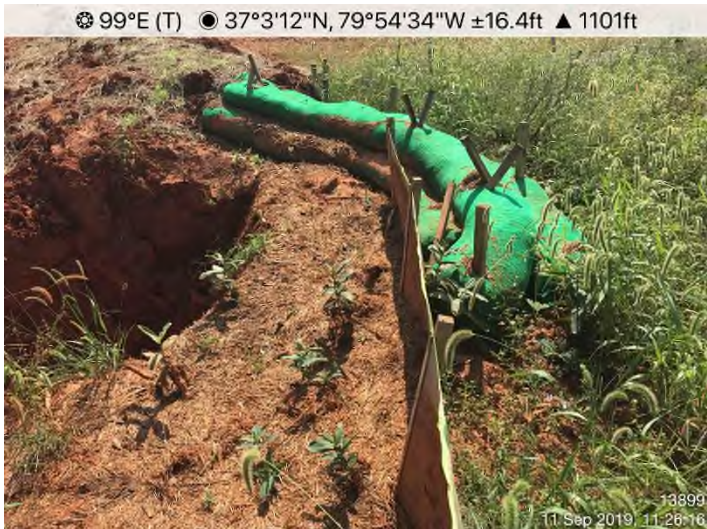
STA 13898+00: Discharge bypassing CFS end treatment.  
STA 13899+00: Inadequate stabilization outside of travel lane.

Fig. 3: **STA 13898+00** – Discharge bypassing end-treatment.

**Recommended Corrective Action:** Install and maintain all controls per the approved plans and PSS&S.

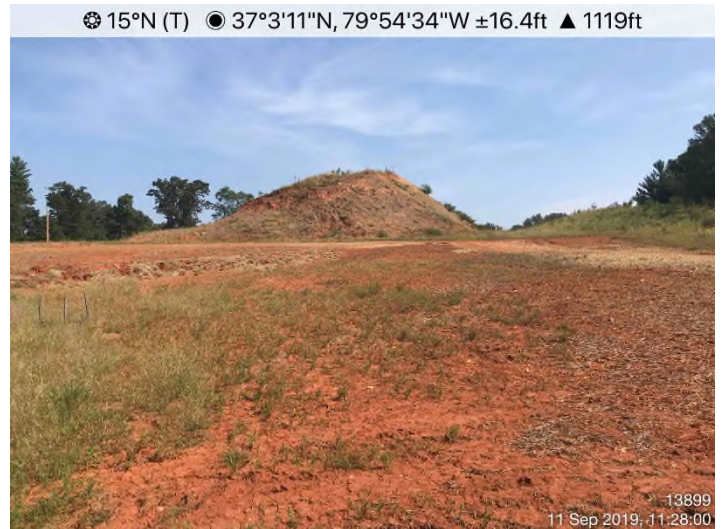
Fig. 4: **STA 13899+00** – Inadequate stabilization outside of travel lane.
