## FIELD INSPECTION

<b>Project Name:</b>	<b>Mountain Valley Pipeline</b>	<b>Inspector:</b>	<b>Marshall Willis</b>
<b>Inspection Date:</b>	<b>Tuesday, September 10, 2019</b>	<b>Project Contact:</b>	<b>Brian Clauto, Cory Chalmers</b>
<b>Spread H:</b> <b>Montgomery County</b>	<b>STA 12298+39 – 12387+85</b> <b>MVP-MN-276.03</b>	<b>Weather (Wet/Dry/Rain):</b>	<b>Dry</b>

# FIELD INSPECTION PHOTO LOG

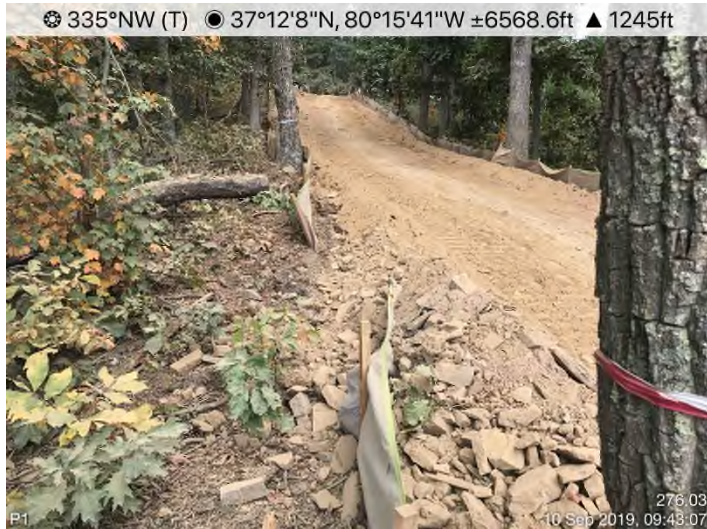
Fig. 1: **STA 12298+00** – Maintain P1 along MVP-MN-276.03.

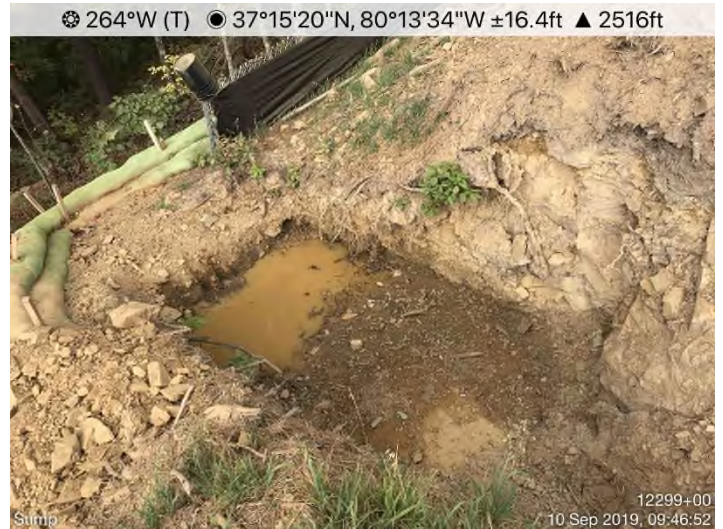
Fig. 2: **STA 12299+00** – Sump maintenance needed.

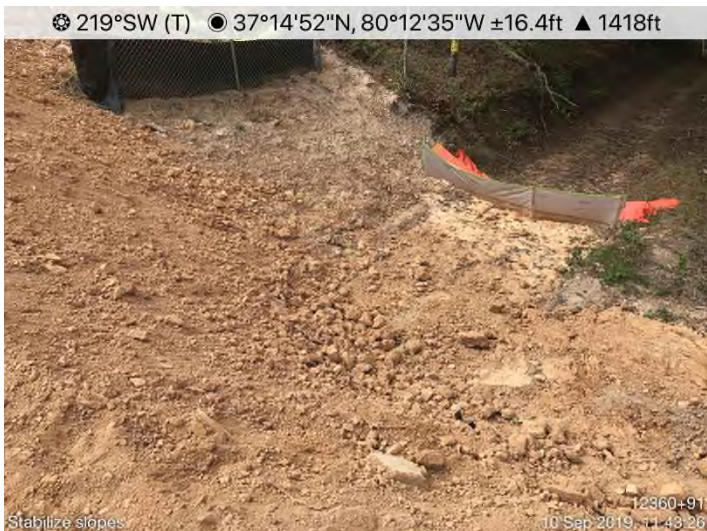
Fig. 3: **STA 12360+91** – Stabilize fill slopes.

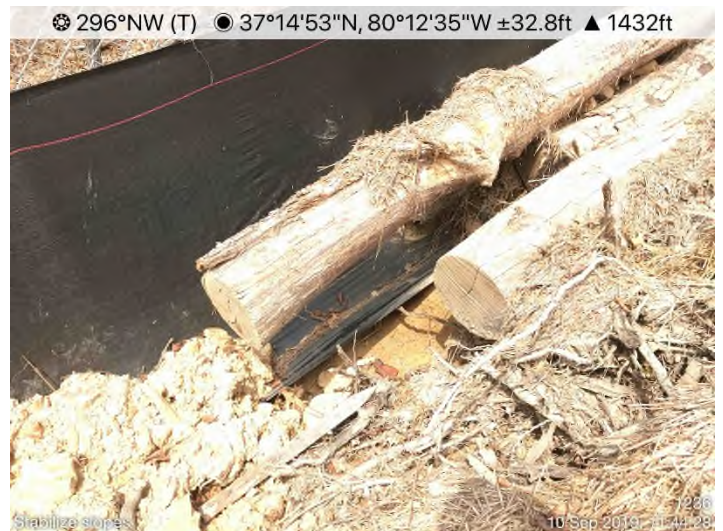
Fig. 4: **STA 12361+10** – SSF undermined.

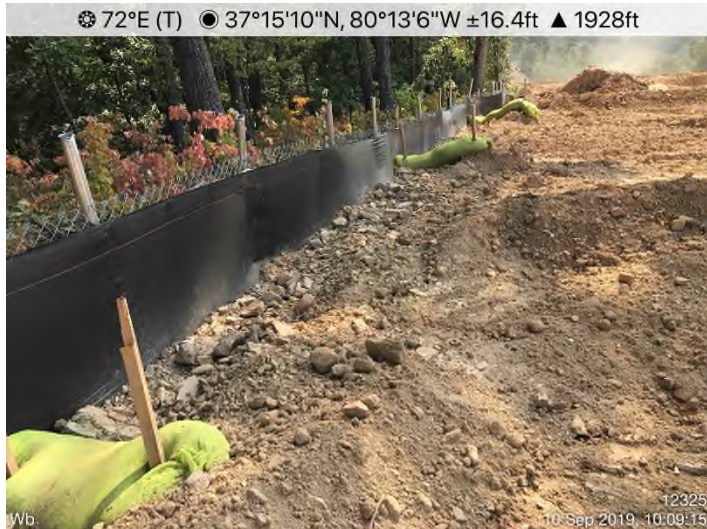
Fig. 5: **STA 12321+00 to 12356+00** – Waterbars do not extend full length of ROW.

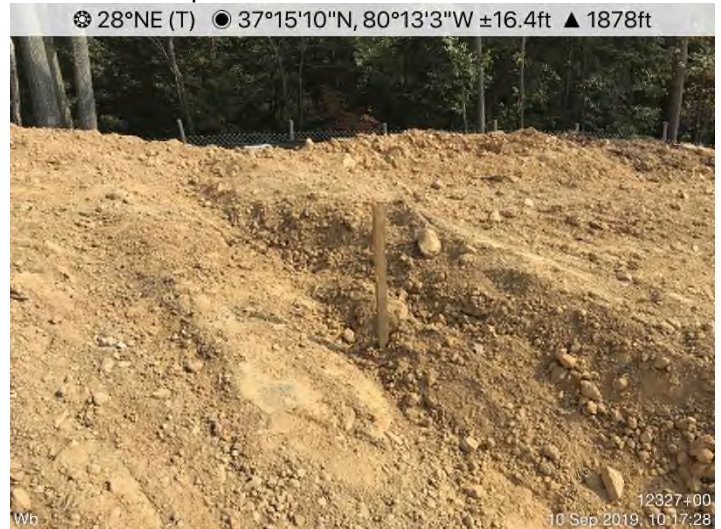
Fig. 6: **STA 12321+00 to 12356+00** – Waterbars do not extend full length of ROW. Waterbars do not meet dimensional requirements of PSS&S.

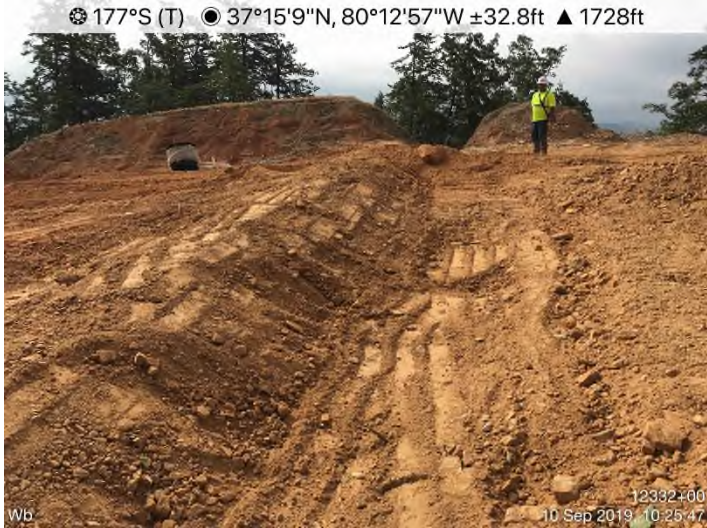
Fig. 7: **STA 12321+00 to 12356+00** – Waterbars do not have positive drainage to end treatments.

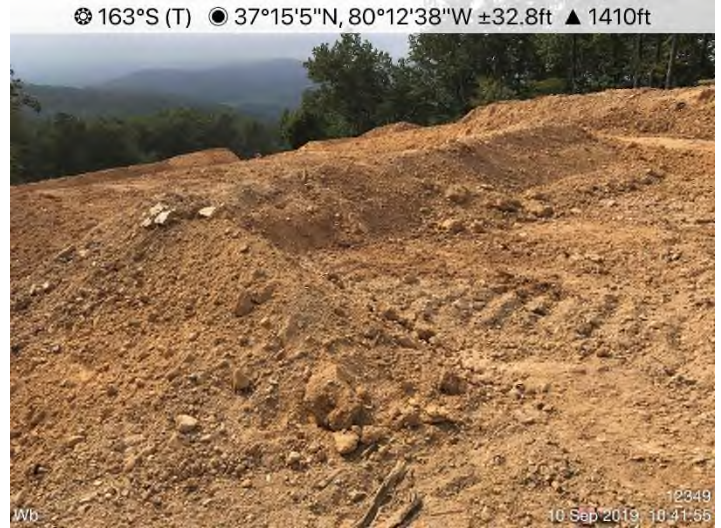
Fig. 8: **STA 12321+00 to 12356+00** – Waterbars do not extend full length of ROW. Waterbars do not have positive drainage to end treatments.
