## FIELD INSPECTION

| <b>Project Name:</b> | Mountain Valley Pipeline | <b>Inspector:</b> | Matthew Grant |
| <b>Inspection Date:</b> | Thursday, September 5, 2019 | <b>Project Contact:</b> | Brian Clauto |

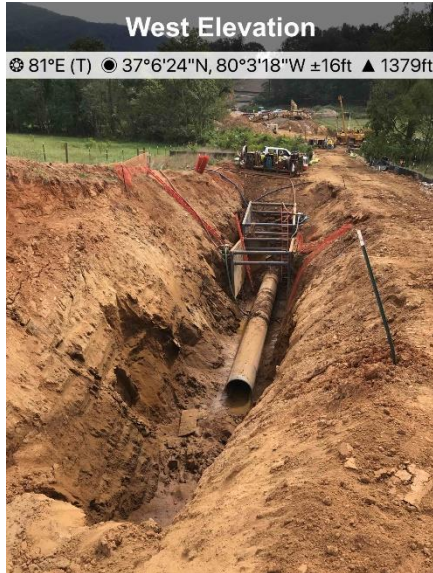
- Fig. 1 Active bore site near GH-7

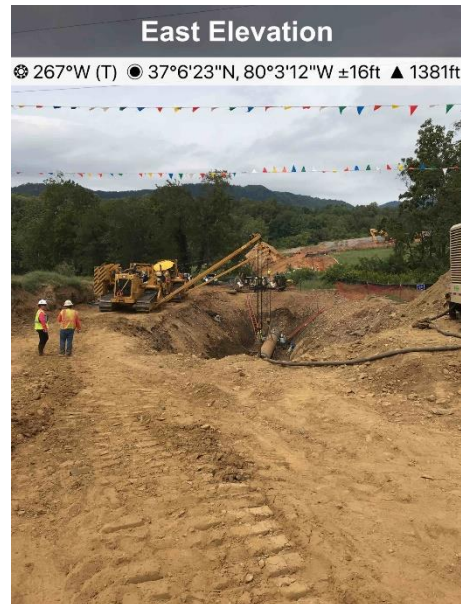
- Inspected designated streams included: SH-1, W-EF3, S-II4, GH-7
- ECD's were in place for active construction and functioning at designated stream & wetland crossings.
- Near ST13308+99 the stock pile lacks stabilization

- Fig. 2. Active bore site near GH-7, stockpile near ST13308+99 lacks stabilization.

**Recommend Corrective Action:** Maintain and install all controls per the approved plan and specs

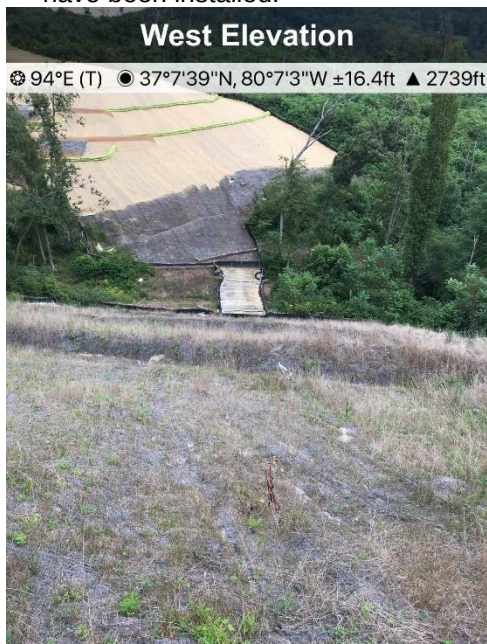
- Fig. 3 Near MP 246.7 stabilization and permanent bars have been installed.

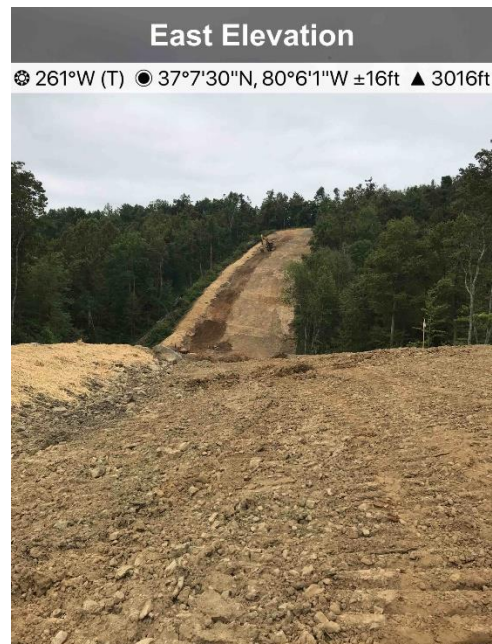
- Fig. 4 Near St13098+00 ongoing grading
