## FIELD INSPECTION

| <b>Project Name:</b> | Mountain Valley Pipeline | <b>Inspector:</b> | Matthew Grant |
| <b>Inspection Date:</b> | Wednesday, September 4, 2019 | <b>Project Contact:</b> | Brian Clauto |

## FIELD INSPECTION PHOTO LOG

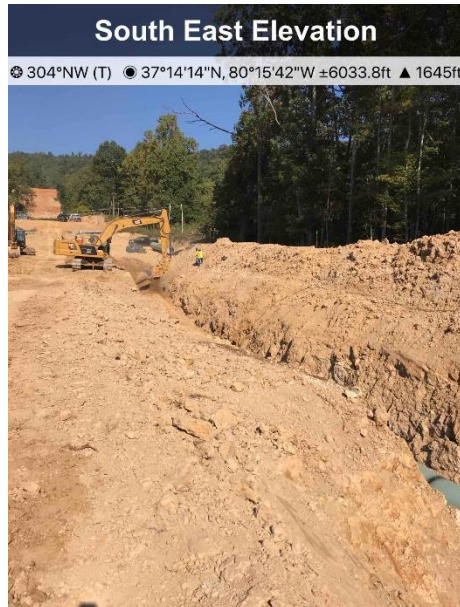
- Fig. 1 Near MP 229 backfilling of trench

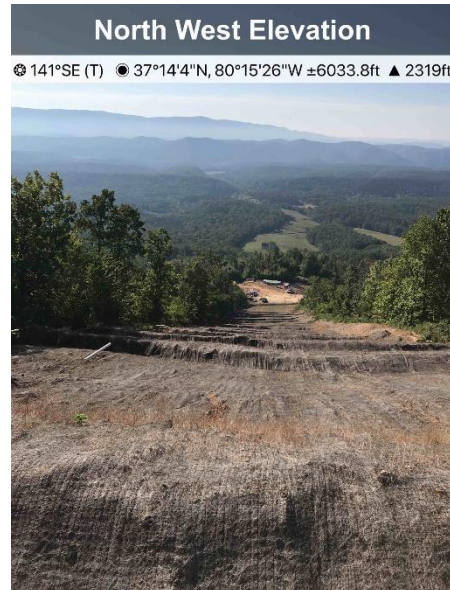
- Fig. 2 Near MP 228.3 area remains matted.

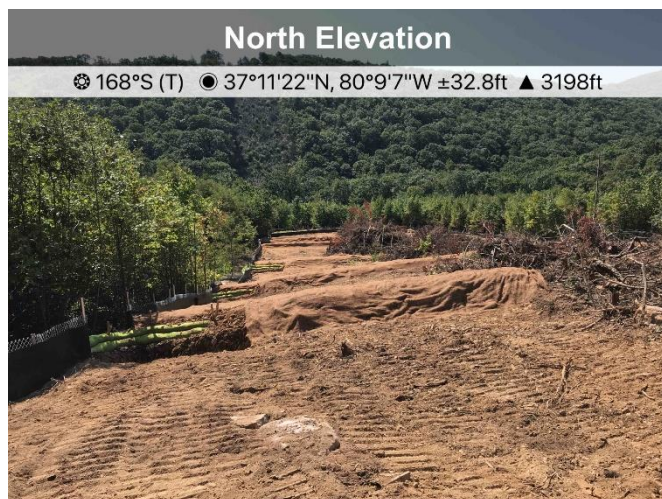
- Fig. 3 Near MP 240.3 waterbars have been matted

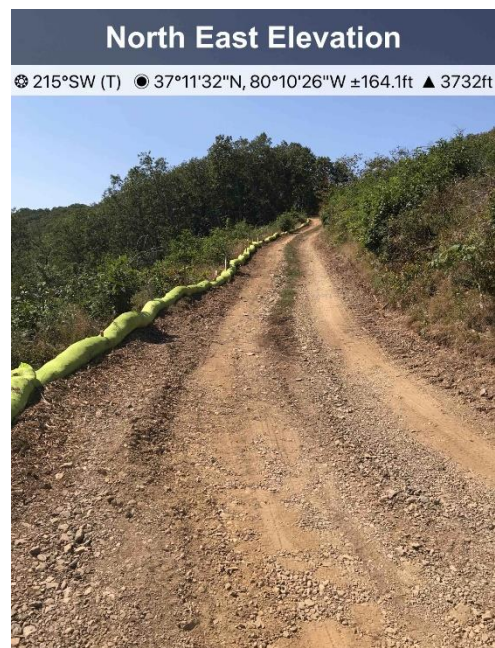
- Fig. 4 ECD's in place at AR279.01
