## FIELD INSPECTION

| <b>Project Name:</b> | Mountain Valley Pipeline | <b>Inspector:</b> | Matthew Grant |
| <b>Inspection Date:</b> | Thursday, August 29, 2019 | <b>Project Contact:</b> | Brian Clauto |
| <b>Spread: Franklin Co.<br/>MP268.7-269.8<br/>MN-AR32</b> | Spread I | <b>Weather (Wet/Dry/Rain):</b> | Dry |

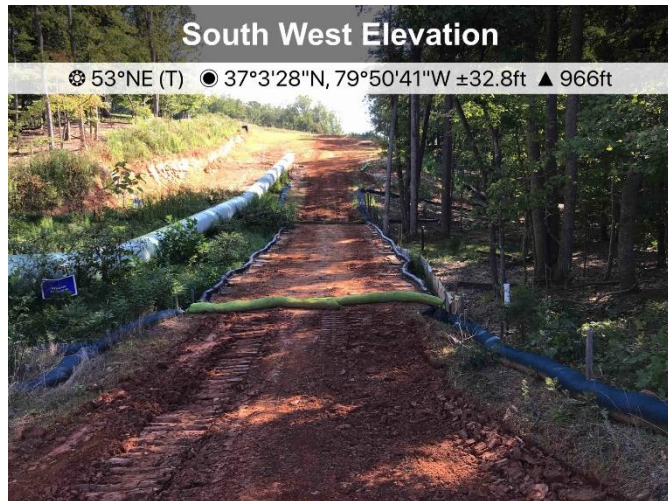
- Fig. 1 Designated stream S-KL52, ECD's in place and functioning.

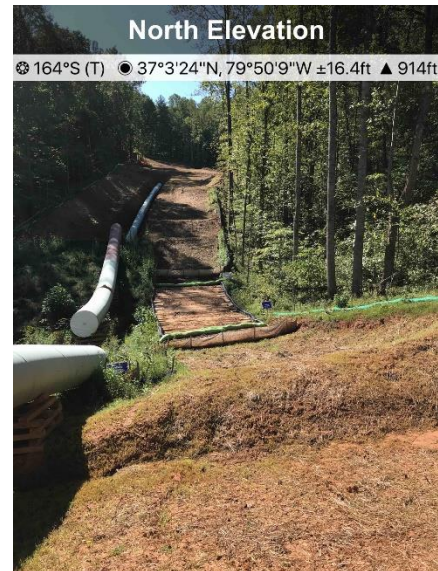
- Fig. 2 Designated stream S-C19, ECD's in place and functioning.

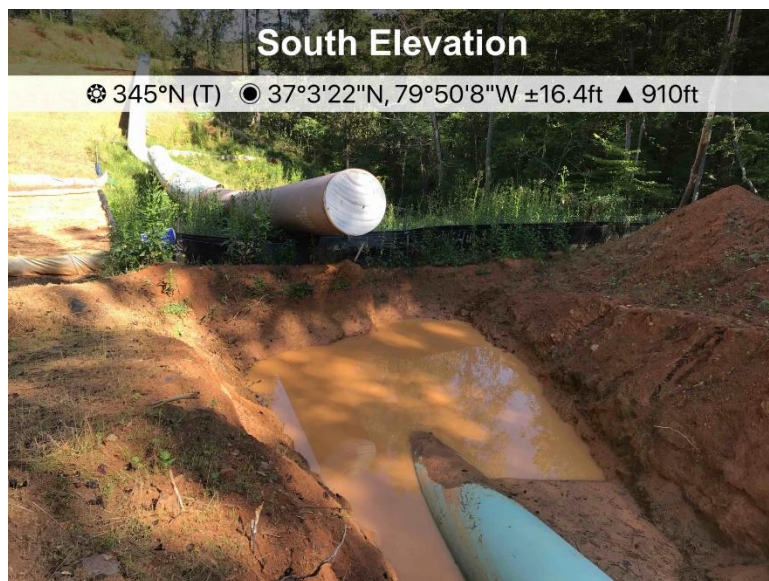
- Fig. 3 Open trench at St14217

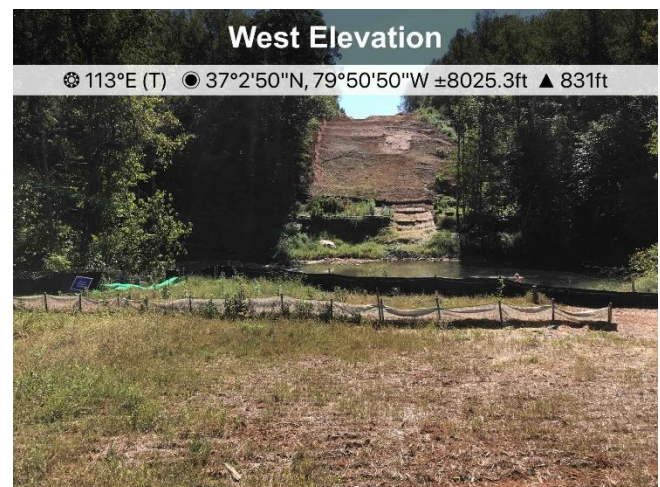
- Fig. 4 Designated stream S-F11, ECD's in place and functioning.
