## FIELD INSPECTION

| <b>Project Name:</b> | Mountain Valley Pipeline | <b>Inspector:</b> | Matthew Grant |
| <b>Inspection Date:</b> | Wednesday, August 28, 2019 | <b>Project Contact:</b> | Brian Clauto |

## FIELD INSPECTION PHOTO LOG

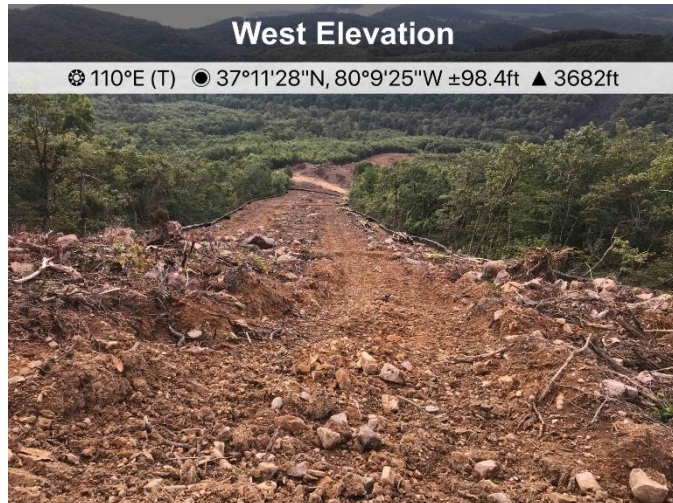
Fig. 1 St12690 lacks stabilization

**Recommend Corrective Action:** Maintain and install all controls per the approved plan and specs

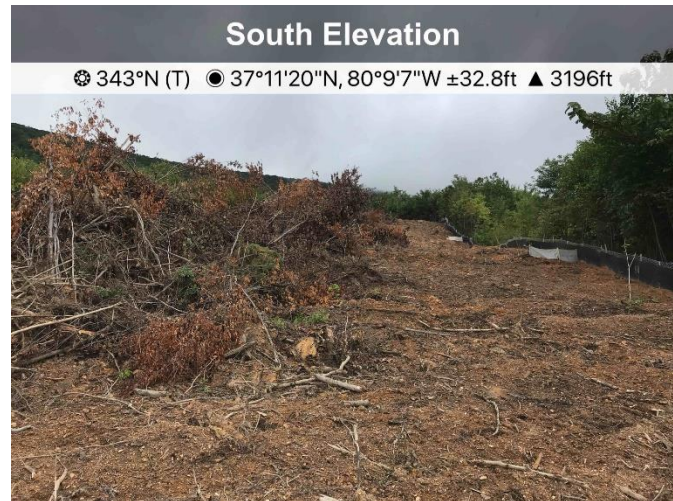
Fig. 2 St12712 lacks stabilization

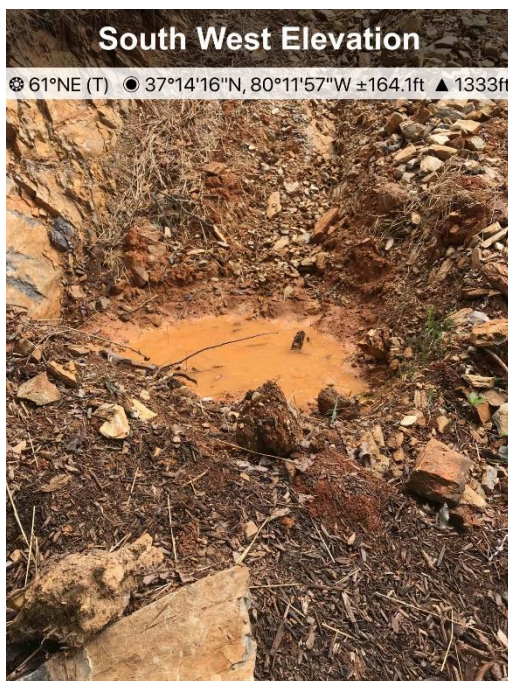
Fig. 3 St12417+00 sump lacks adequate capacity

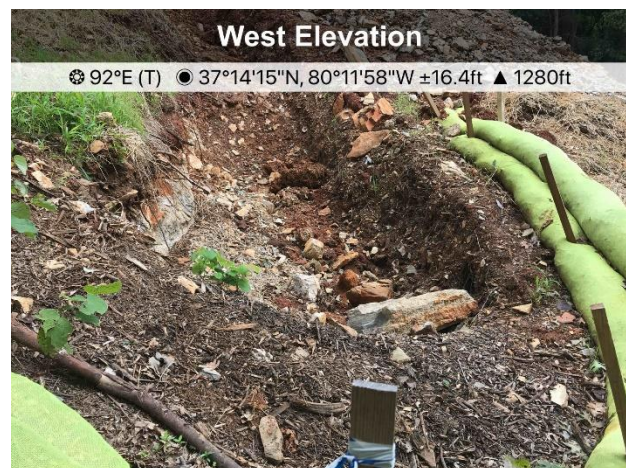
Fig. 4 St12418+00 sump lacks adequate capacity
