## FIELD INSPECTION

| Project Name: | Mountain Valley Pipeline | Inspector: | Marshall Willis |
| Inspection Date: | Tuesday, August 27, 2019 | Project Contact: | Brian Clauto, Cory Chalmers |
| Spread I:<br>Franklin County | STA 14131+21 – 14209+88<br>STA 13784+35 – 13828+95 | Weather (Wet/Dry/Rain): | Rainy |

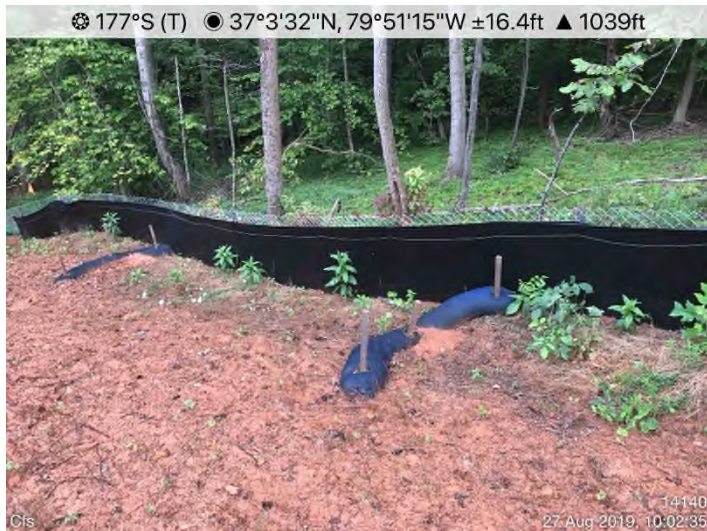
Fig. 1: **STA 14140+00** – CFS maintenance needed.

**Recommended Corrective Action:** Install and maintain all controls per the approved plans and PSS&S.

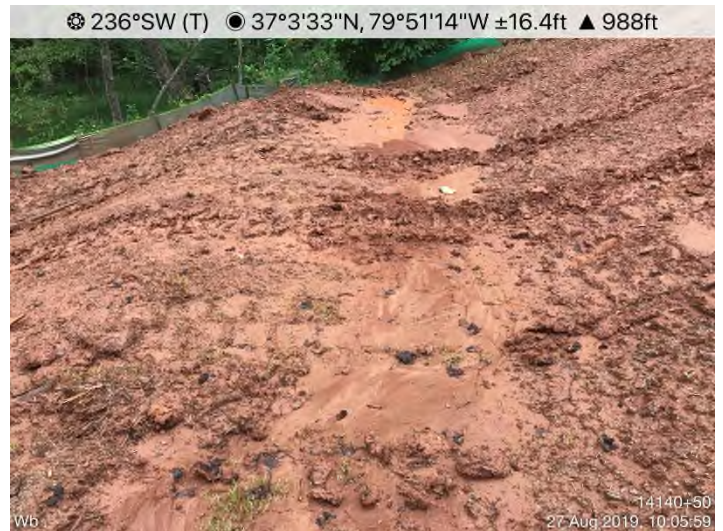
Fig. 2: **STA 14140+50** – Waterbar maintenance needed.

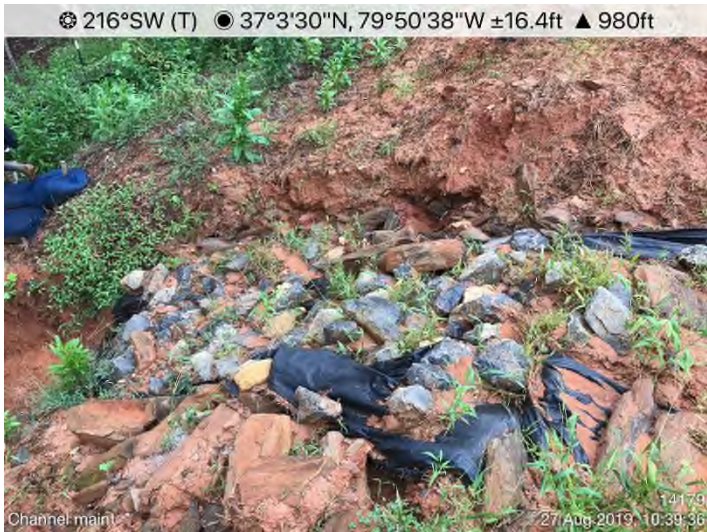
Fig. 3: **STA 14179+00** – Rock swale maintenance needed.

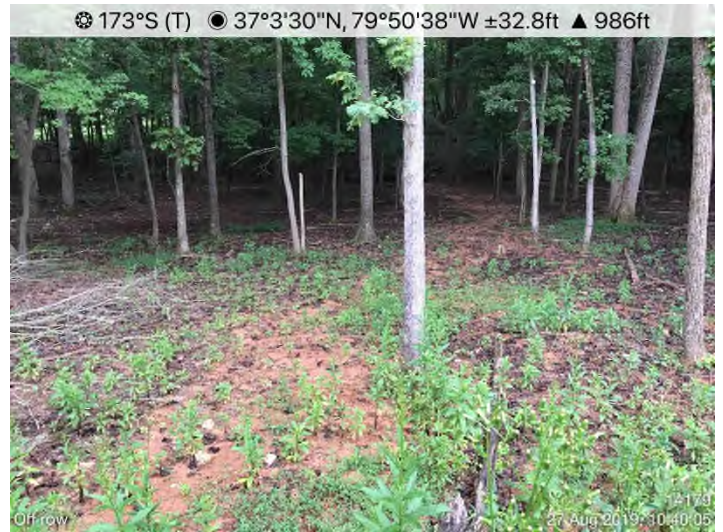
Fig. 4: **STA 14179+00** – Sediment off ROW.

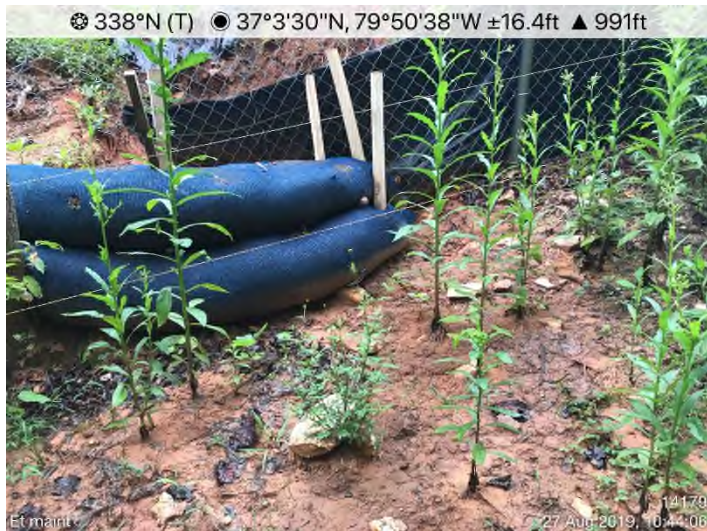
Fig. 5: **STA 14179+00** – End-treatment maintenance needed.

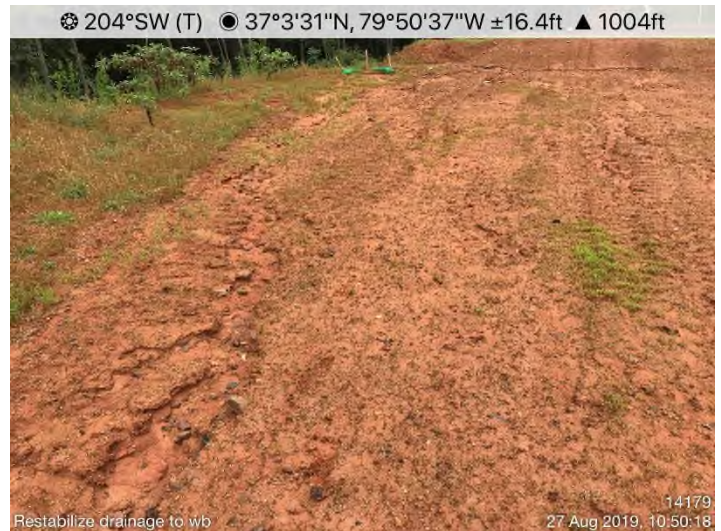
Fig. 6: **STA 14179+00** – Re-stabilization needed.

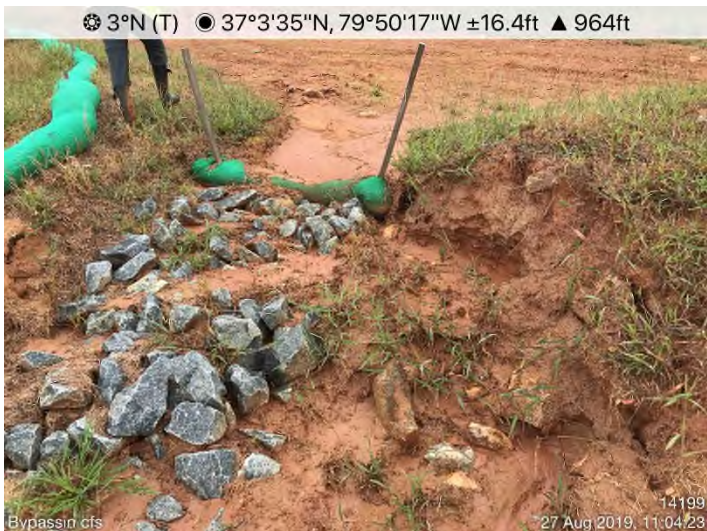
Fig. 7: **STA 14199+00** – CFS maintenance needed.

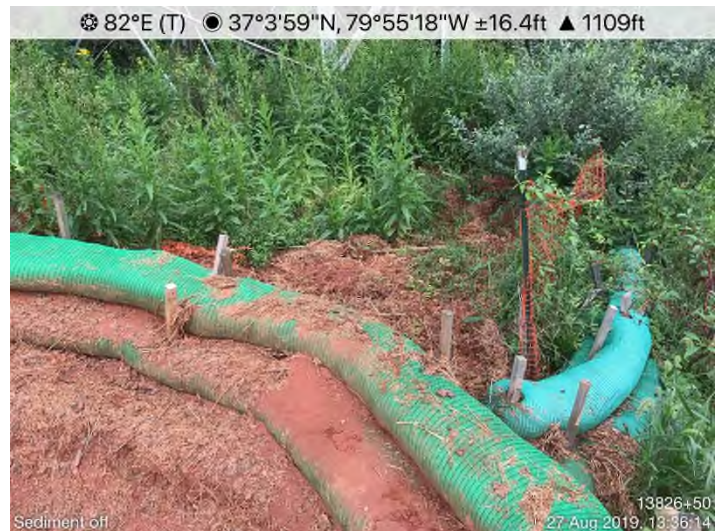
Fig. 8: **STA 13826+50** – Sediment off ROW.
