## FIELD INSPECTION

<b>Project Name:</b>	Mountain Valley Pipeline	<b>Inspector:</b>	Matthew Grant
<b>Inspection Date:</b>	Thursday, August 22, 2019	<b>Project Contact:</b>	Brian Clauto
<b>Spread: Franklin Co. MP261 St13805-13803 MP265.9</b>	Spread I	<b>Weather (Wet/Dry/Rain):</b>	Dry

## FIELD INSPECTION PHOTO LOG

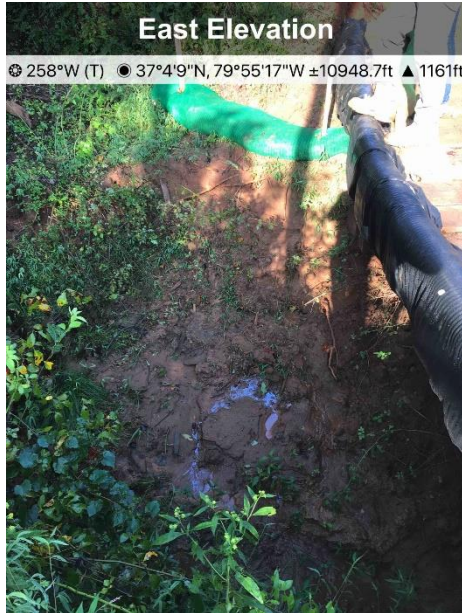
- Fig. 1 Designated stream S-D20 has been impacted by sediment.

**Recommend Corrective Action:** Maintain and install all controls per the approved plan and specs, remove sediment per DEQ approval.

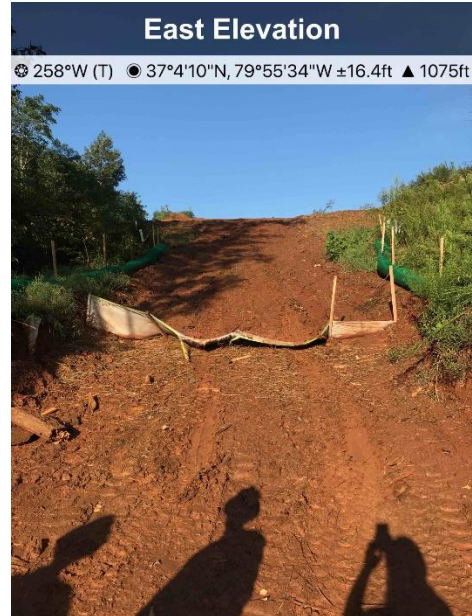
- Fig. 2 St13805 P1 is down, repair or replace with adequate control

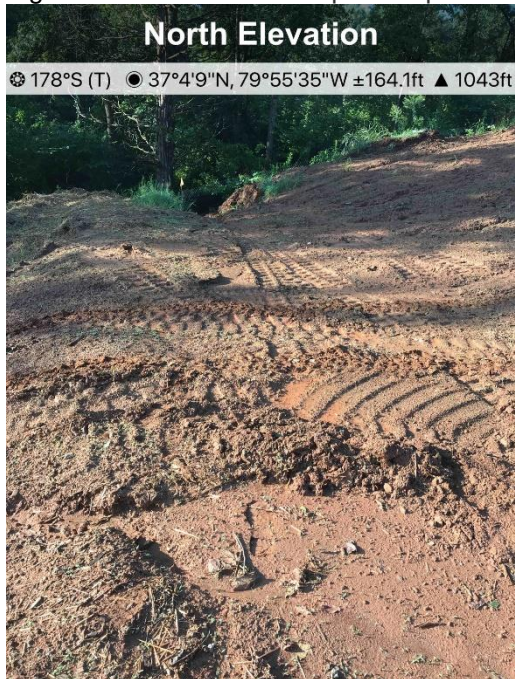
- Fig. 3 St13805 waterbar requires repair

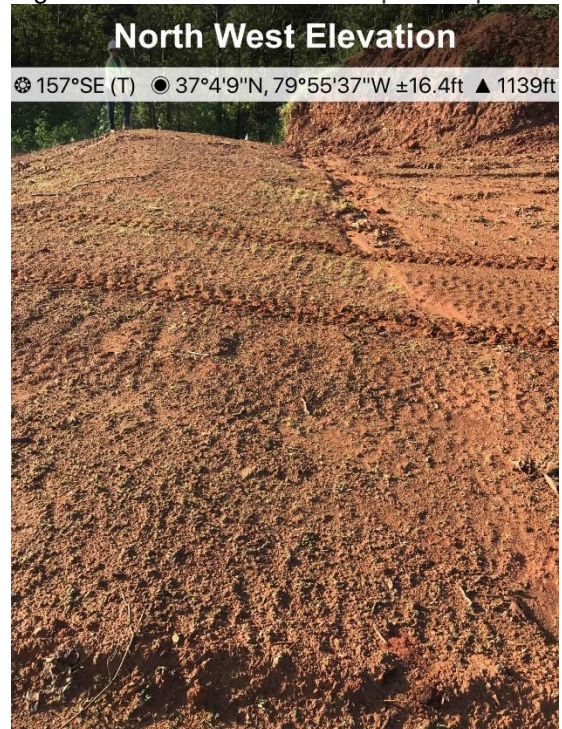
- Fig. 4 St13803+50 waterbar requires repair

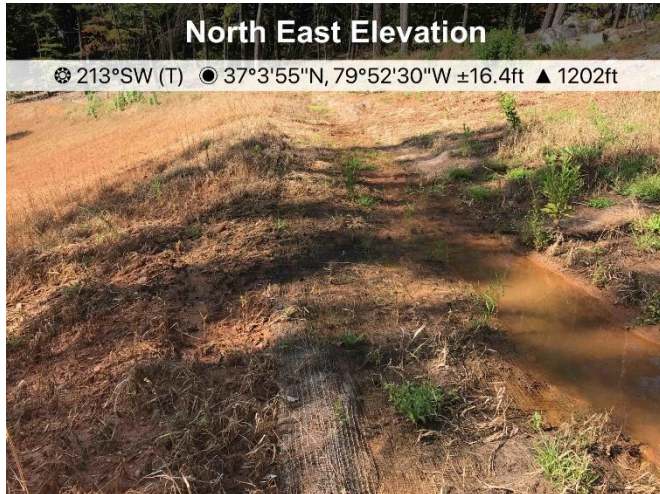
- Fig. 5 St14064+70 waterbar requires repair for adequate height

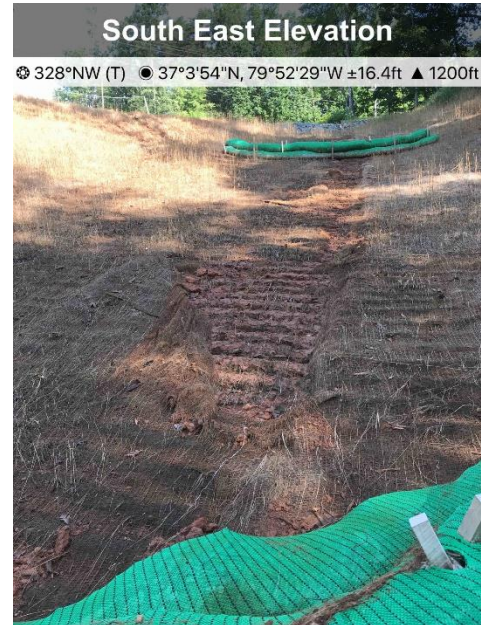
- Fig. 6 St14063 stabilization matting requires repair

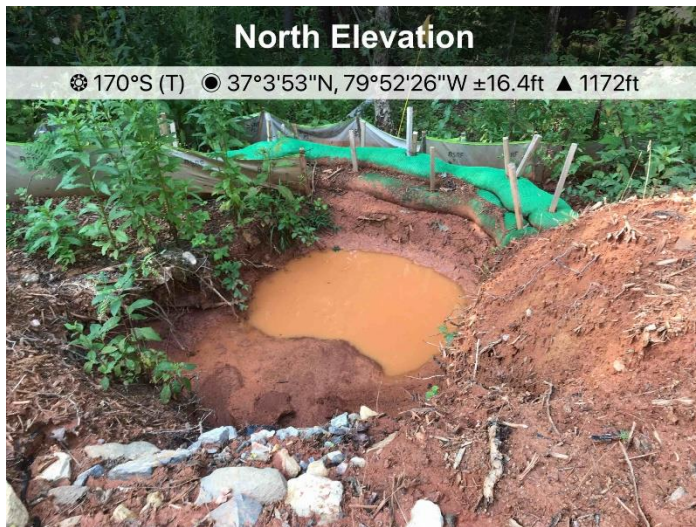
- Fig. 7 St14067 sump requires maintenance

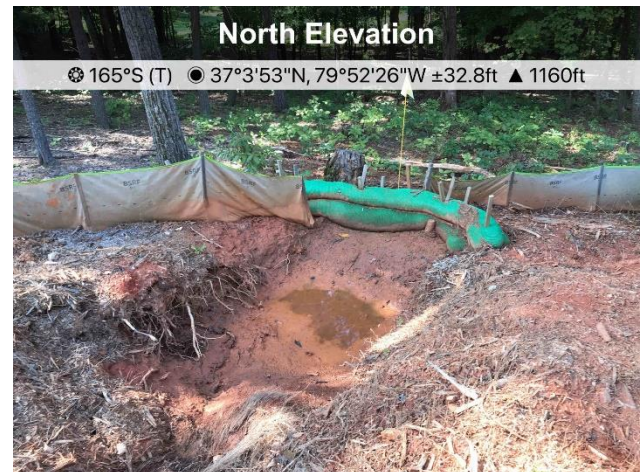
- Fig. 8 St14068+50 sump requires maintenance

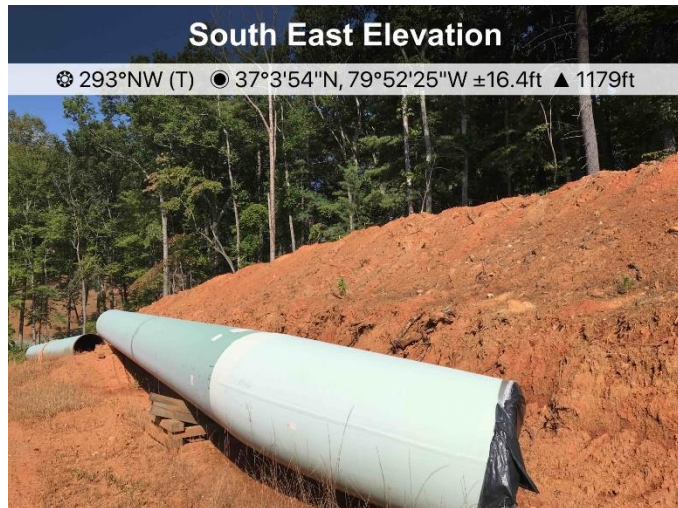
- Fig. 9 S14067+25 stockpile requires additional stabilization
